Client:
Mr. & Mrs. Walton

Project:
Suncroft
5 Station Road, Warkworth
Northumberland

Site Plan as Proposed
Site entrance

22014 **505**

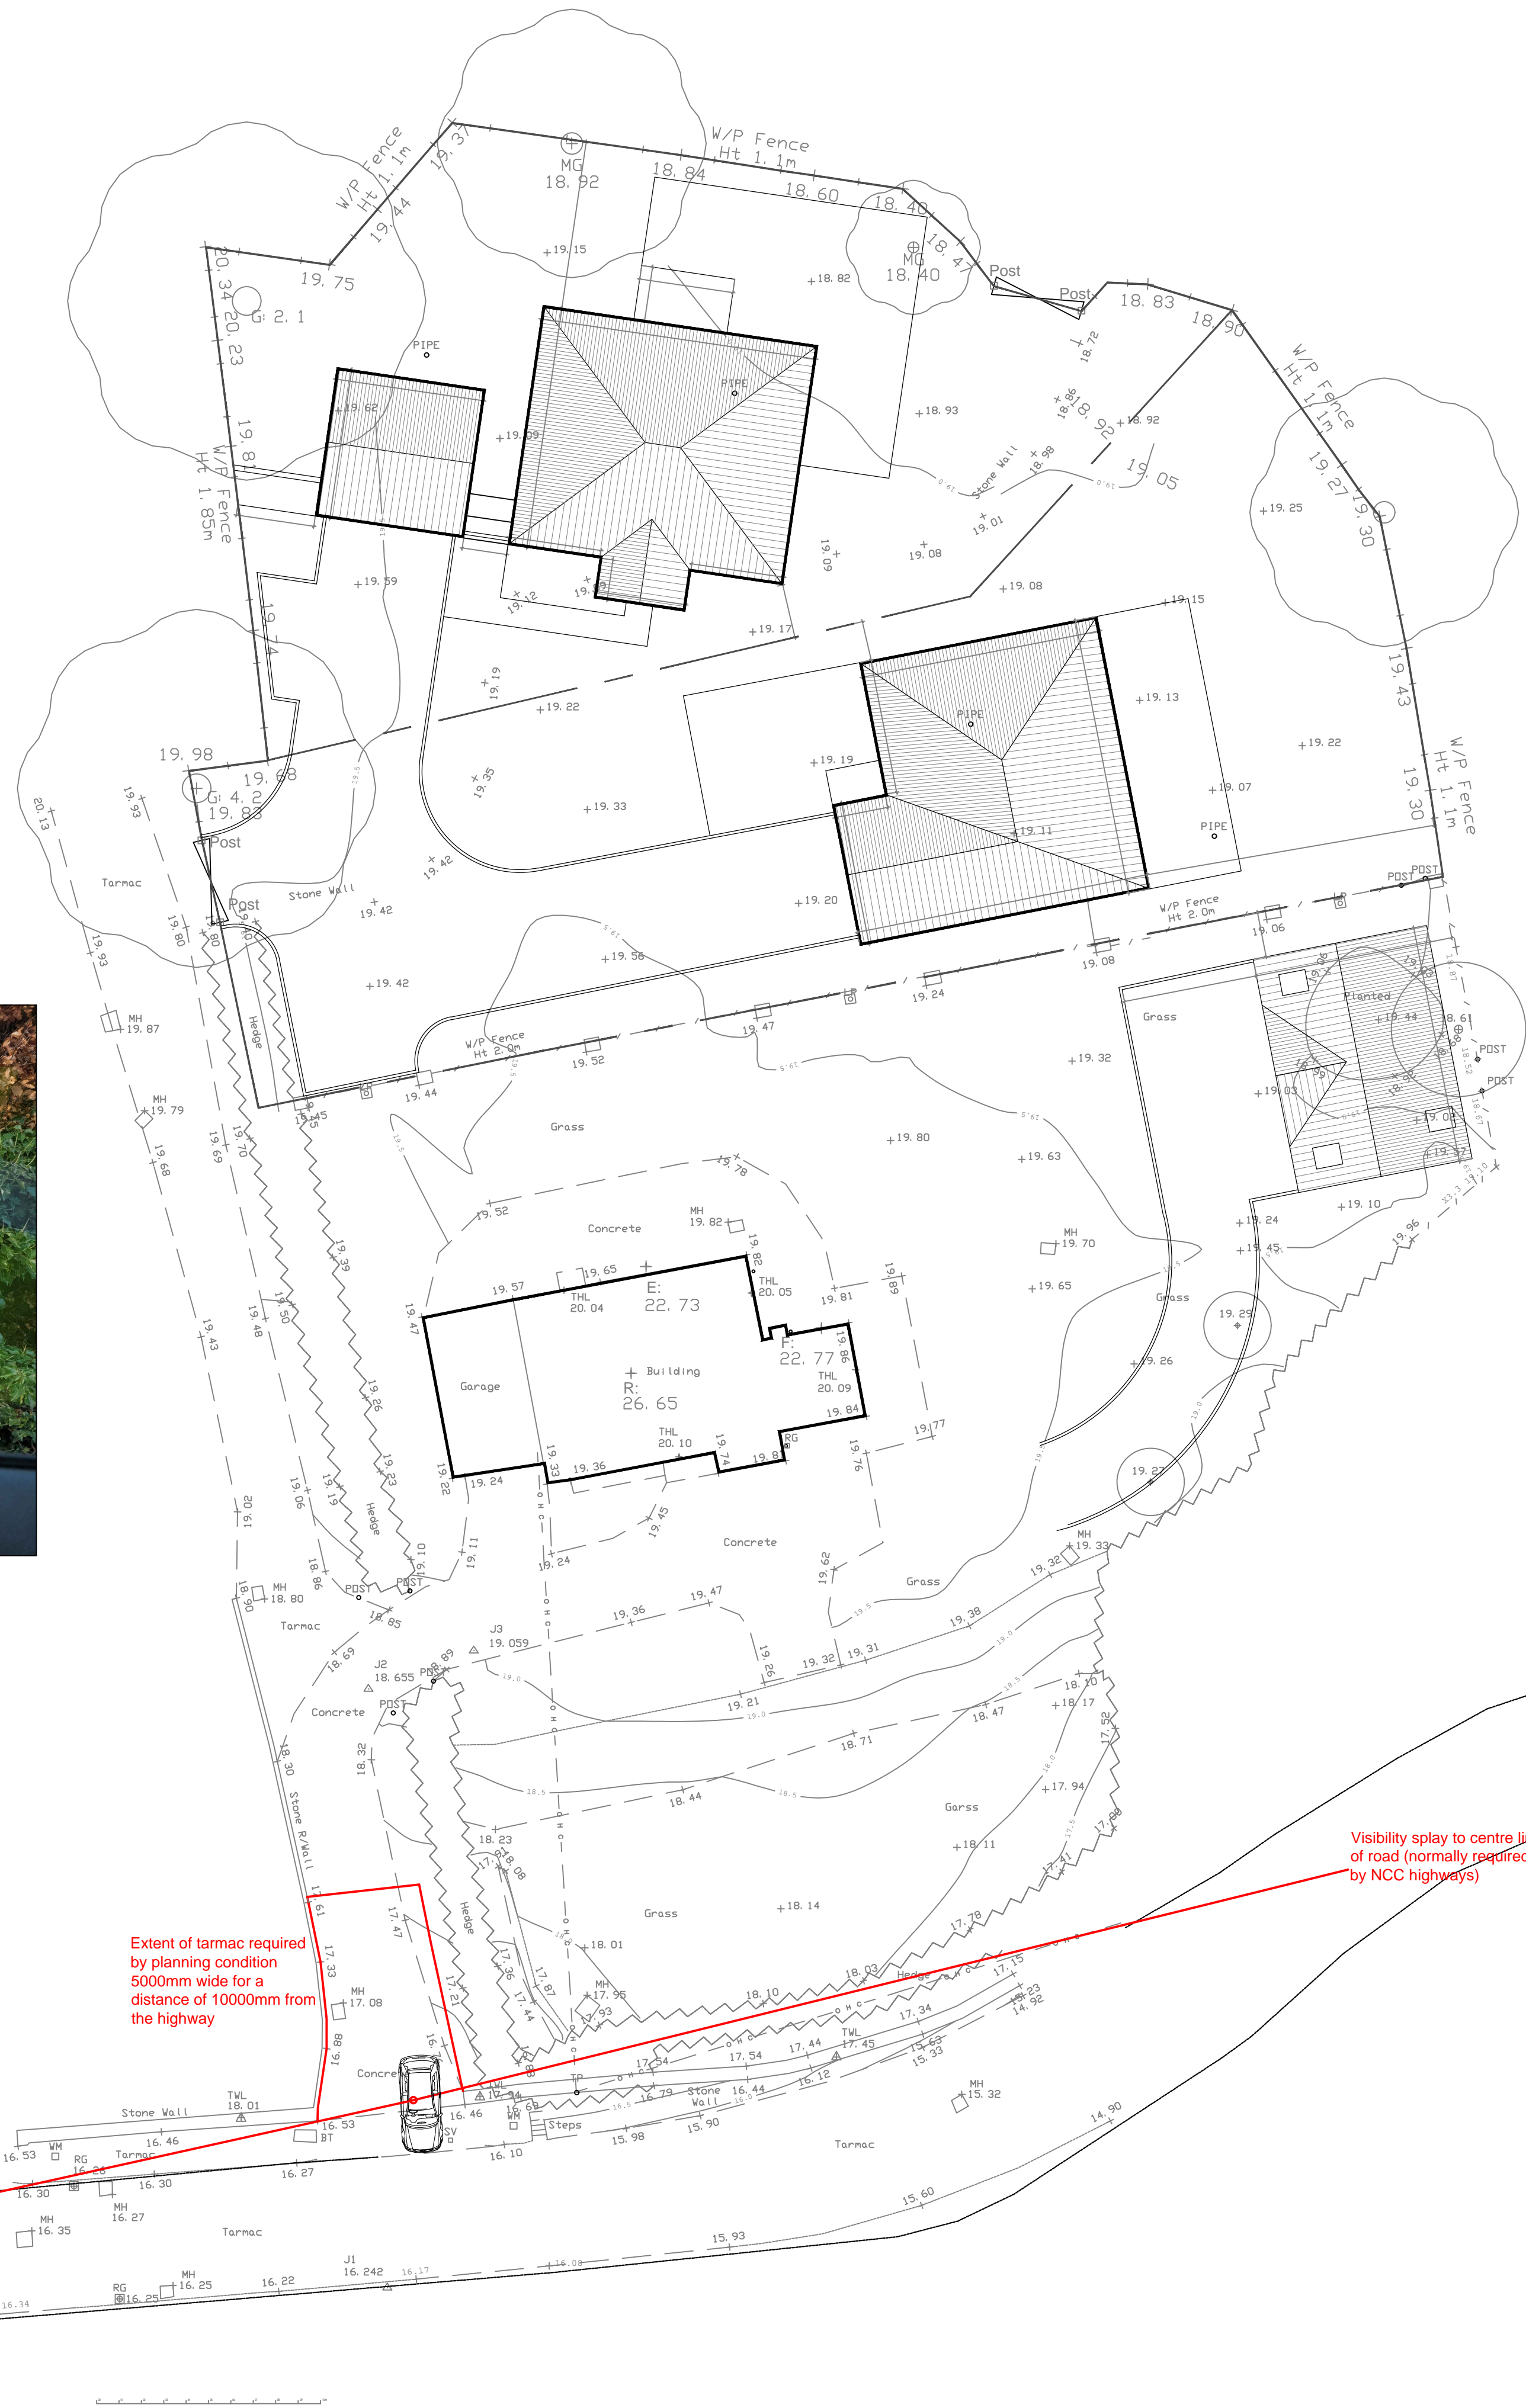
Visibility splay to west is just achieved (on plan) and is not part of the planning condition. Visibility on site is obstructed by vegetation
