This drawing has been prepared in accordance with BS 5837:2012.

Rev	Details	Date	Checked By
Drawing Number		AEL-18793-TWP	
Apex Environmental Ltd 3 Lawrence Way, Lichfield, WS13 6RD TEL: 0121 249 1235 e-mail: info@ael-treeconsultants.co.uk web: www.ael-treeconsultants.co.uk			
Client		Surfacing Standards Ltd	
Project Queen Elizabeth Grammer School, Horncastle			
Title Tree Work Plan			
Scale	Date	Drawn By	Checked By
1:500	23/07/2023	RJH	
Revision		Drawing Number	
A			
THIS DRAWING IS CONFIDENTIAL AND MUST NOT BE REPRODUCED WITHOUT THE CONSENT OF APEX ENVIRONMENTAL LTD

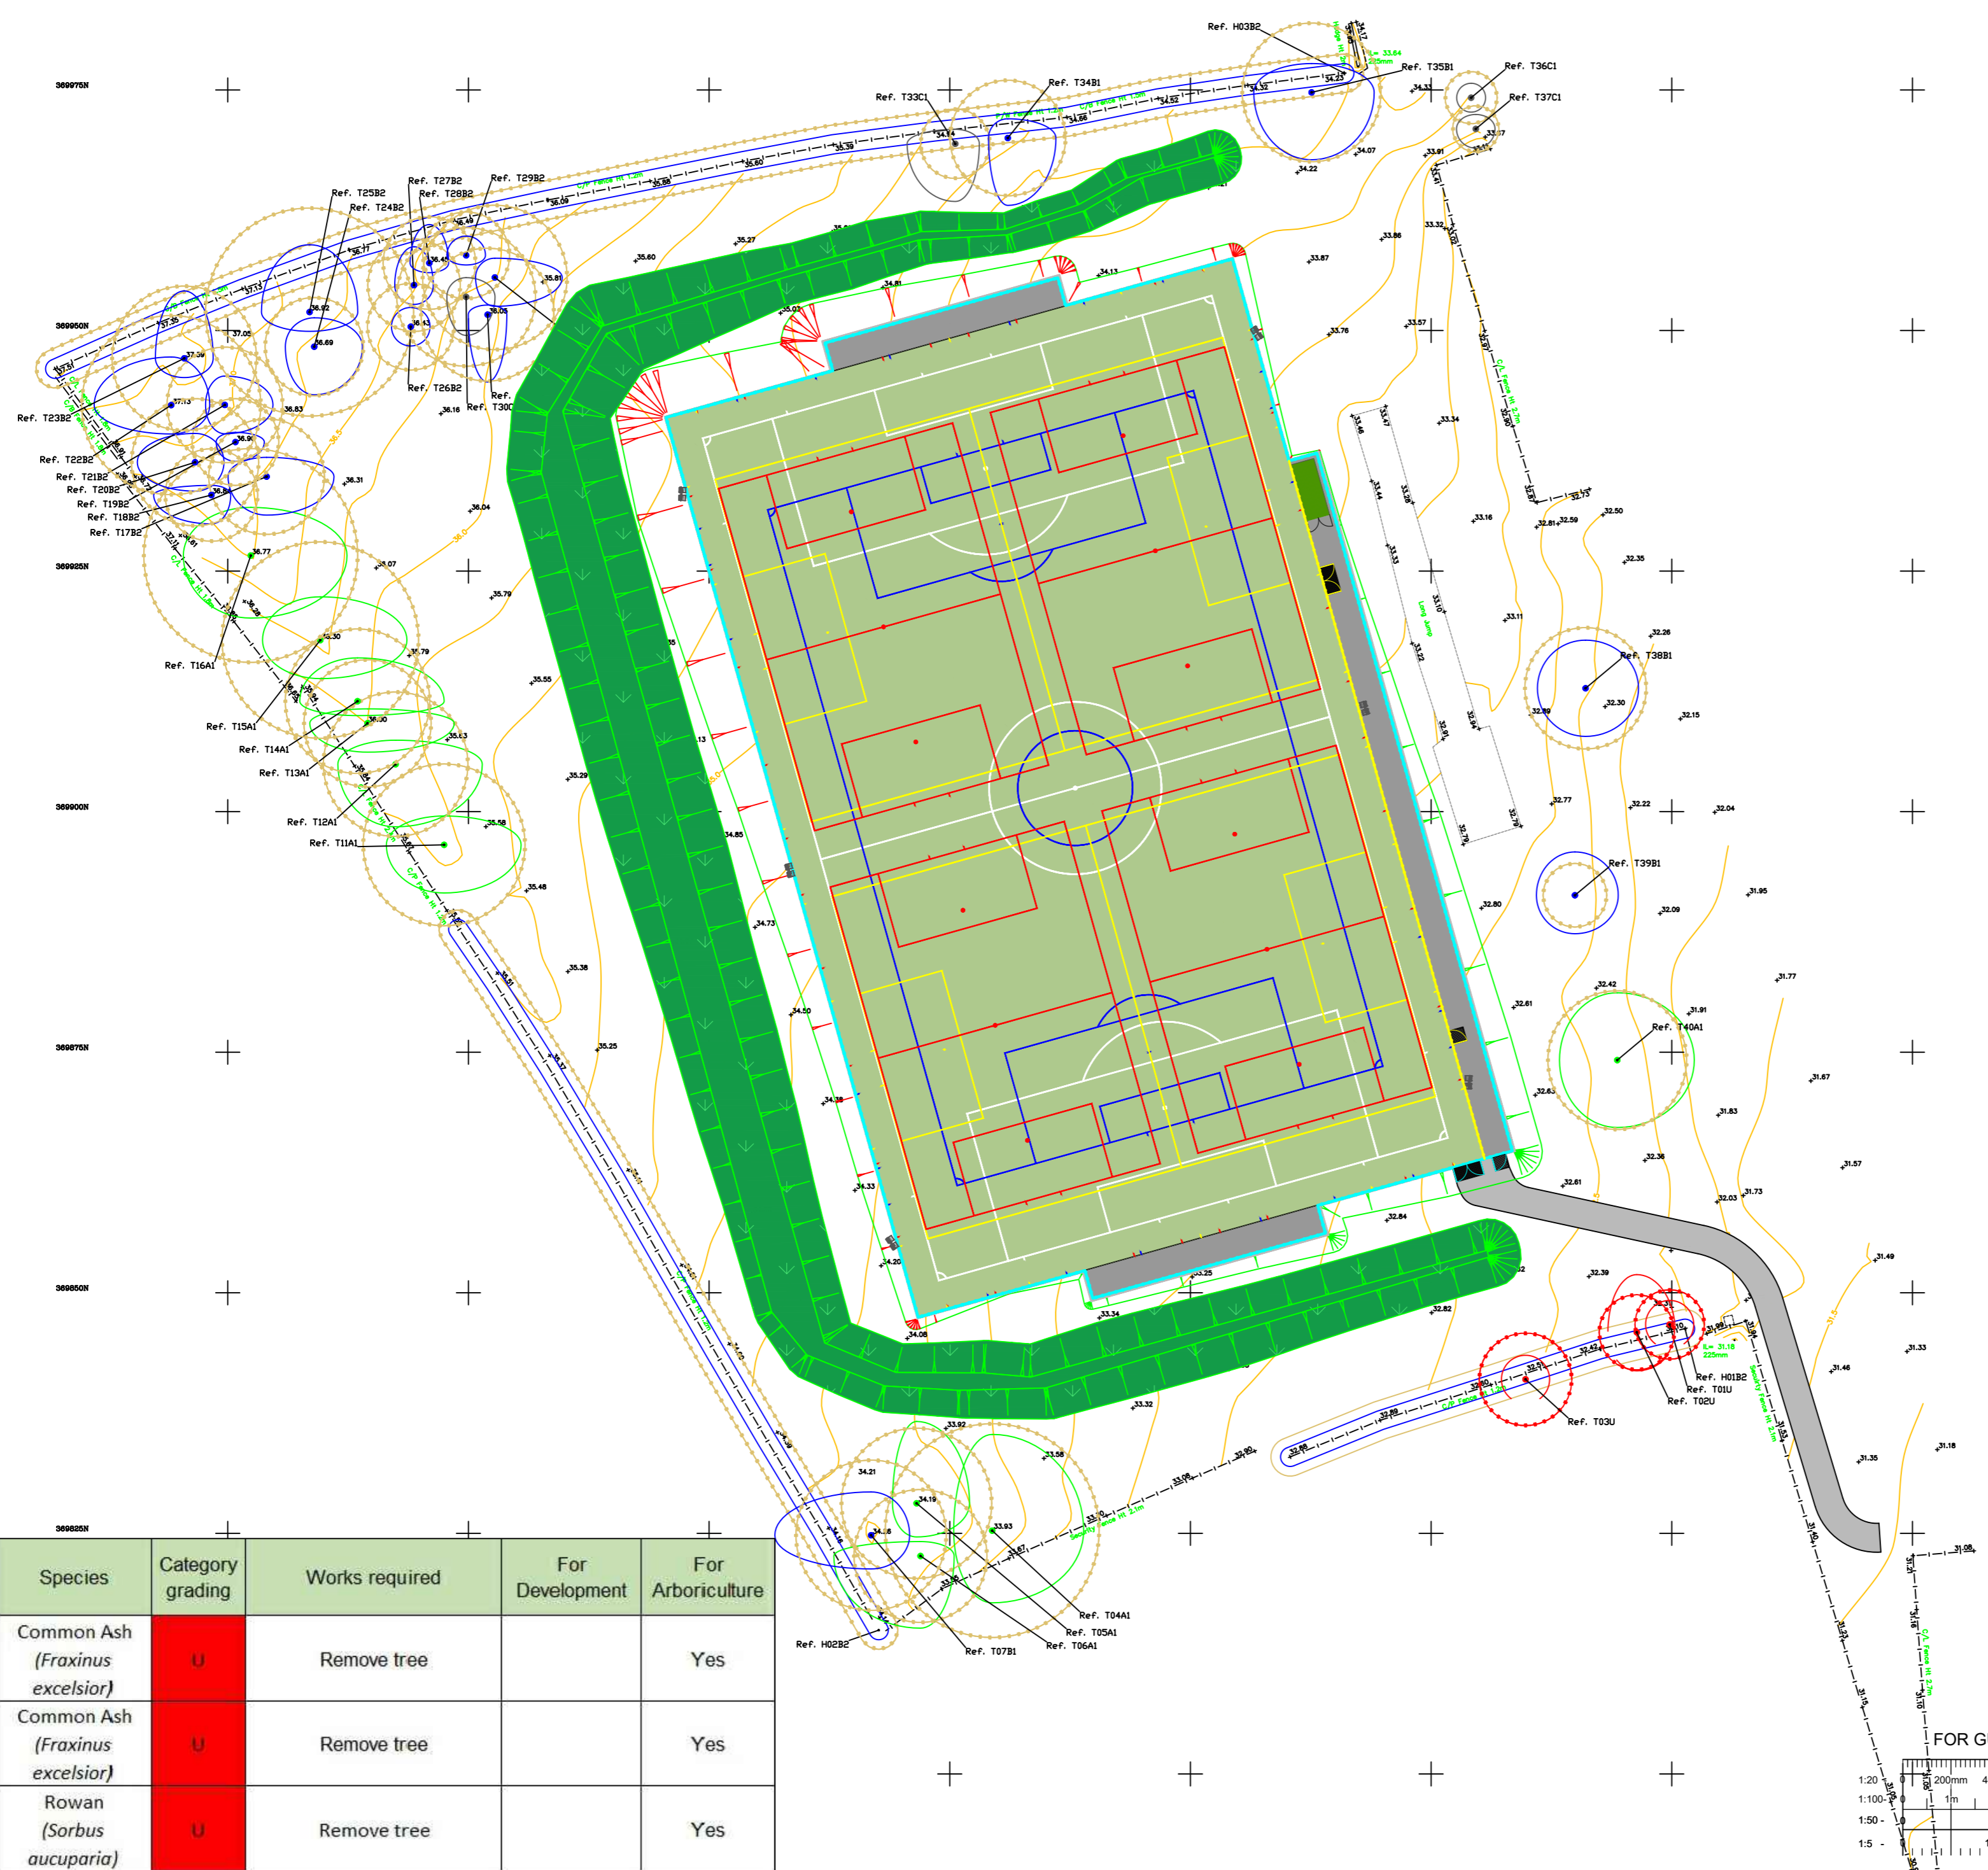
- KEY**
- Root Protection Area (RPA)
 - Tree Stem
 - T1 Tree No.
 - Tree to be removed
 - Tree to be pruned

Tree reference number	Species	Category grading	Works required	For Development	For Arboriculture
T01	Common Ash (<i>Fraxinus excelsior</i>)	U	Remove tree		Yes
T02	Common Ash (<i>Fraxinus excelsior</i>)	U	Remove tree		Yes
T03	Rowan (<i>Sorbus aucuparia</i>)	U	Remove tree		Yes
