Proposed Repairs To Boundary Walling And Installation Of New Steel Fencing At Barham Court Teston For Mr. M. J. Older

Project
Elevations & Plan

Project	834	Sheet
Date	9-8-23	834bctree
Scale	1-100 & 1-50

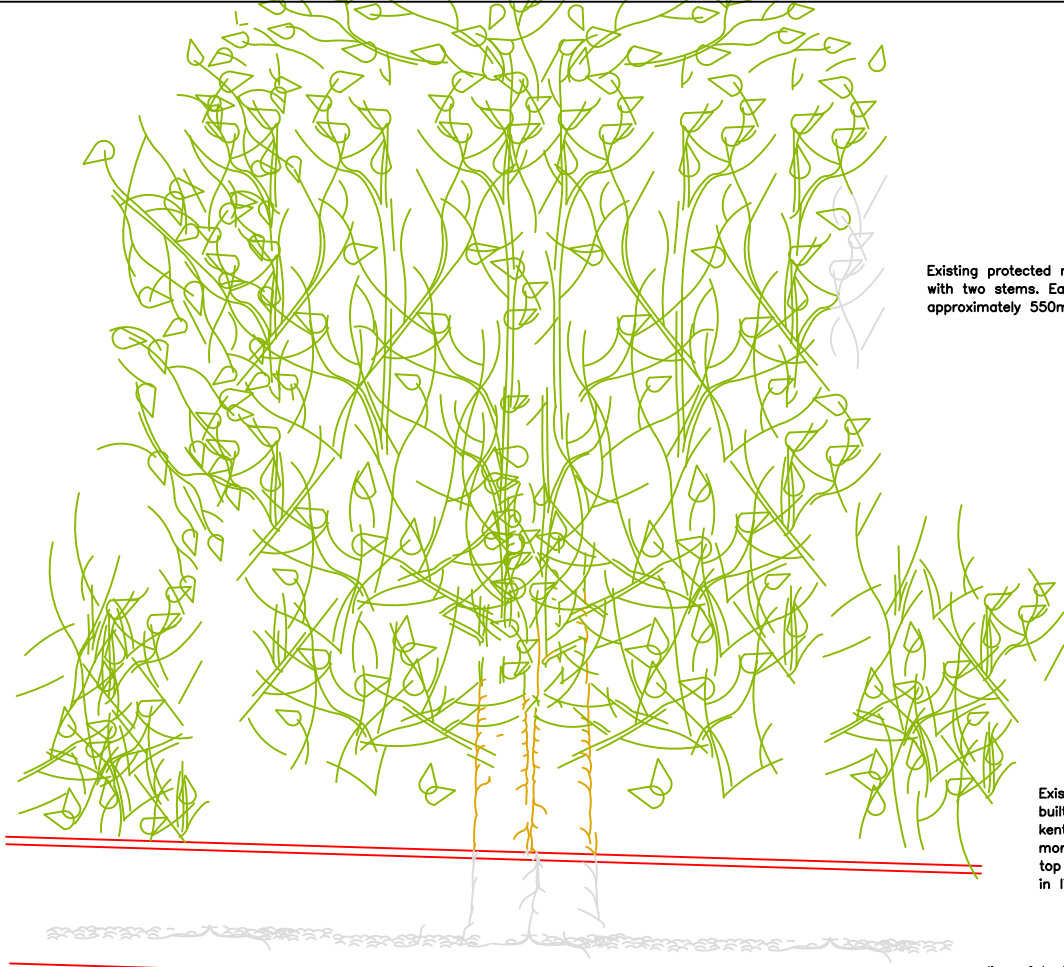
Existing protected mature Holm oak with two stems. Each stem being approximately 550mm in diameter.

Existing 1.65m high 225mm wall built in flemish bond incorporating kent red imperial bricks laid in lime mortar. The wall is finished at the top with a brick on edge again laid in lime mortar.

line of kerb some 800mm from the face of the wall

Drawing showing the wall prior to wall failing and falling into the adjoining road.

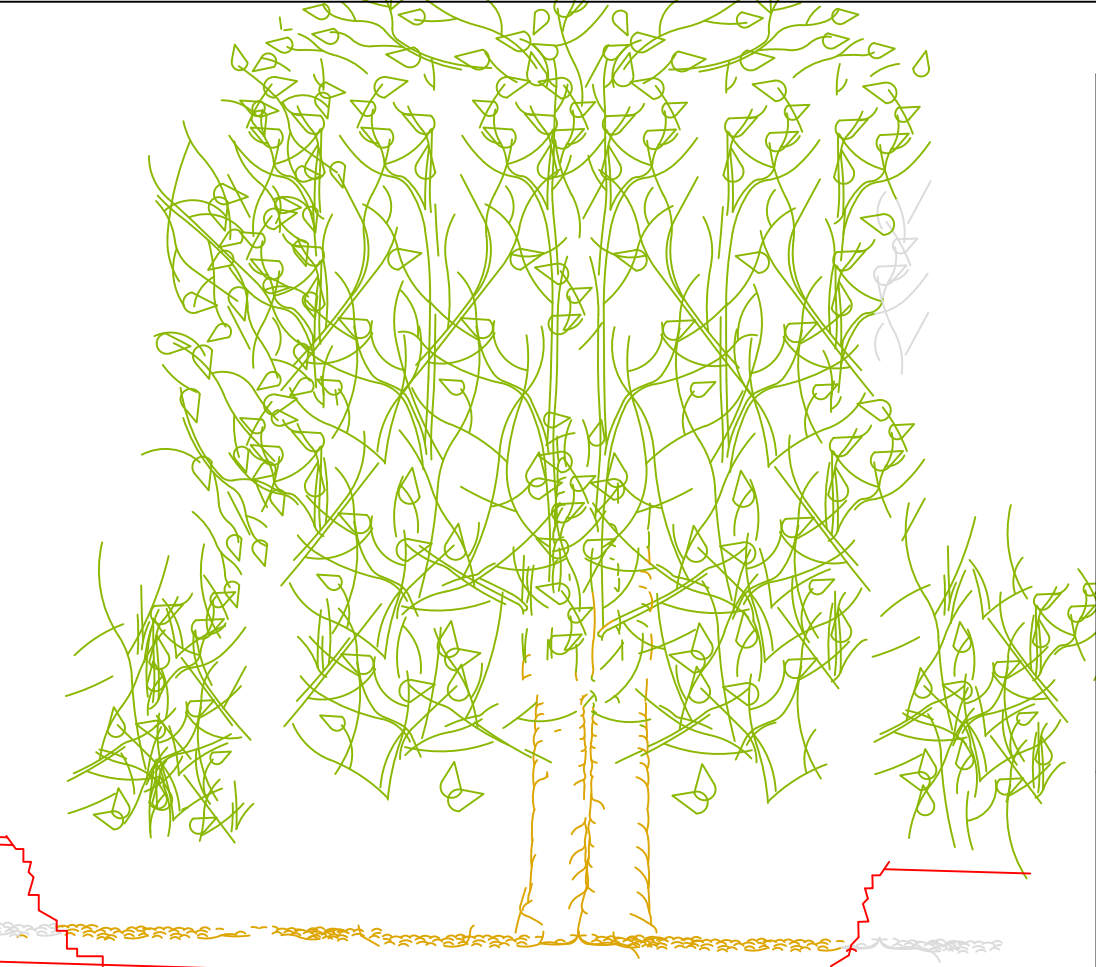
line of kerb some 800mm from the face of the wall

The two stems are shown extending to the ground level to the rear (east) of the wall. The ground level at the rear of the wall is some 550mm higher than at the front of the wall.

Drawing showing the wall with the section of walling now missing. See the ground level to the east of the line of walling.
