**Arboricultural Survey to BS5837:2012**

**Mr M & Mrs T Shearwood**

**The Old Mill, Knights Mill,  
St Teath,  
Bodmin  
PL30 3JE**

**05 July 2023**

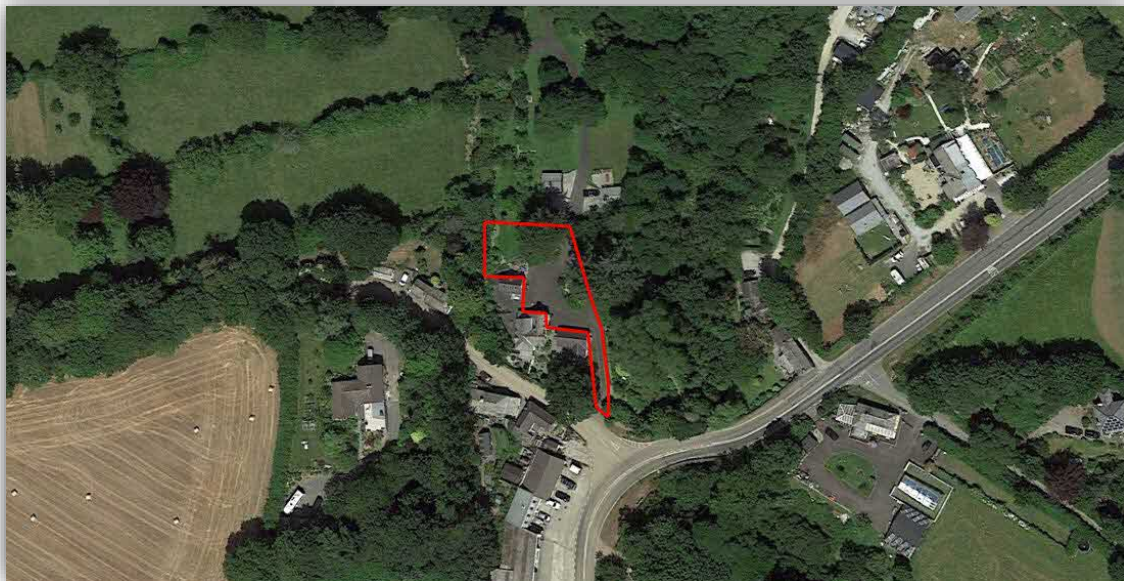
Figure 2: Aerial Image of site with approximate red line boundary showing survey area (Google Earth)

Multiple small trees and shrubs occupy the site, none of which meet the minimum diameter requirements to be considered for this survey. The survey effort for the site was limited to the development area as indicated by the survey boundary at Figure 2.

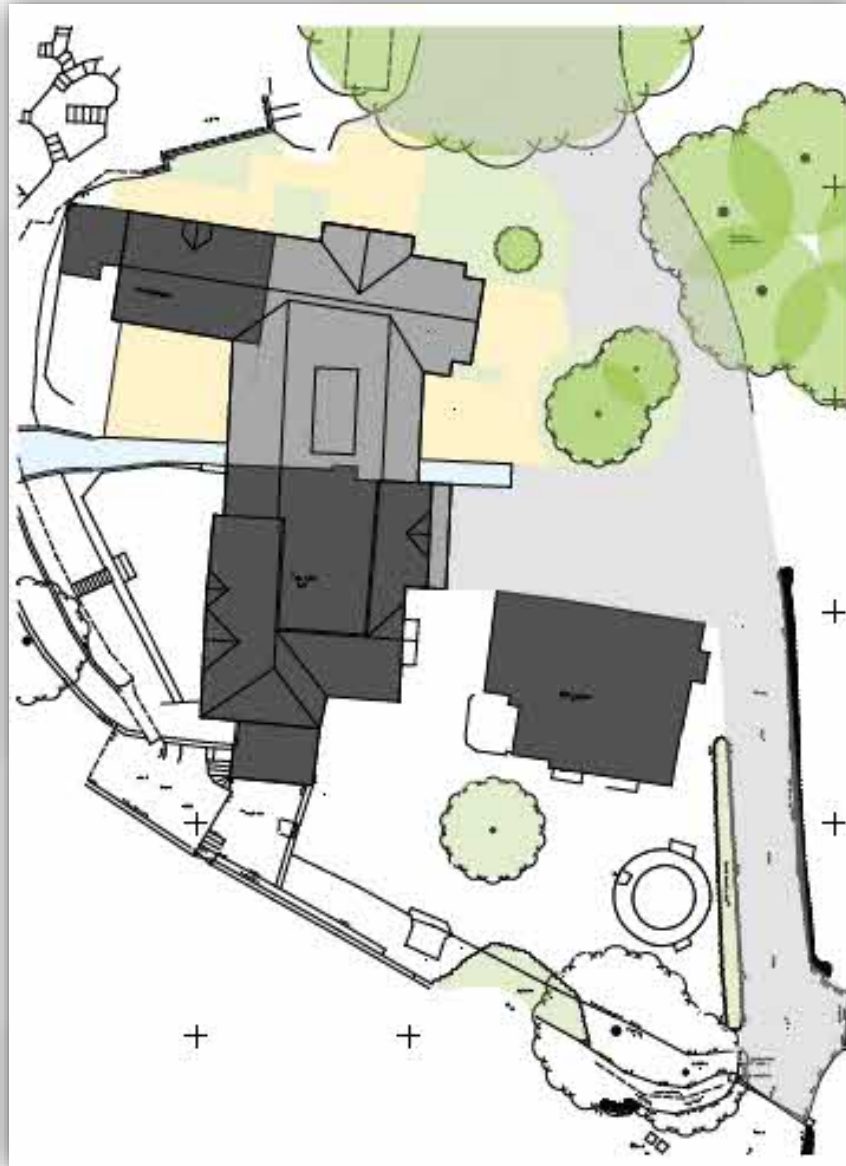
Figure 3: Proposed Site Plan, Drawing No. 22.425 S02.05 (Swain Architecture).

To build an extension which will join the Mill house to the converted stables to form one larger property. The building will occupy an area which is currently tarmacked. No trees will be removed and the existing drainage will be utilised

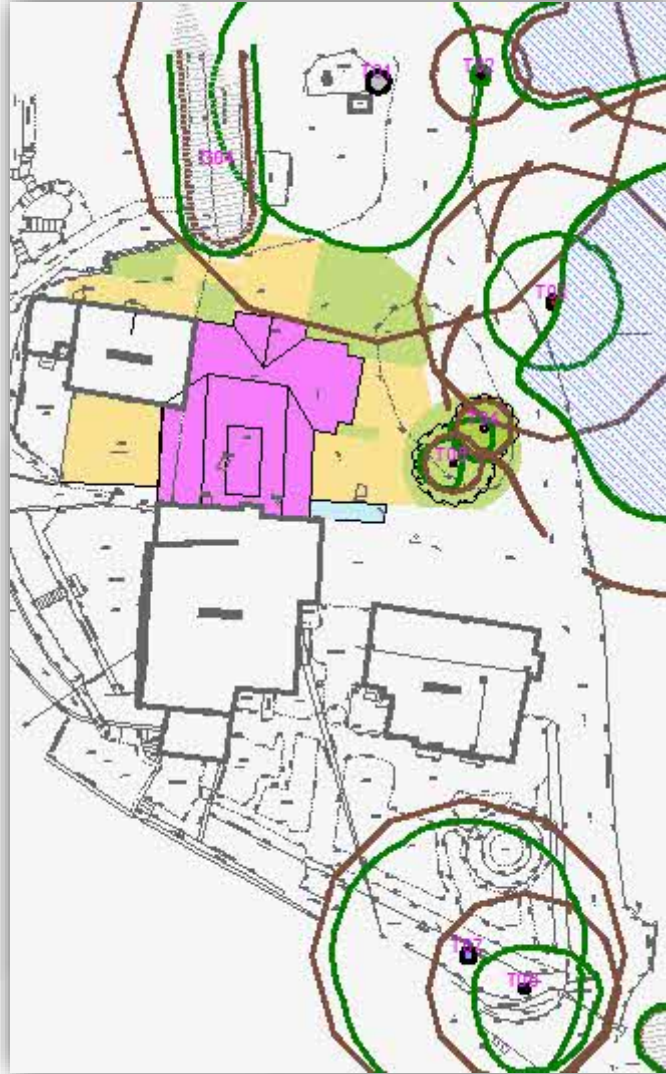
**Figure 4:** Proposed Site Plan, Drawing No. 22.425 S02.05 (Swain Architecture) with Tree Constraints Plan, Drawing No. Arbtech TCP 01 (Arbtech) overlaid showing no RPA incursions.

It is likely that proposed development can be installed successfully with suitable arboricultural methodology and tree projection.

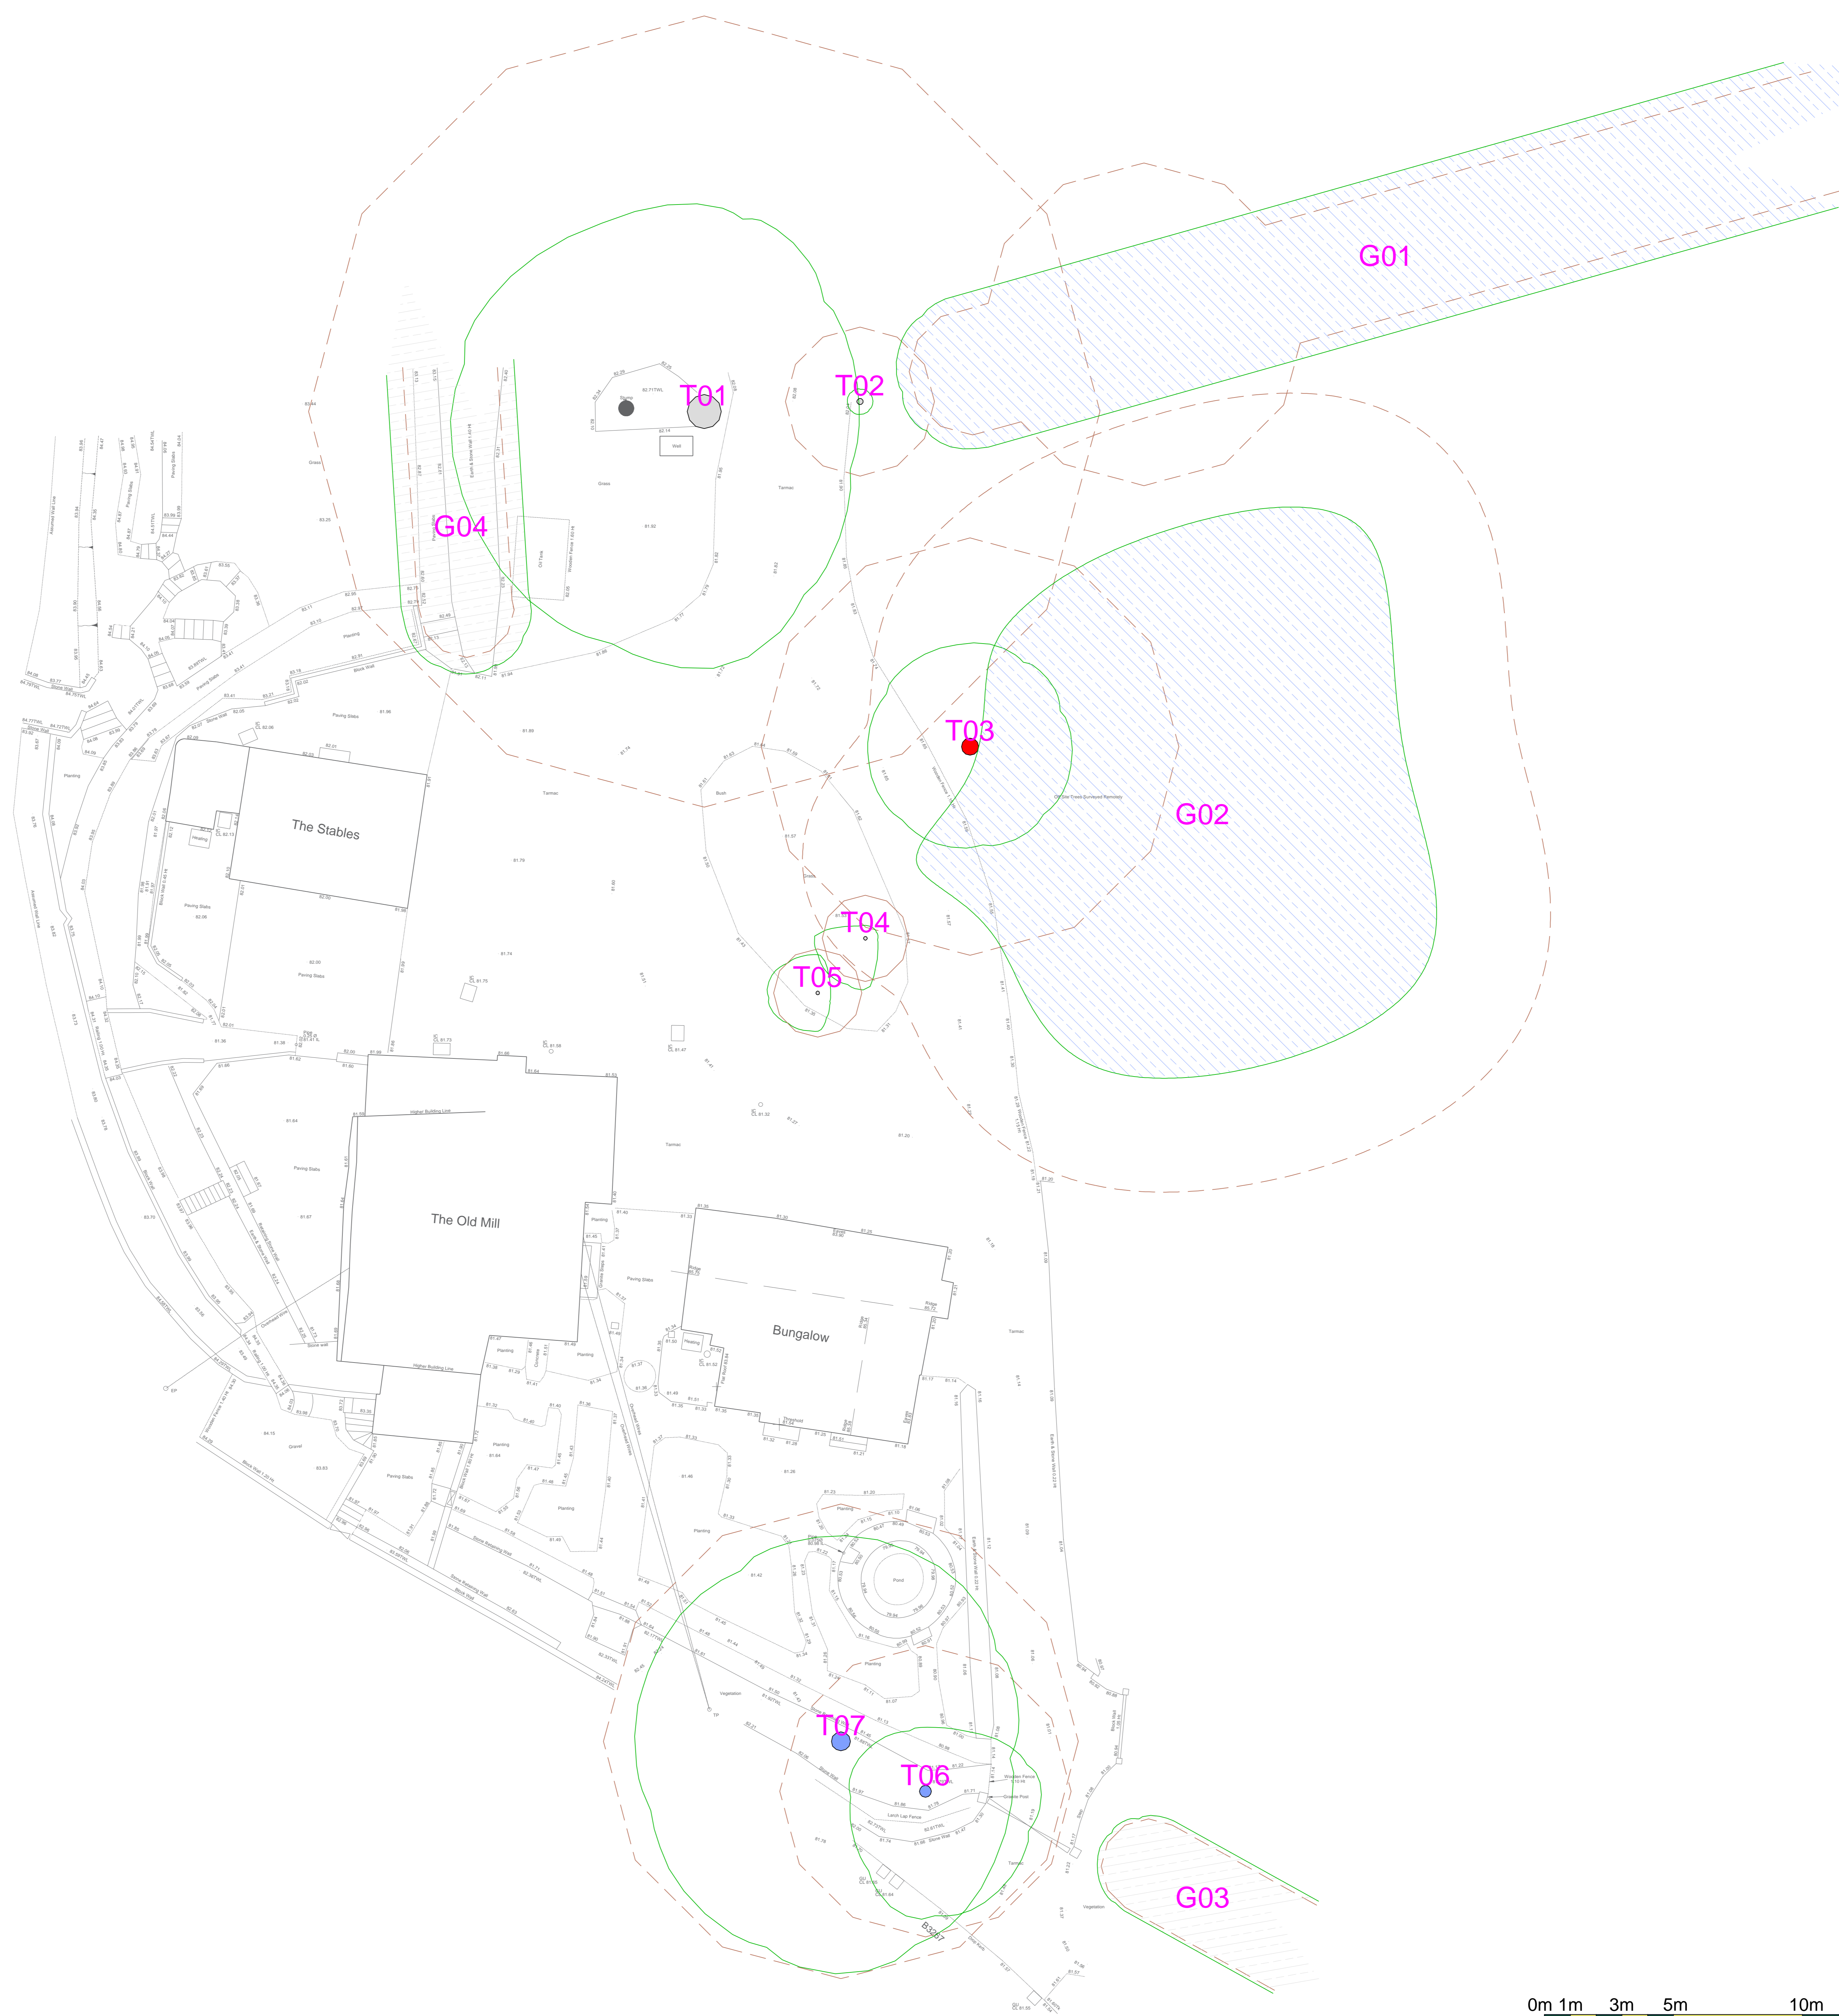
**Drawing:**  
Tree Constraints Plan

In order to avoid damage to the roots or rooting environment of retained trees, the Root Protection Areas (RPAs) should be plotted around each of the category A, B and C trees. This is a minimum area in m<sup>2</sup> which should be left undisturbed around each retained tree.

The calculated RPA is capped to 707m<sup>2</sup>, which is the equivalent to a circle with a radius of 15m. Where there appears to be restrictions to root growth the root protection area is reshaped to more accurately reflect the likely distribution of the roots.

We make the following recommendation to ensure that no conditions relating to arboriculture are attached to any planning consent secured - obtain arboricultural report to include:

- a) An arboricultural impact assessment (AAI);
- b) An arboricultural method statement (AMS); and
- c) A tree protection plan (TPP)
