Heritage Statement
Folly Cottage, Penton Mewsey, SP11 0RQ

Folly Cottage is a Grade II listed building dating from the late 18th century. Construction is traditional cob, with a tiled roof.

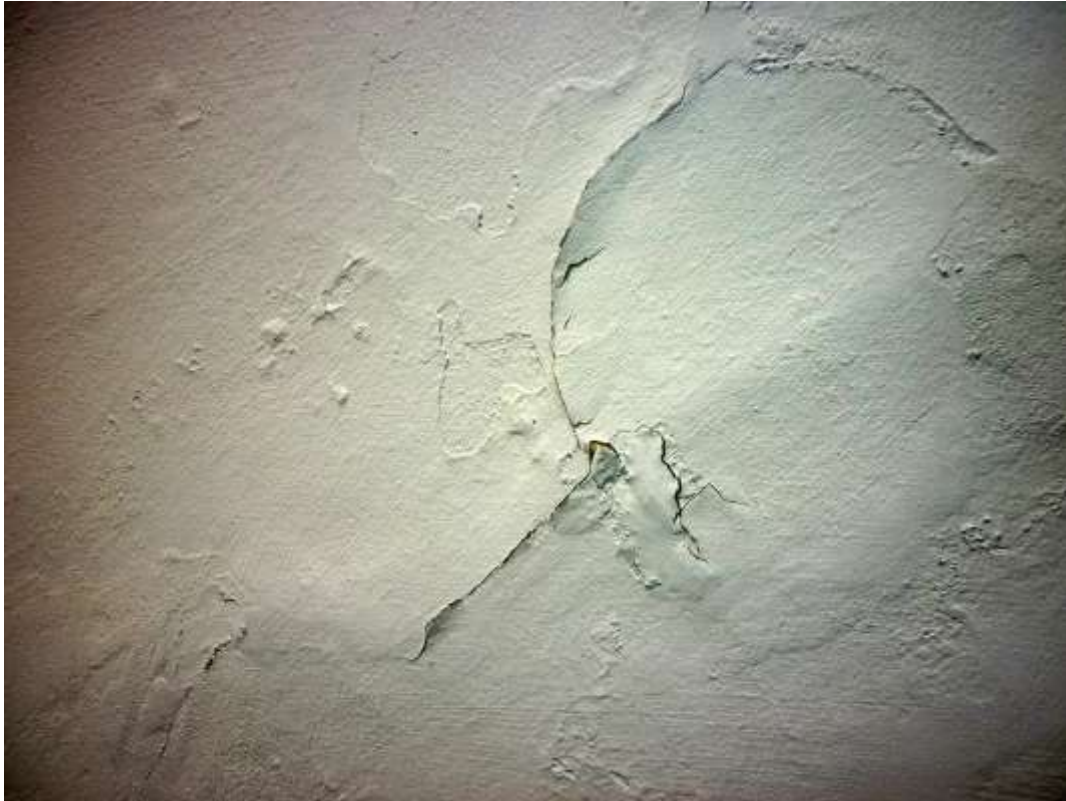
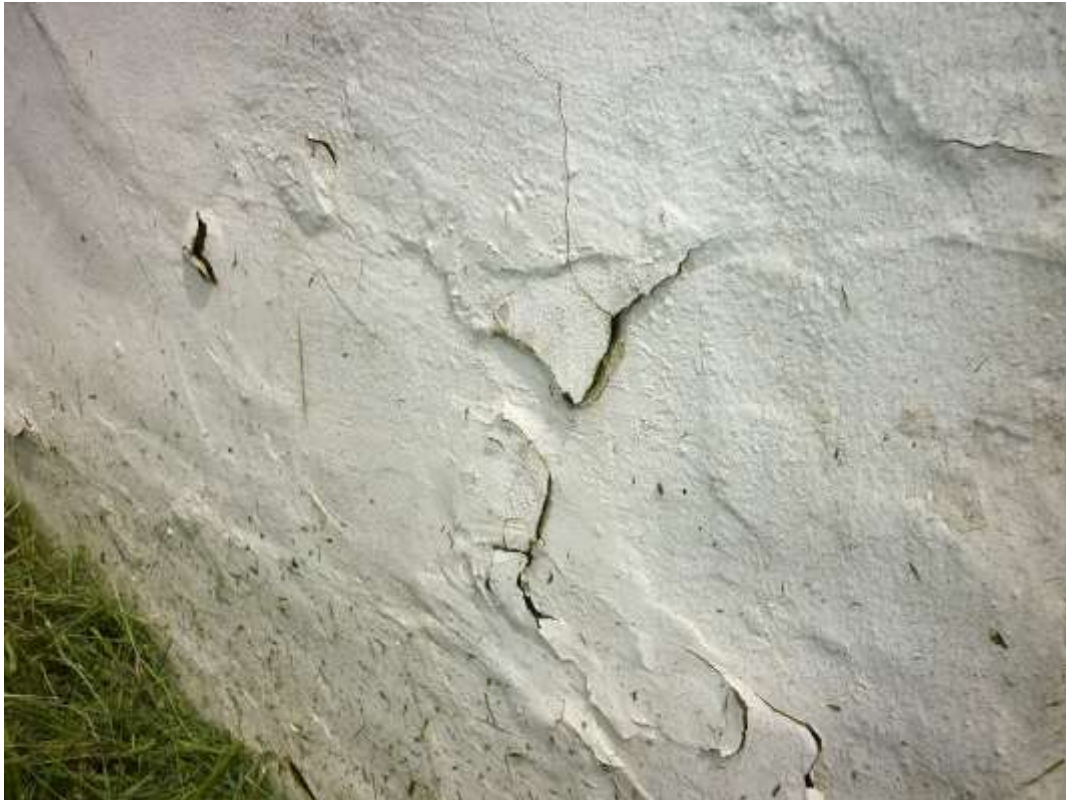
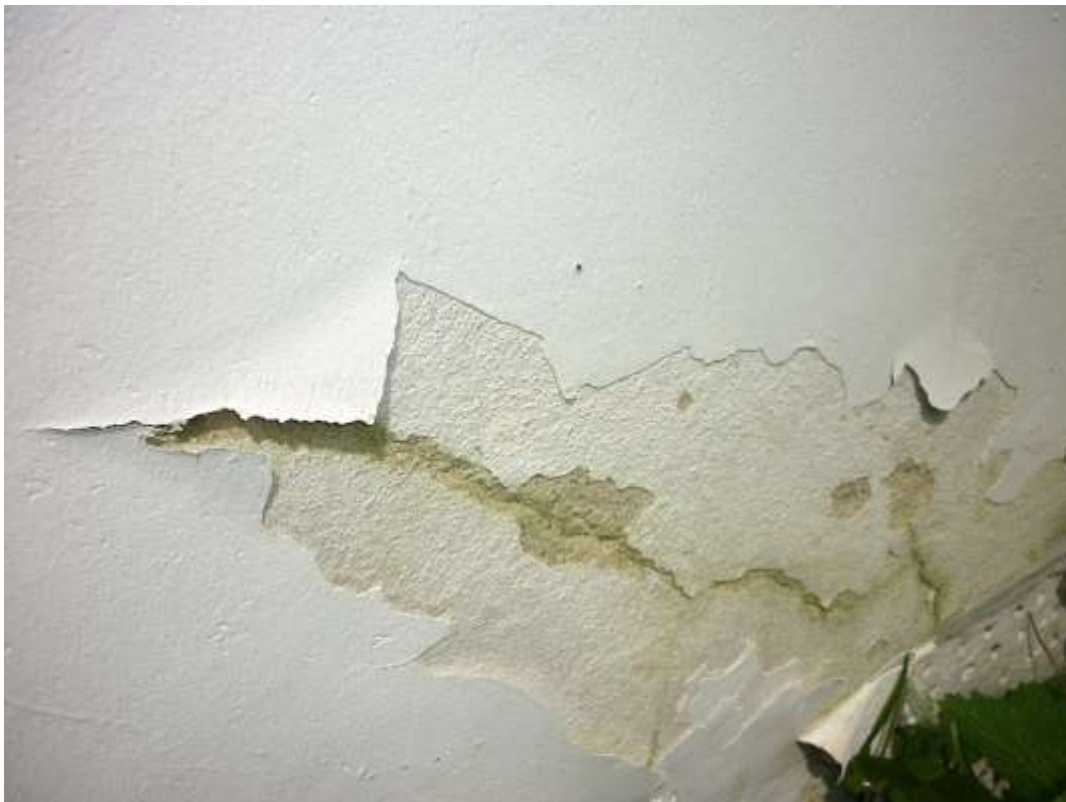
This cob-built building has suffered due to the previous owner having modern “weatherproof” paint applied to the exterior walls. Over time, the inability of the wall to breathe has caused the paintwork to crack and blister – sample pictures provided below. There is a danger that, if left unresolved, the external aspect of the house will seriously degrade and moisture in the cob (with nowhere else to go) may move inside the house, causing damp.

Existing hard render and non-breathable paint will be causing damage to the cob walls by trapping moisture against the cob. Remove this and replace it with lime-based, breathable render, with a breathable paint on top, and repair the cob beneath using traditional materials.
