| brownhill hayward brown chartered architects | | DRAWING NO 4007-006 |
| Highclere Castle - Render Repairs West Wing - First Floor as Existing Highclere Estate | | REV DATE Aug '23 |
| LISTED BUILDING CONSENT | DRAWN CHECKED JH SPF | SCALE As Shown @ A1 |

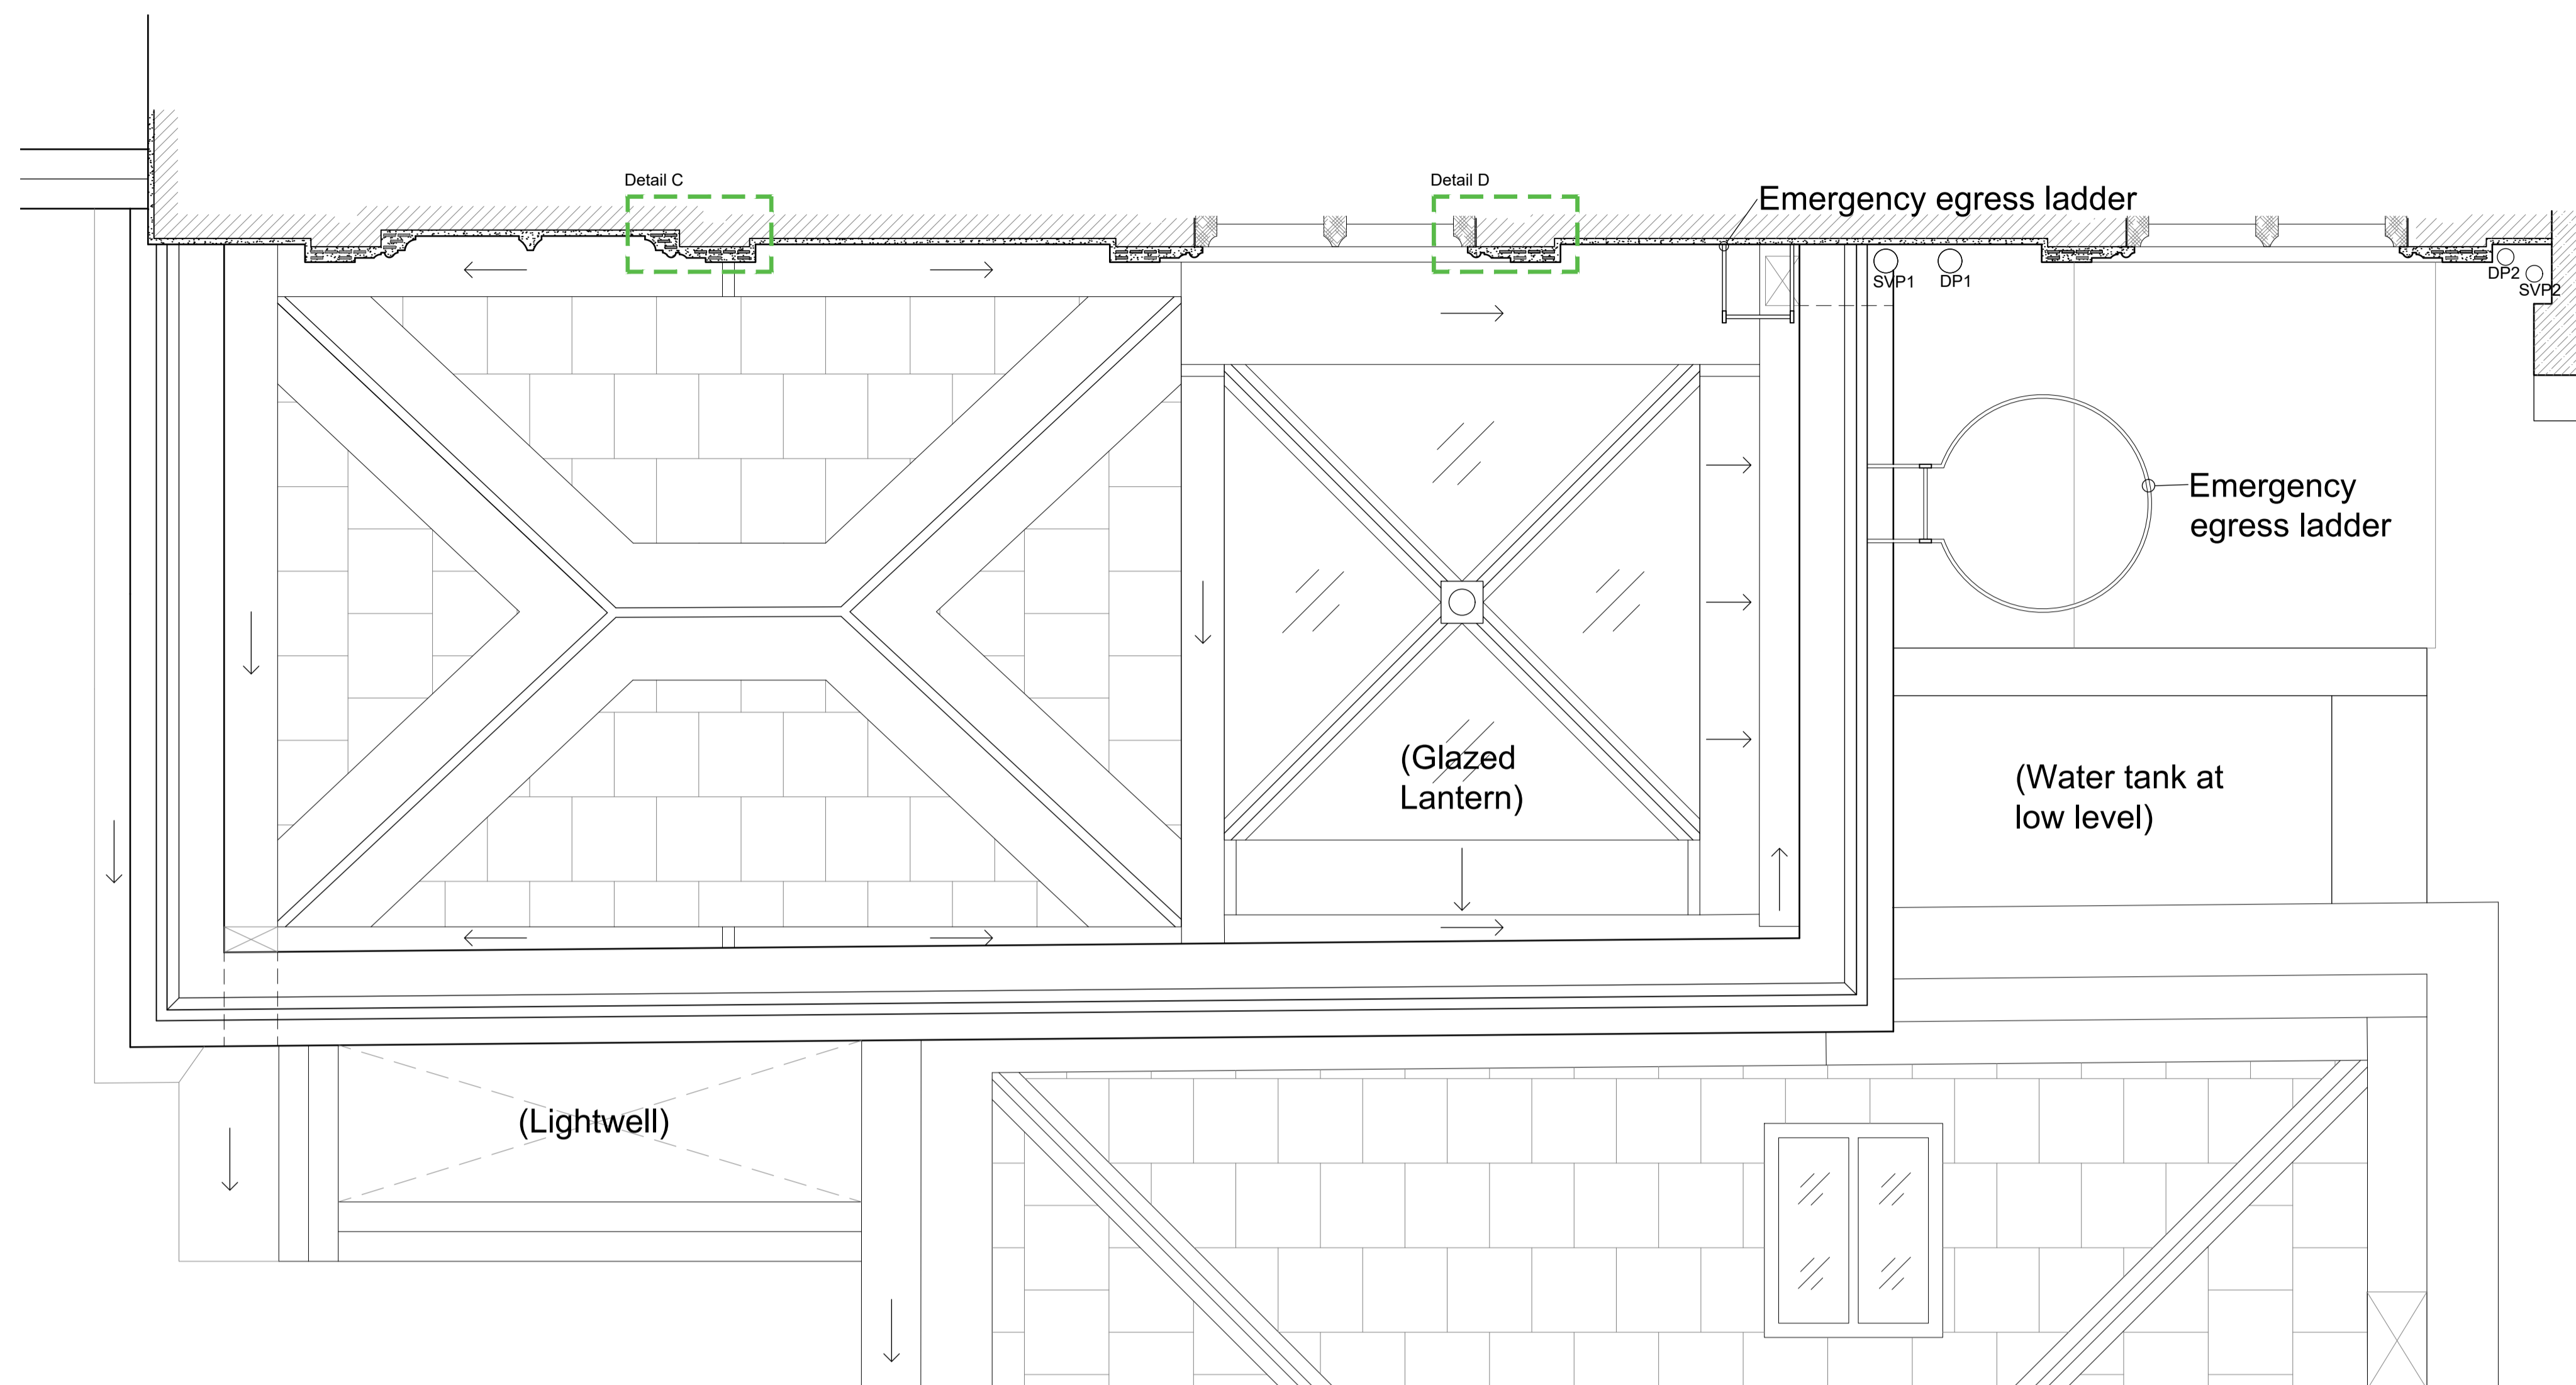
Section 2 as Existing (First Floor Roof Plan)
Scale 1:20

Note:
Render thickness and depths to masonry substrates are assumed.

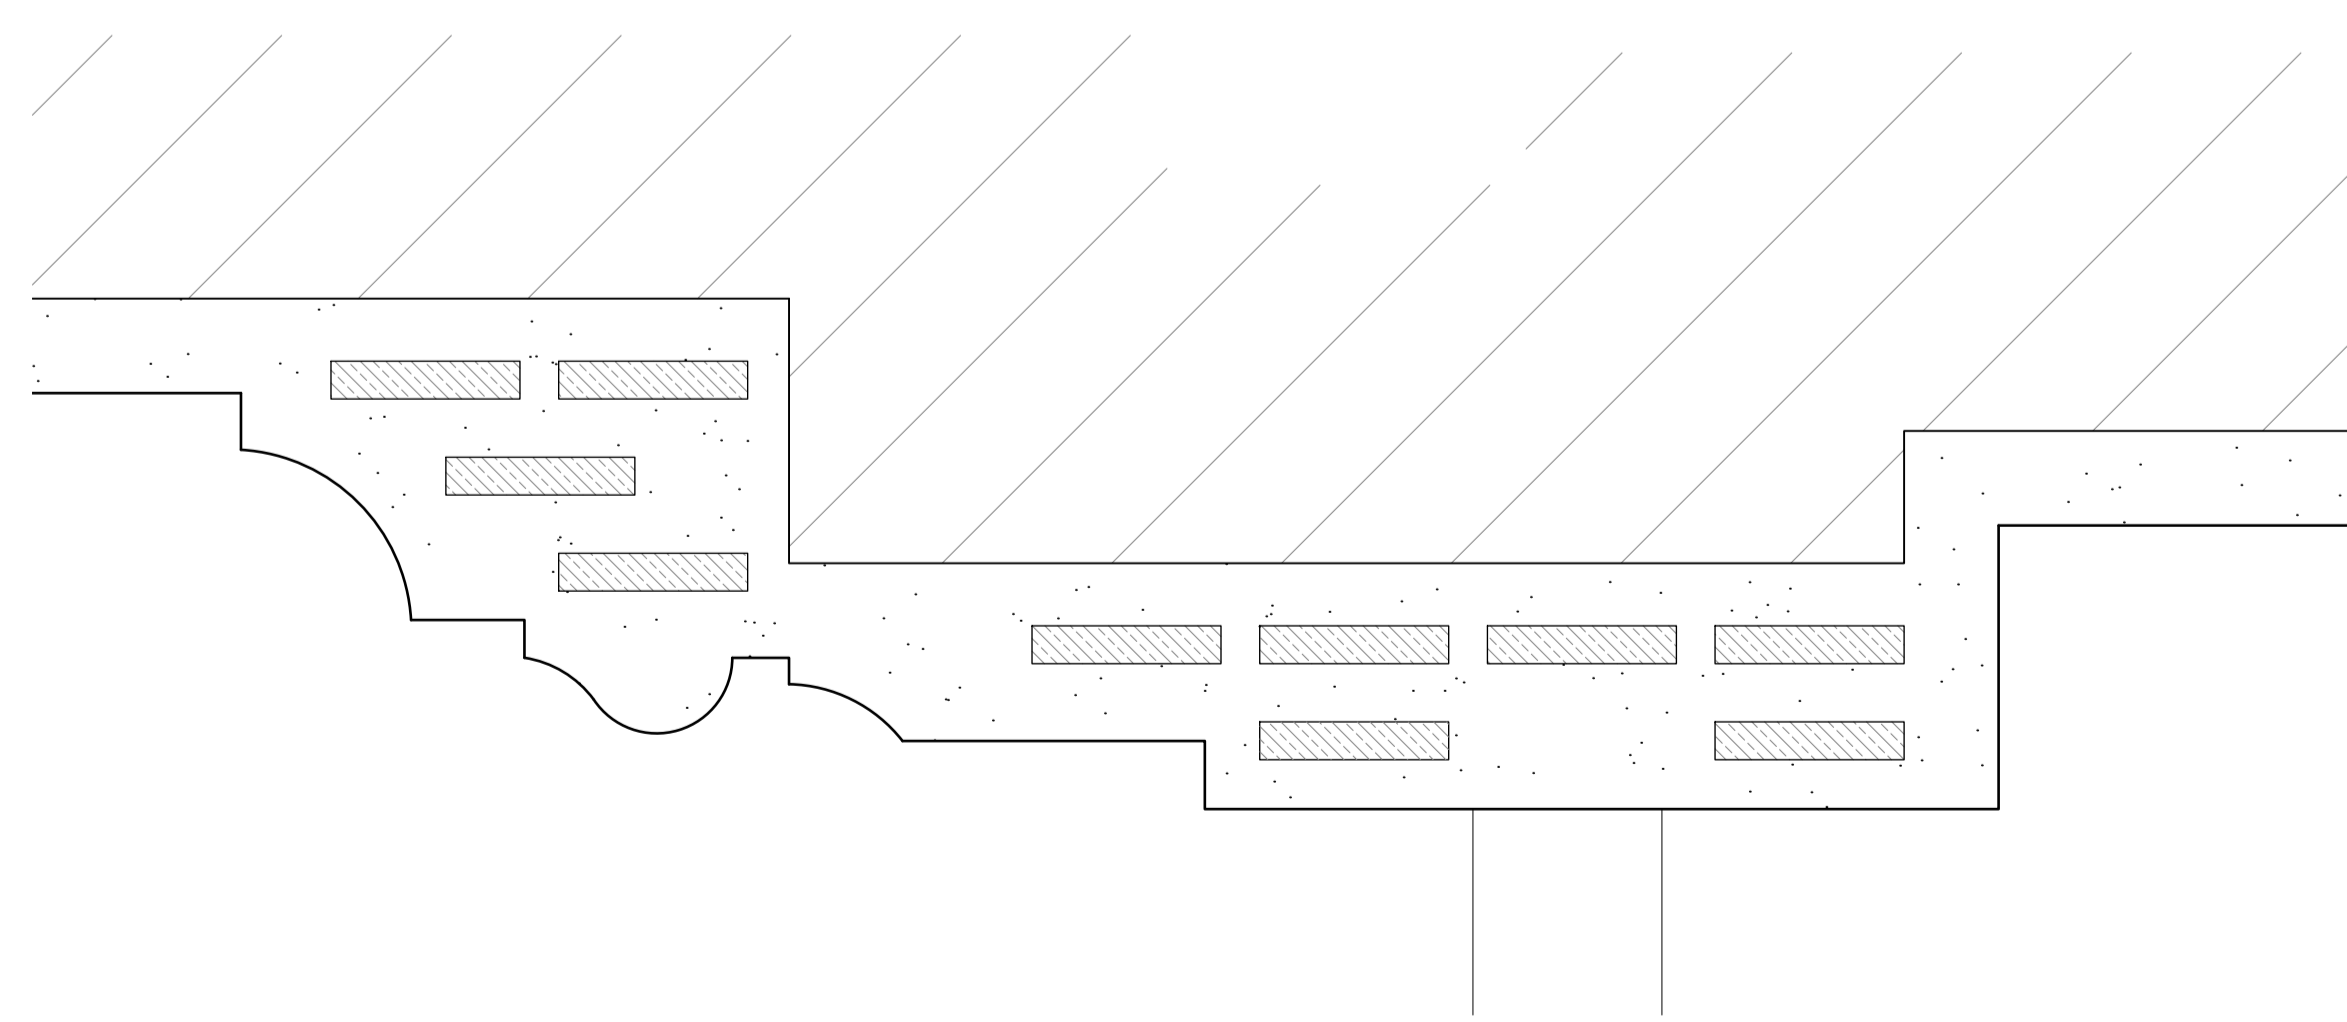
Detail C as Existing
Scale 1:2

- Red clay tile shard packers within render
