## Heritage and Supporting statement

### **Proposed alterations and refurbishment works at The Old Rectory, Norton Road, Tostock, Bury St Edmunds**

for Mr & Mrs Bowyer

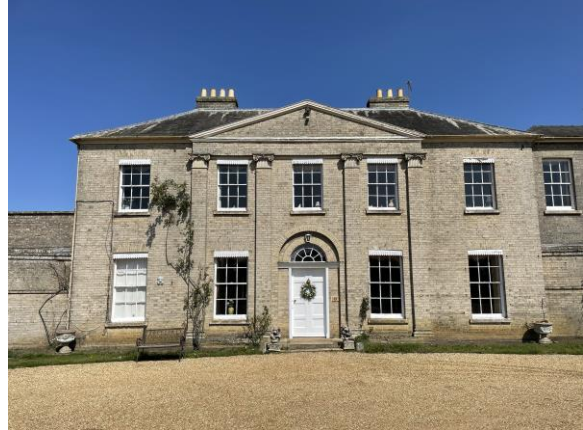
Front elevation of The Old Rectory

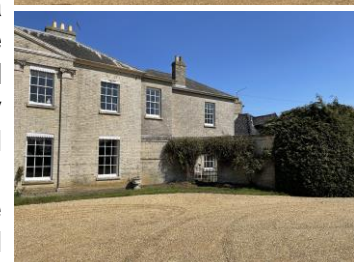
South (front) elevation:

The south / front elevation provides entry to the main dwelling coming from a gravel driveway. The elevation is finished with a buff brick. The roof is a dark grey natural slate multi-section hipped roof with white painted timber fascia and soffit and a white gutter, with several chimneys finished with matching buff brick. The front elevation is stepped back from the centre entrance section, with several steps either side of the entrance section. Some of the front elevation is hidden behind high level curved walls in a matching buff brick extending from the furthest most projected section of the front elevation to partially enclose the driveway. The curved walls have gated access through them with arched head openings, brick projecting courses and a projecting header detail. To the right of the front elevation is the later extension side wing of the property, which is constructed of a matching buff brick with a black pantile hipped roof, incorporating dormer windows, and connected back to the main dwelling by a matching buff brick wall. The side wing of the property cannot be seen fully from the driveway as it is hidden behind the curved wall section. To the left of the main entrance is the single storey ball room projecting from the main dwelling, with a parapet wall and stone capping detail hiding a decaying felt flat roof behind. All of the windows on the front elevation of the main dwelling are matching white painted sliding sash windows with vertical and horizontal glazing bars creating six upper and six lower panels in each window. All windows (where possible) are accompanied by a projecting stone cill and large header details approx. 300mm high, including white painted timber detailing within the window reveals of the centre most windows. The centre most bay contains projecting brick piers with stone header details and a projecting gable roof detail, with the white painted eight panel timber entrance doors with matching arched fanlight in the centre.

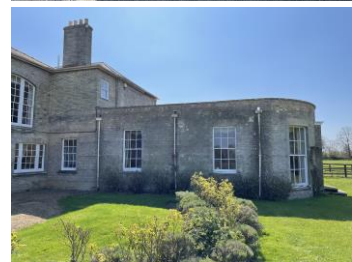
### North (rear) elevation

The north / rear elevation is open to the rear garden, and is partially enclosed by the rear courtyard. The elevation is finished with a buff facing brick and the roof is a dark grey natural slate multi-section hipped roof with sections of flat roof with white painted timber fascia and soffit and a white gutter to the main two storey dwelling, with several chimneys finished with matching buff brick. The ball room projection to the right of the rear elevation is a single storey flat roof with a parapet hiding the felt roof behind. The windows in the rear elevation are a mix of white painted sliding sash windows with vertical and horizontal glazing bars creating six upper and six lower panels in each window (matching the front elevation) and white painted crittall windows with a white painted timber surround within the reveal. Matching the front elevation, all windows have a projecting stone cill and a single header course approx. 150mm high.
