Proposed alterations to the Farmhouse at Churton Hall Farm, Churton, Chester CH3 6LR

External door schedules 01 Residential units 01 and 02

439-SK-14

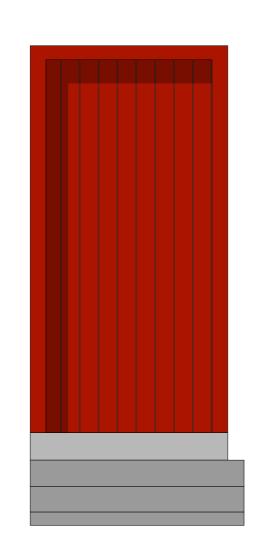
D001

Entrance Hall / unit 01 solid timber door

Proposed works: retain and refurbish as required.

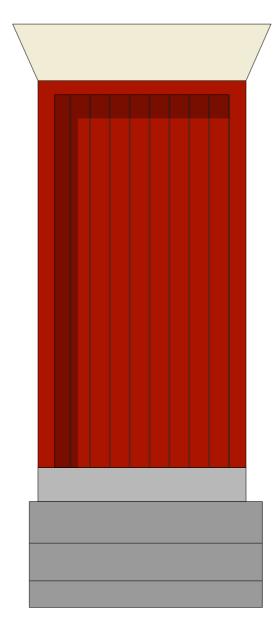
D002

Sitting room / unit 01 solid timber door, stone external sill and steps.

Proposed works: retain and refurbish as required.

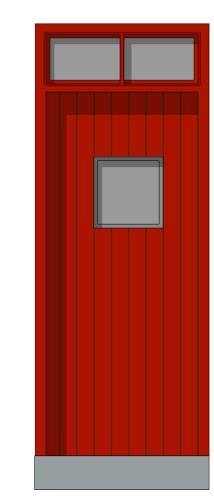
D004 proposed

Kitchen / dining / unit 02 proposed glazed timber door with stone external sill.

Proposed works:
To replace existing solid timber door.
