SCHOOL COTTAGES, HELMINGHAM

PROPOSED ALTERATIONS

HERITAGE IMPACT ASSESSMENT

and Design and Access Statement

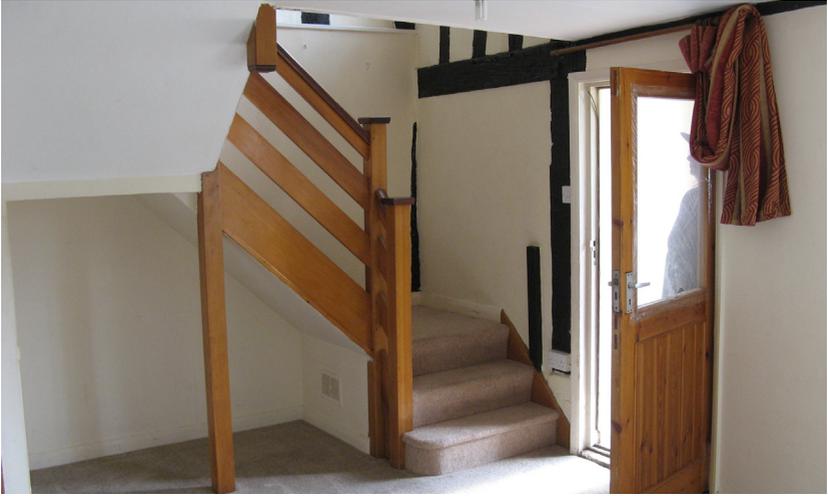
Staircase to be reorientated and replaced (No. 93).

Removal of 2no. staircases and construction of 1no. in existing location.
Infilling of stairwell in 94. New balustrade to landing / bathroom.

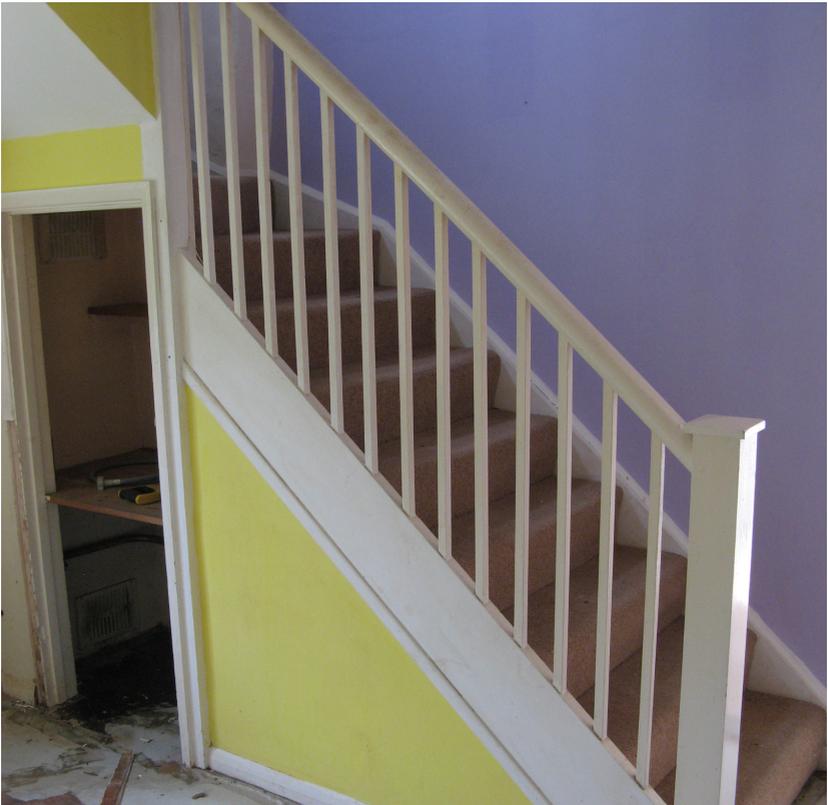
Staircase to be removed (No. 94).

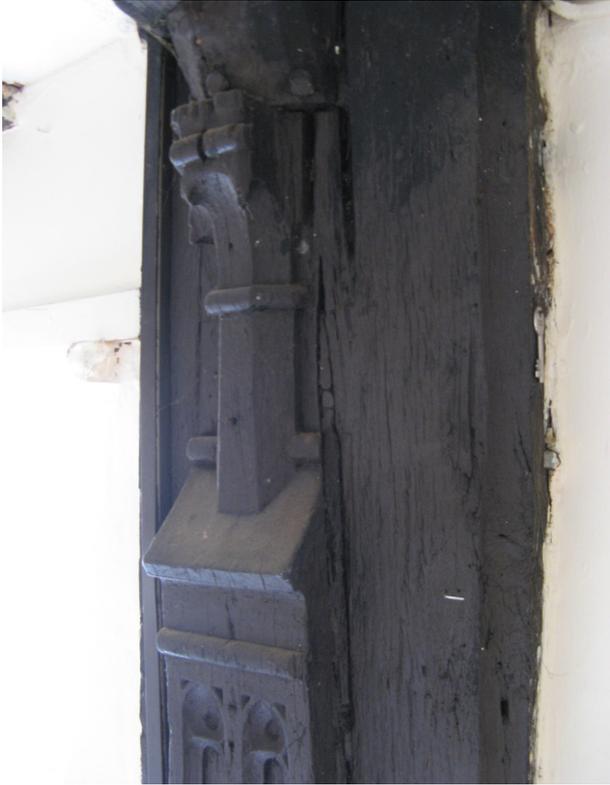
Carved principal post at ground storey. Later insertion of floor beam

Although there are better-preserved examples of this type of Suffolk dwelling, the special significance of School Cottages is in the quality of surviving timber frame; much of which lies within no.92 but with 93 containing a carved principal post of rare quality supporting the arched tie beam of the former open hall (- the original roof structure rebuilt at a later date).

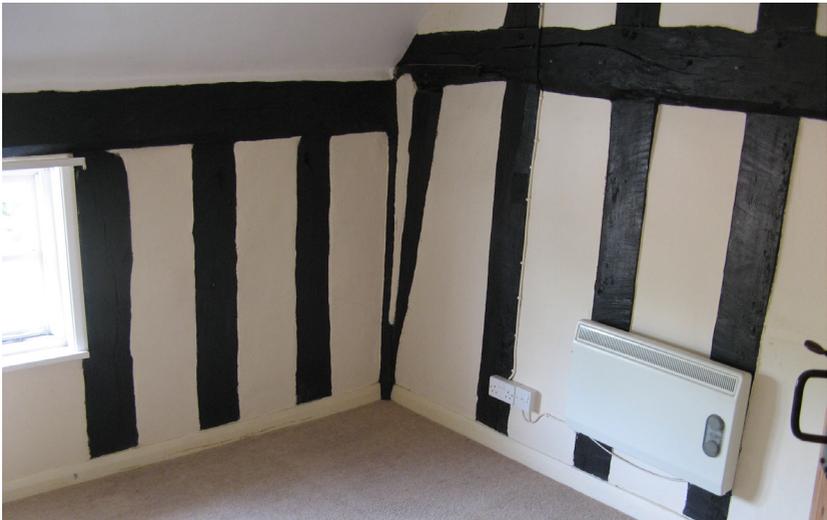
Typical quality of the timber frame as expose on the first floor.

In some interior areas the original timber frame is exposed and is of good quality close-studding. However, much of the interior of the cottages relates to the work of their subdivision and includes plasterboard partitions and ceiling linings. The inside of the external walls, on the ground storey, is formed with metal lath and plaster. Where inspected, the wattle and daub panels in the ground storey have been lost but there is no thermal insulation. Ground floors are of concrete. A general refurbishment is due. The condition of the timber frame has not been fully investigated, but repairs are anticipated.

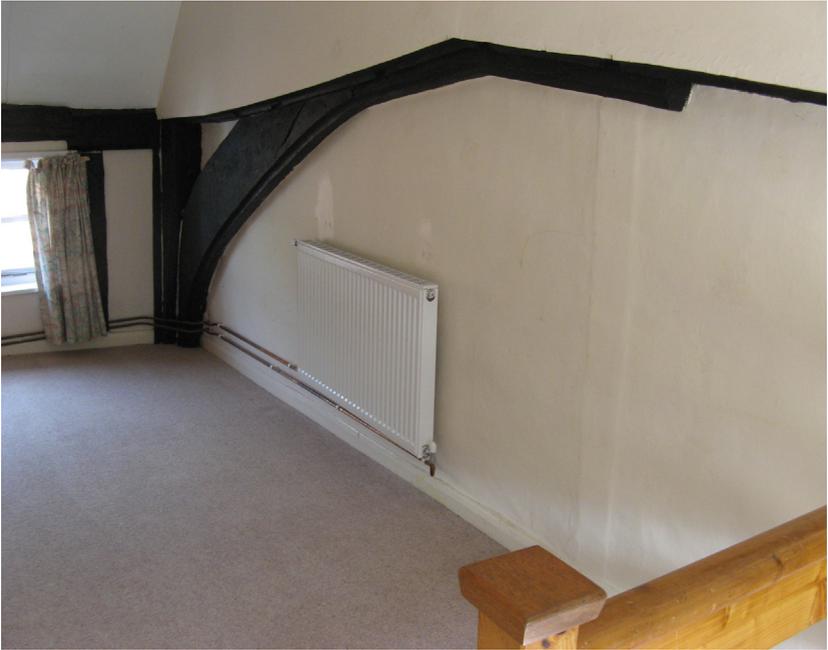
Arch braced tie beam and inserted first floor accross former open hall.

No.93 contains the former open hall; No.94 the service cell; and No.92 the parlour cell, which was probably rebuilt in late C16 or C17 (not examined). The open truss of the hall has an arch-braced cambered tie-beam, hollow chamfered; at the base of one arch brace there survives a finely carved pilaster shaft, the upper half polygonal with a moulded capital, and the lower half in the form of a buttress with sunk traceried panels. Good close studding. In late C16, an upper floor was inserted in the hall, with closely spaced chamfered joists. The roof was rebuilt in C17 with principal rafters and purlins.

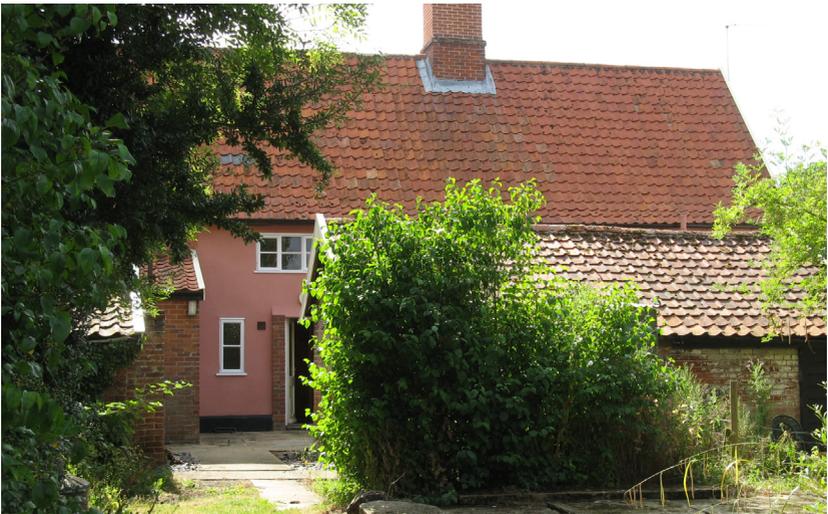
Rear view of the cottages.

More extensive render repairs are required on the rear elevation to no.93, where cracking suggests decay in the sole plate.
