PLANNING ISSUE

Conversion of thrashing barn into residence at Lords Farm, 2 Queen Street Eynsham, Witney OX29 4HQ

Proposed Sections A to D

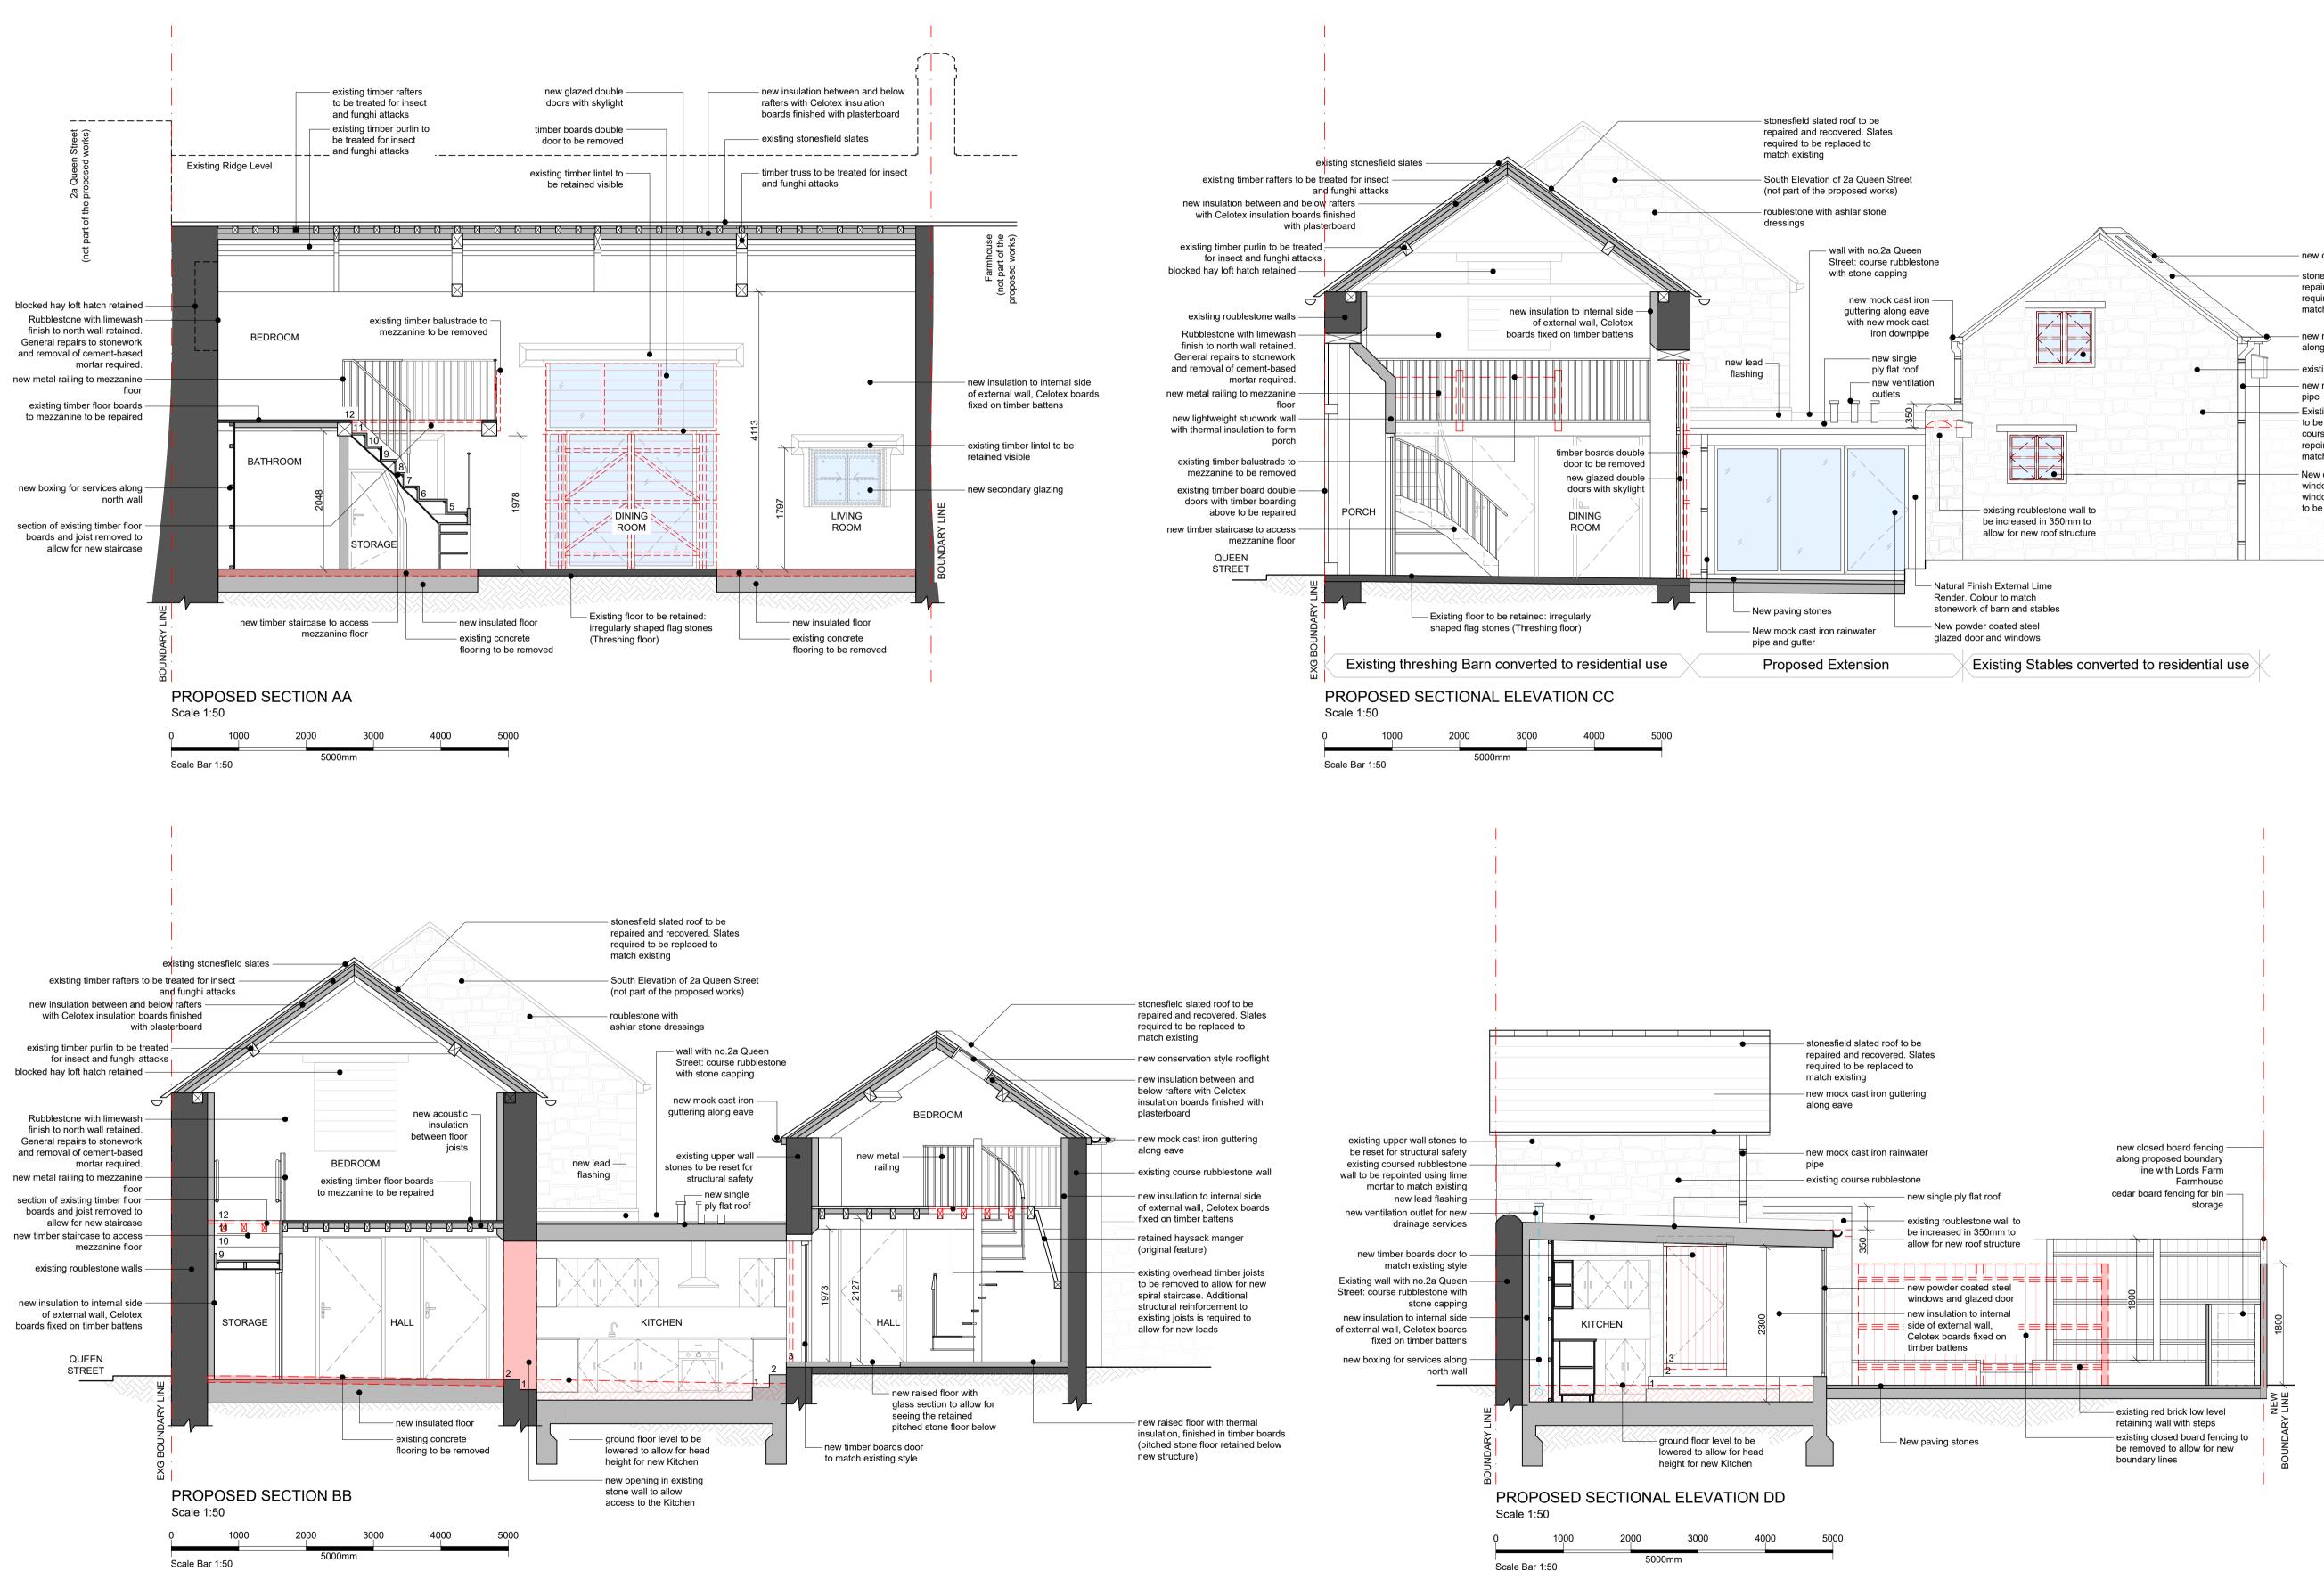
new conservation style rooflight
 stonesfield slated roof to be repaired and recovered. Slates required to be replaced to match existing

new mock cast iron guttering along eave

existing course rubblestone wallnew mock cast iron rainwater

Existing cement-based repairs
 to be remove and existing coursed rubblestone wall to be repointed using lime mortar to match existing

New double glazed timber window to match existing window style. Existing window to be removed
