Heritage Statement

Proposed rear extension(s) & alterations including new
garage/garden store to 23 & 24 Park Cottages

Park Cottages (23-24)

Ref: 488 – HS01 rev 1

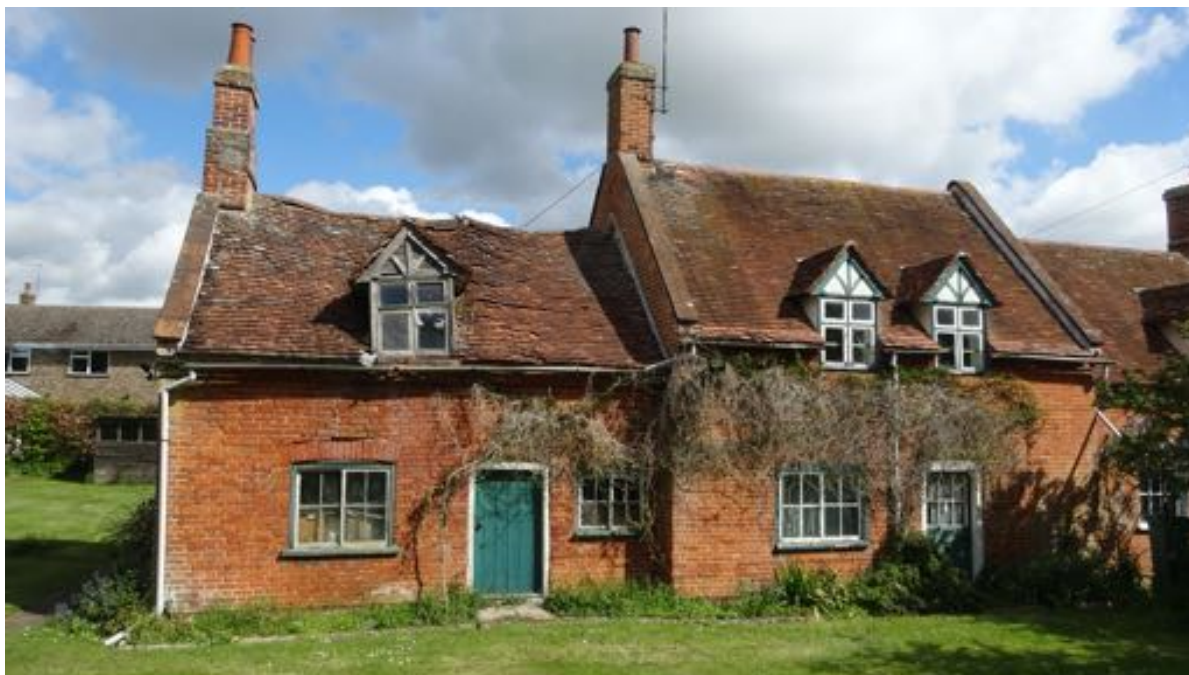
Image 2. South (front) elevation (May 2021). Image of the principle elevation showing the 2 no. structures visible with 23 having a higher ridge and is still habitable. No. 24 is derelict and is not habitable in its current form.

- Image 2. South elevation. (May 2021) Image of the principle elevation showing the 2 no. structures visible with 23 having a higher ridge and is still habitable. No. 24 is derelict and is not habitable in its current form.

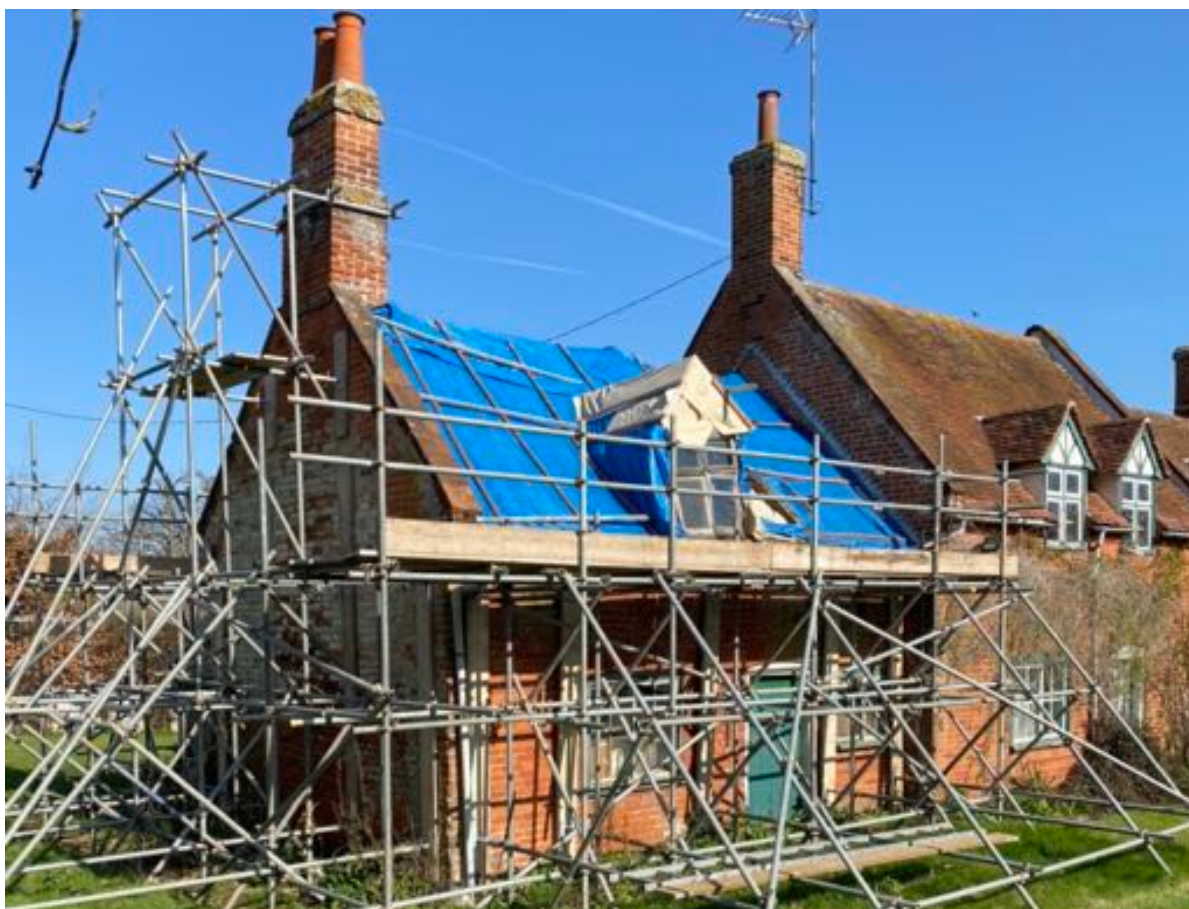
Image 3. South (Front) Elevation (March 2022). This image shows No. 24 is in a significant state of disrepair and will require a large element of reconstruction, The building has been 'propped' to avoid total collapse however, the built structure continues to deteriorate. This is clearly visible there the lead flashing meets no. 23 illustrating how much the roof has 'dropped'.

- Image 3. South (Front) Elevation (March 2022). This image shows No. 24 is in a significant state of disrepair and will require a large element of reconstruction, The building has been 'propped' to avoid total collapse however, the built structure continues to deteriorate. This is clearly visible where the lead flashing meets no. 23 illustrating how much the roof has 'dropped'.

- 2.4 The structure forming 24 is derelict and will need a considerable amount of reconstruction. The existing built form will be dismantled and reconstructed to structural engineers approval and in accordance with on-going discussions with the heritage planning team. The existing derelict staircase will be omitted and floor partially reinstated to match existing.

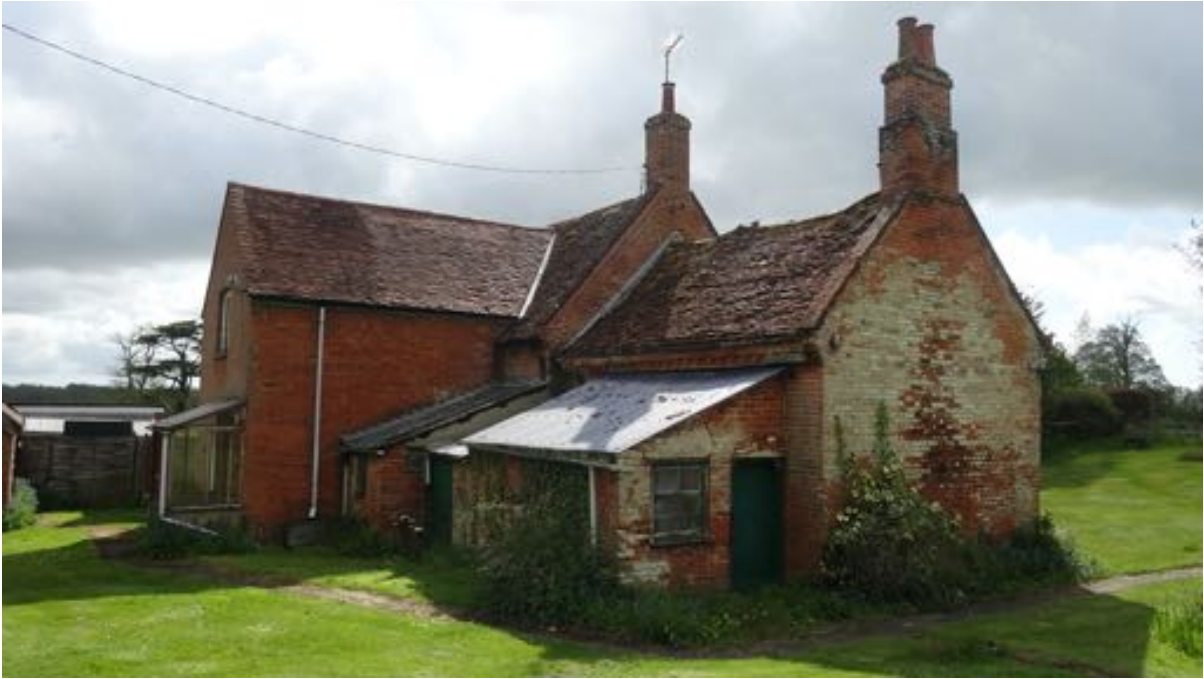
Image 4. West Elevation (May 2021). This images shows both 23 & 24 with the single storey lean-to additional and the two storey extension to the rear of no. 24.

- Image 4. West Elevation. (May 2021) This image shows both 23 & 24 with the single storey lean-to addition and the two storey extension to the rear of no. 24.

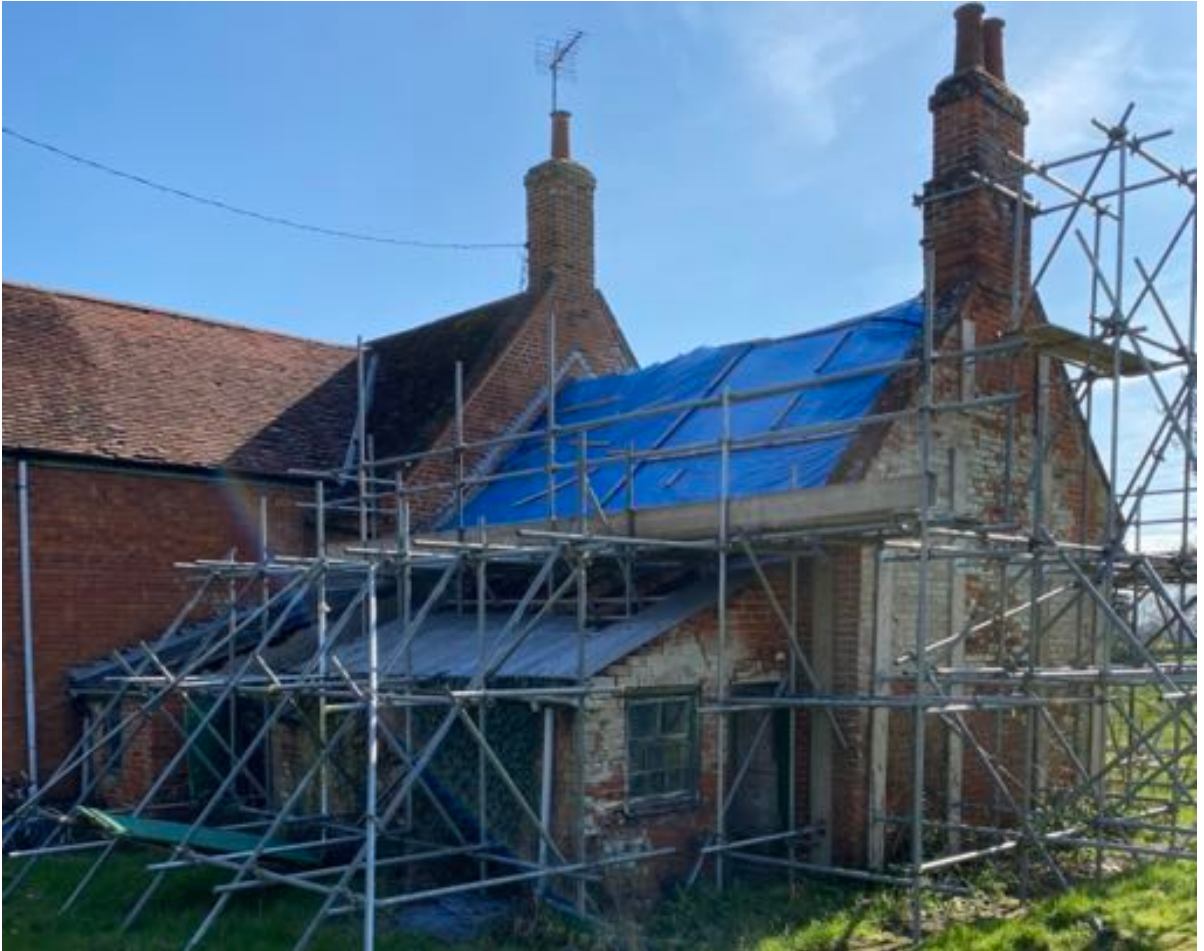
Image 5. West Elevation (March 2022). This image shows both 23 & 24 with the single storey lean-to additional and the two storey extension to the rear of no. 24. As with image 3, this clearly shows the significant deterioration over the past 10 months

- Image 5. West Elevation (March 2022). This image shows both 23 & 24 with the single storey lean-to addition and the two storey extension to the rear of no. 24. As with image 3, this clearly shows the significant deterioration over the past 10 months.

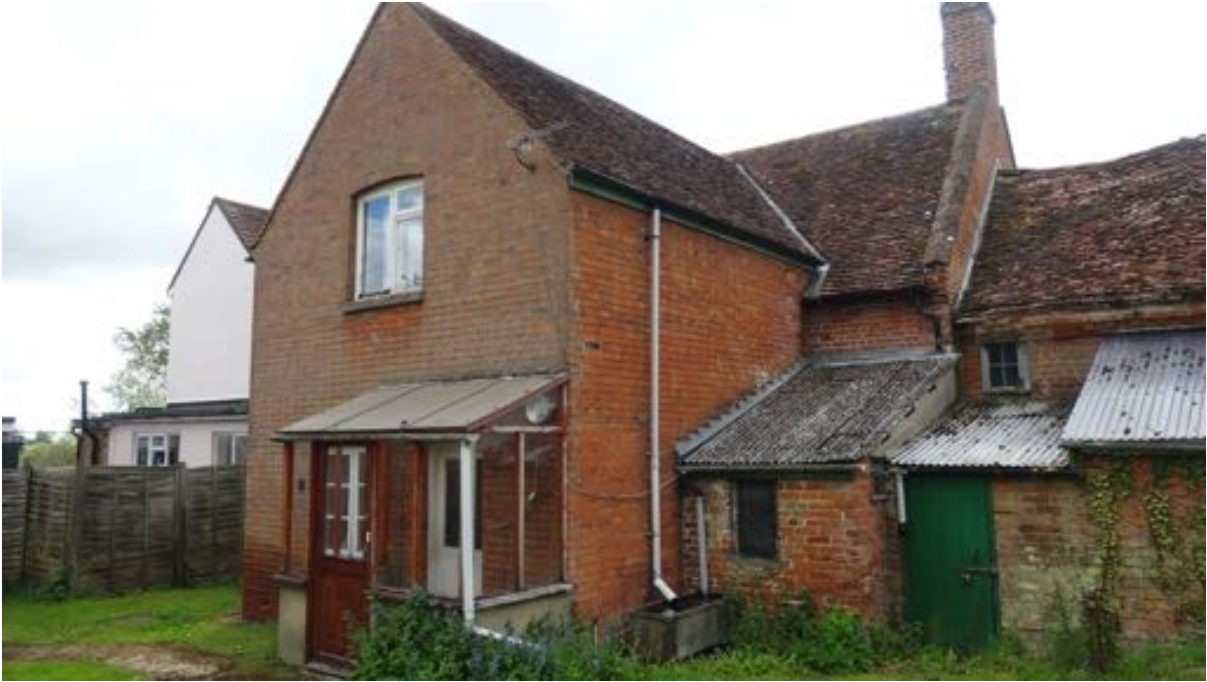
Image 6. North Elevation (May 2021). This shows the latter addition 2 storey rear extension to the rear of no. 23 along with the single storey lean-to additions to the rear of both 23 & 24.

- Image 6. North Elevation. (May 2021) This shows the latter addition 2 storey rear extension to the rear of no. 23 along with the single storey lean-to additions to the rear of both 23 & 24.
