1 Rose Bank  
Burley in Wharfedale

North Elevation (Side garden)  
Existing & Proposed

20.007

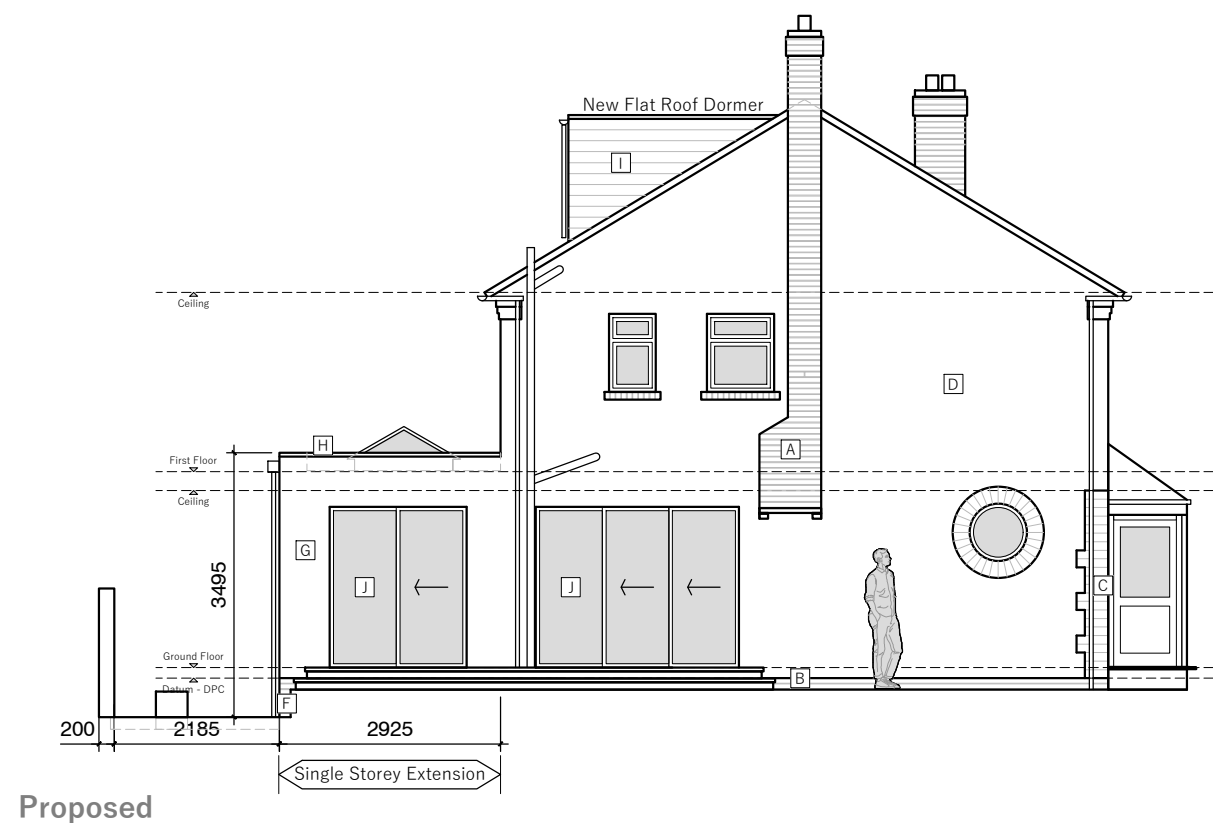
Proposed

- A Existing brickwork
- B Existing brickwork plinth
- C Existing stonework
- D Existing render
- E Existing concrete roof tile
- F New brickwork Plinth to match existing
- G New render to match existing
- H New stone parapet cap to match existing stonework hue
- I New composite cladding and fascia boards to match existing concrete tile hue
- J New uPVC double glazed windows
- K New brick sill detail to match existing
- L New lantern rooflight
- M New painted metal Juliet balcony
- N New Rainwater goods to match existing
