**PEACOCK LAKE**

**5 PEACOCK CLOSE**

**GUNTHORPE**

**BAT SURVEY REPORT**

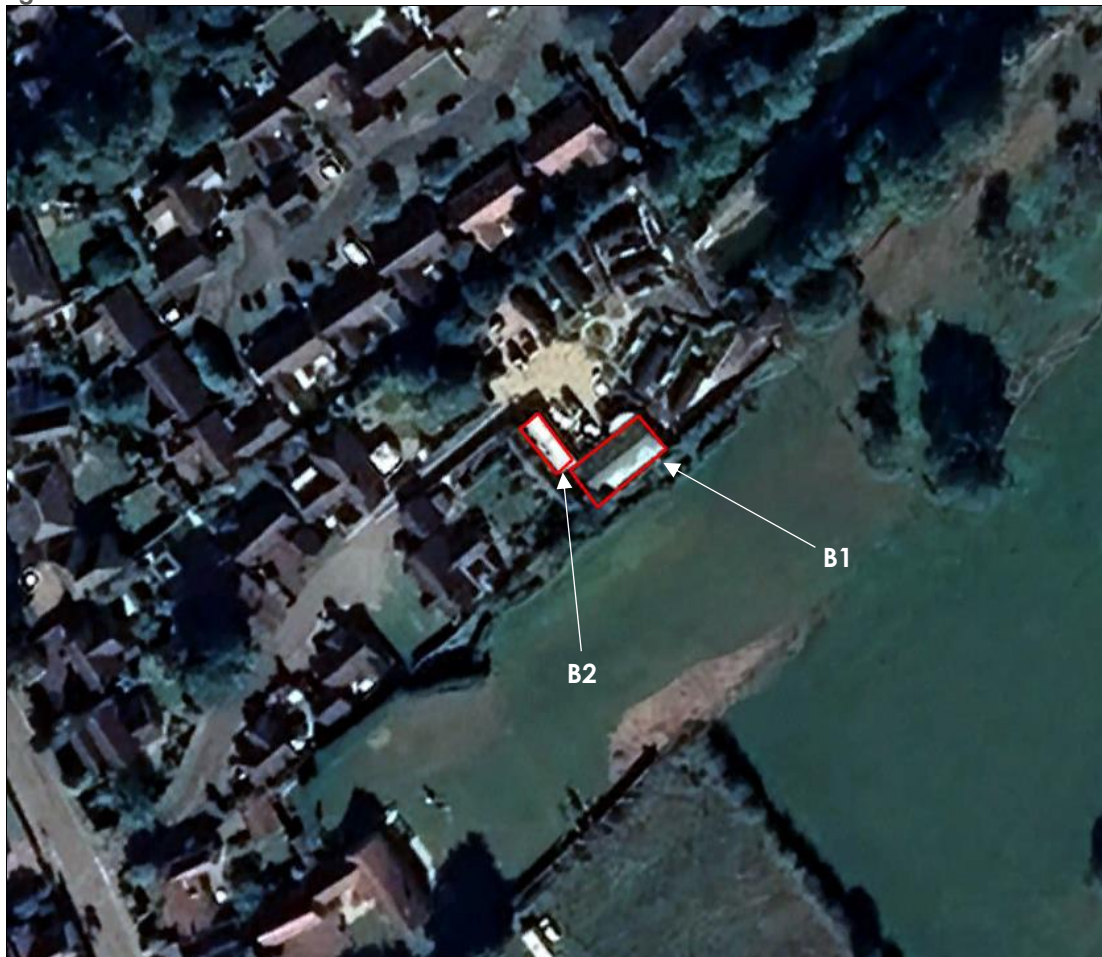
Figure 1.1: Site Context

- 1.2 The Site is located in rural Gunthorpe. The building (B1) and caravan (B2) are set within hardstanding adjacent to glamping pods and the car park. The surrounding land supports, a lake, agricultural land, residential properties and woodland with roads, hedgerows, watercourses (including the River Trent) and tree lines dissecting the landscape.

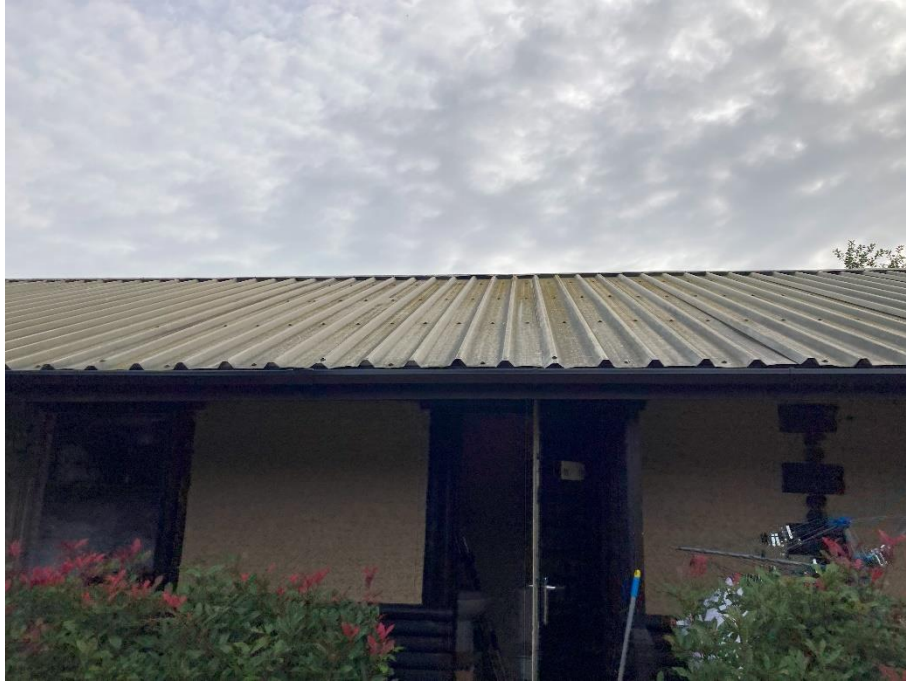
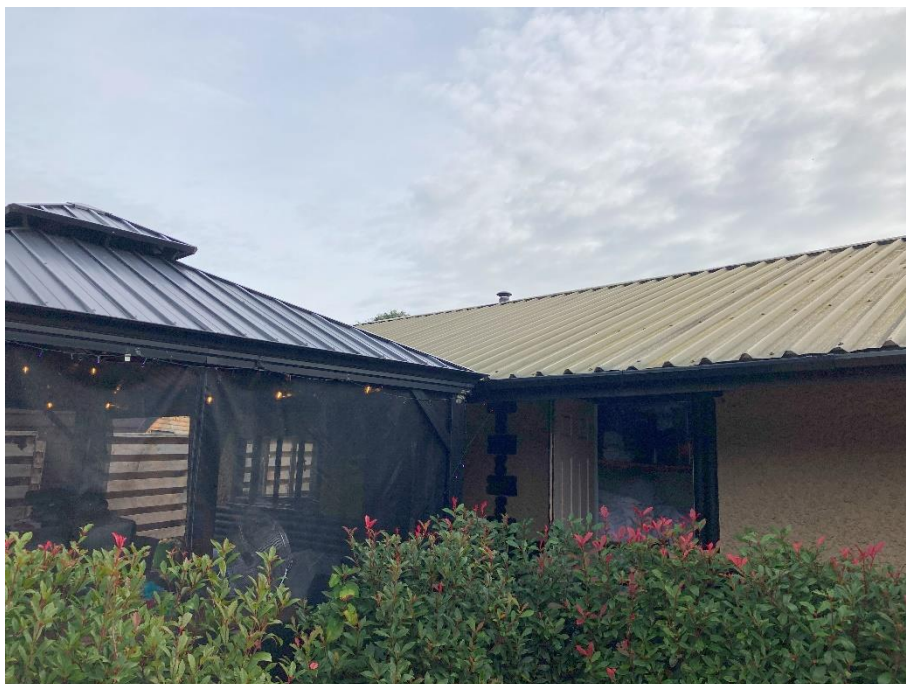
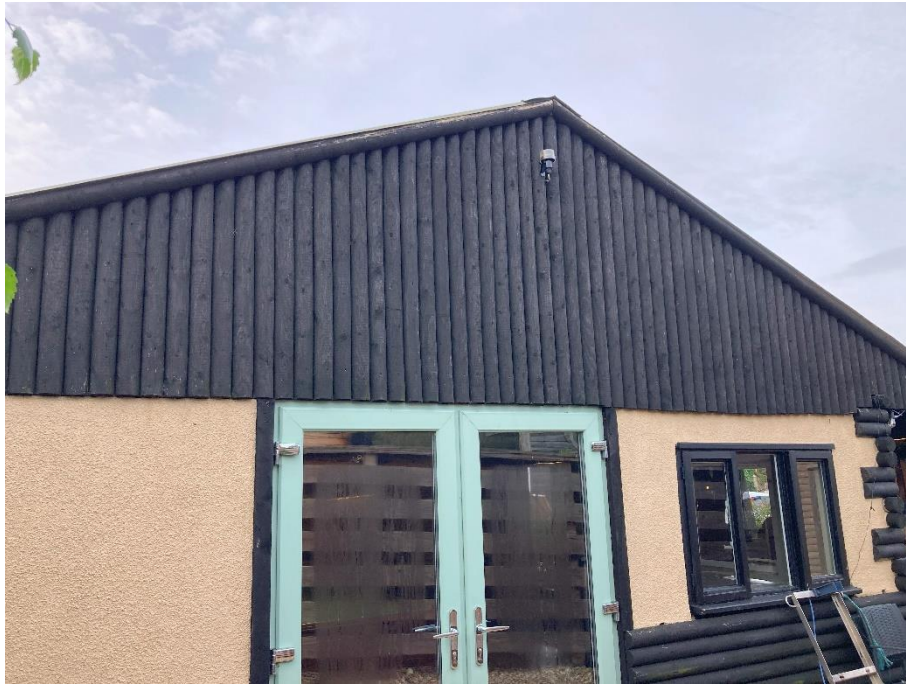
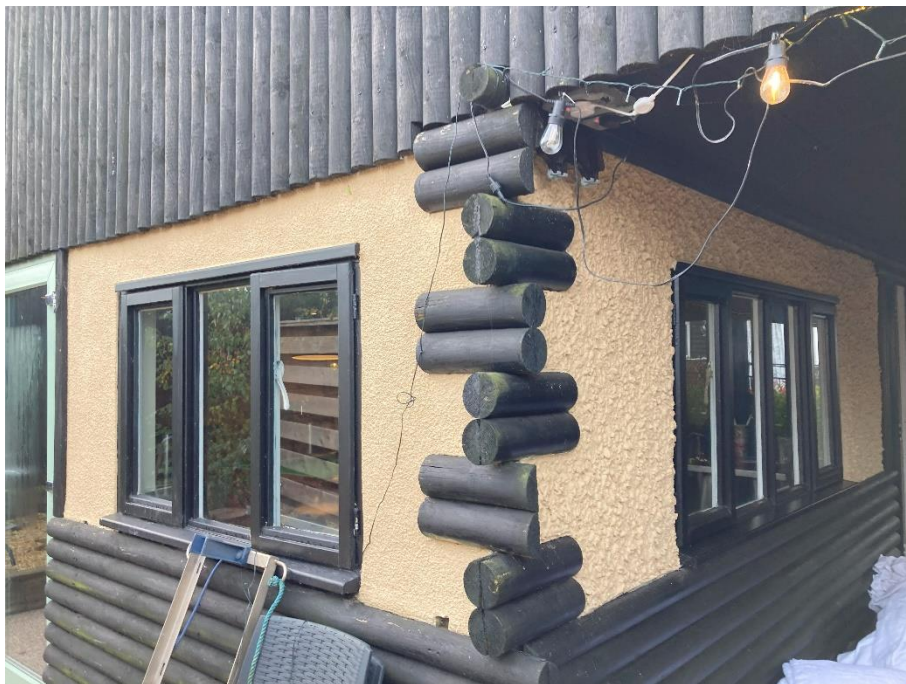
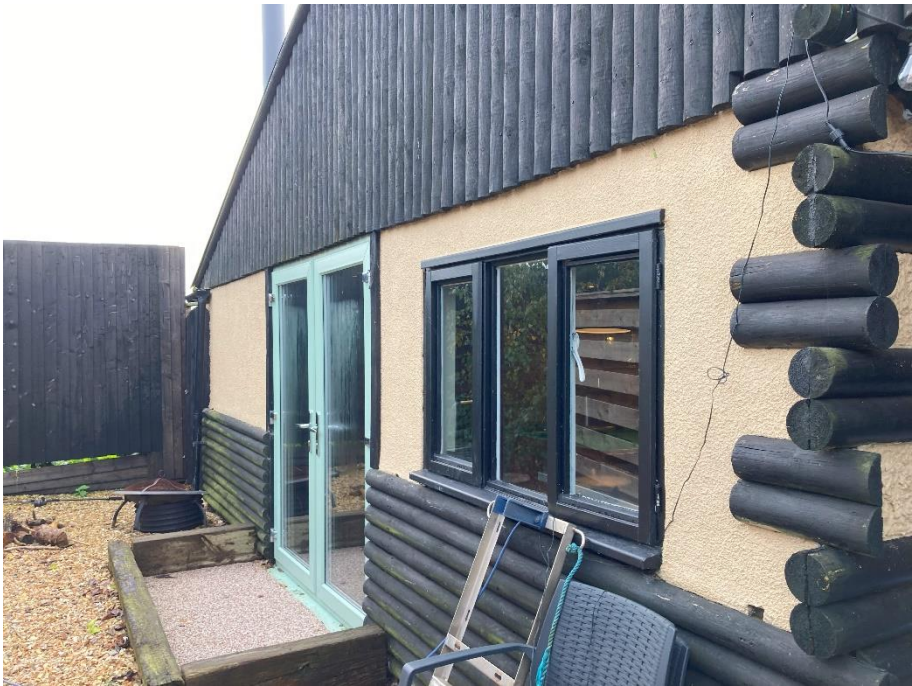
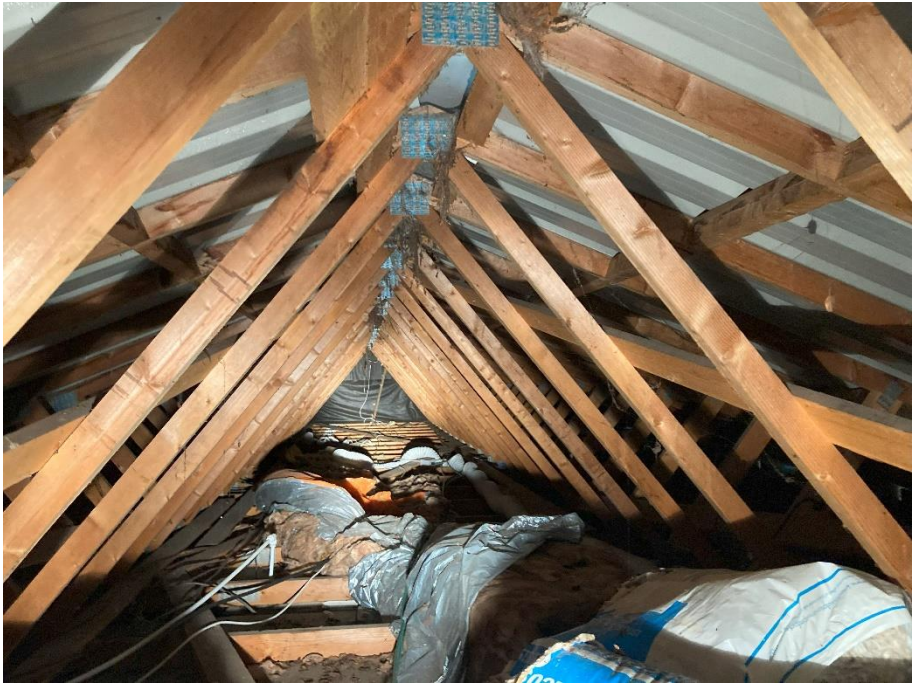
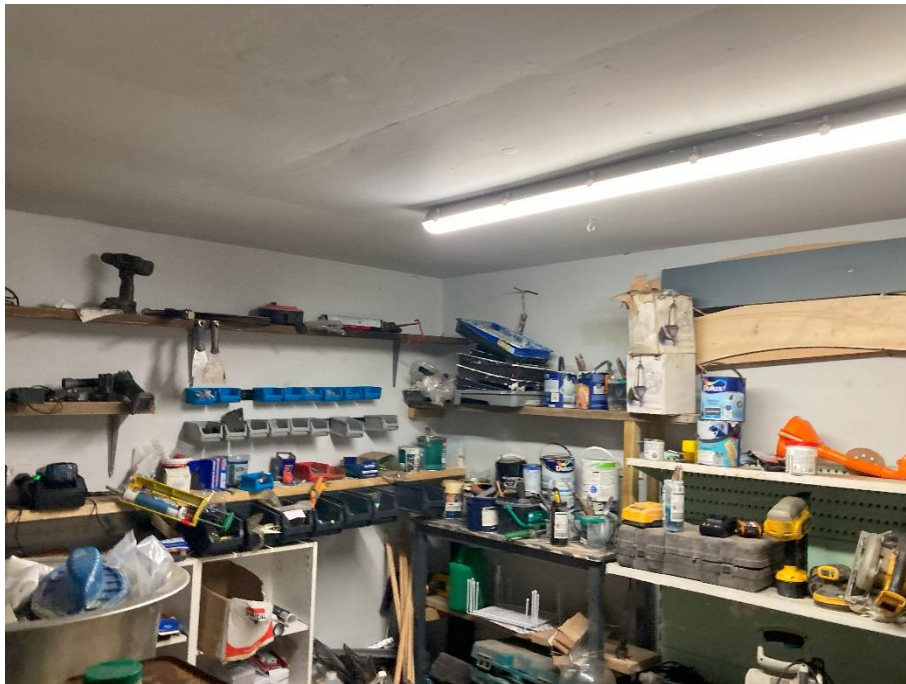
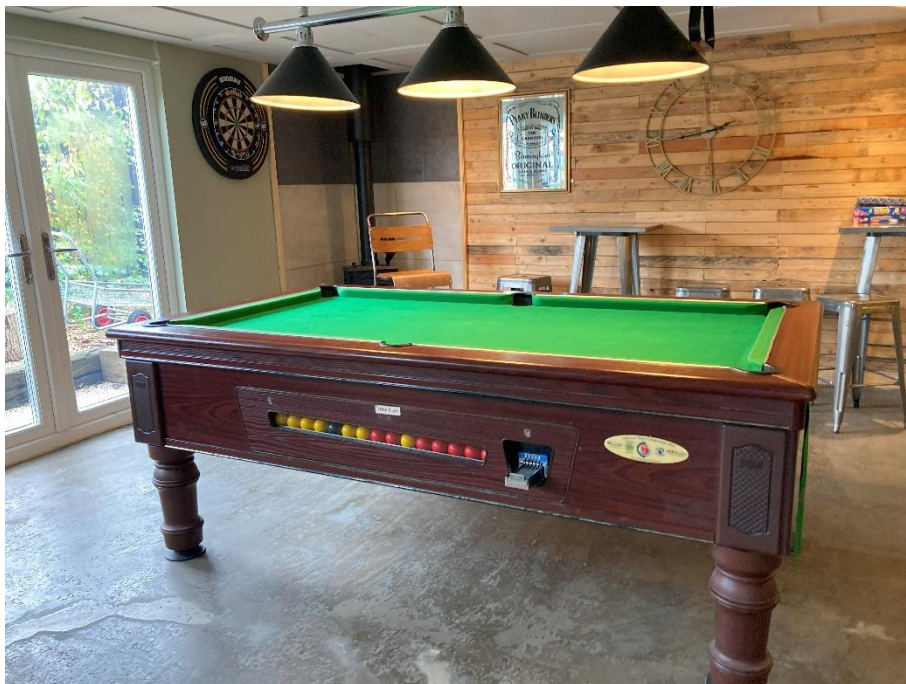
### Building 1

Building	Description	Potential Roosting Features	Bat Roosting Potential	Further Survey Required
B1	<p>Single storey amenity building utilised for recreation by glamping guests and plant/machinery storage. The building supported a corrugated metal roof and had an overhanging boxed eaves on the north-western aspect as well as partial wood cladding which was all in a good state of repair.</p> <p>The loft space supported fibrous insulation machine cut timbers and metal corrugated roof material exposed with no underlining. The roof was loose fitting and therefore very exposed in terms of light and weather.</p>	<p>Loose fitting corrugated metal roof liable to temperature, light and humidity fluctuations which are not favourable for bat roosting.</p> <p>No crevice/void features suited to roosting;</p> <p>Artificial lighting associated with the building reduces likelihood of roosting</p>	Negligible Potential	No

- 4.4 No nesting birds were seen during the survey and nests were considered unlikely (not impossible) in B2. The risk of nesting in B1's roof cannot however be entirely ruled out as the roof structure was considered loose fit with gaps big enough for birds to exploit.
- 4.5 In the absence of mitigation bird nests could be destroyed and individual birds could be killed or injured (or disturbed when nesting) during demolition/construction. This would be a potentially minor adverse effect at a local level.

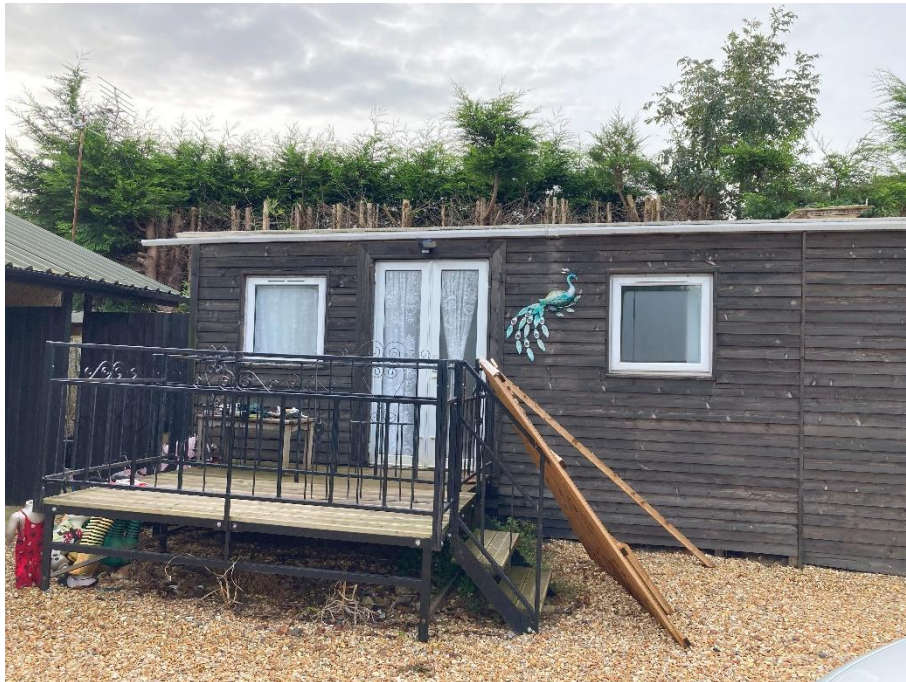
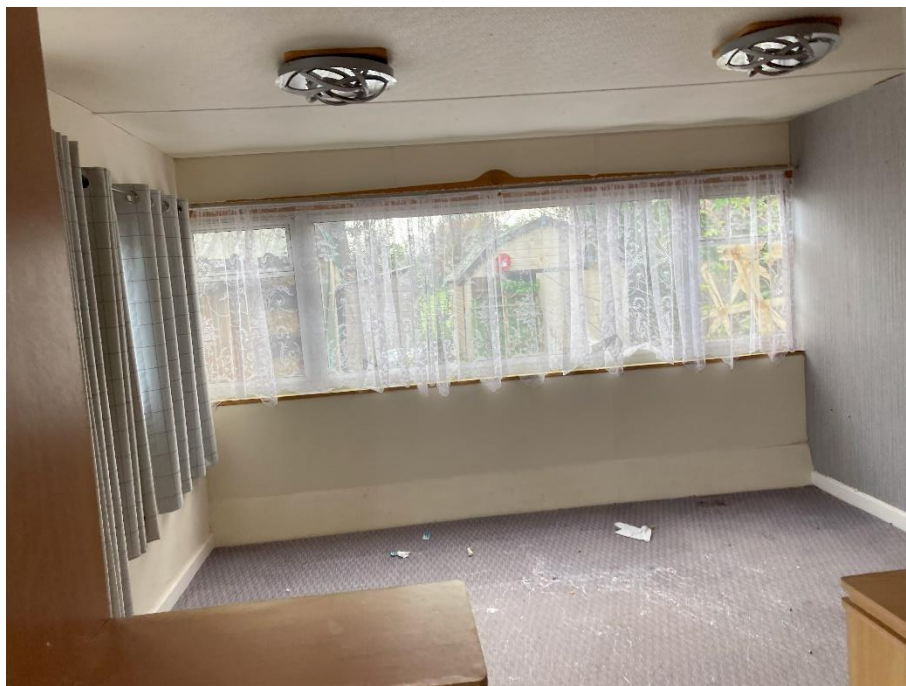
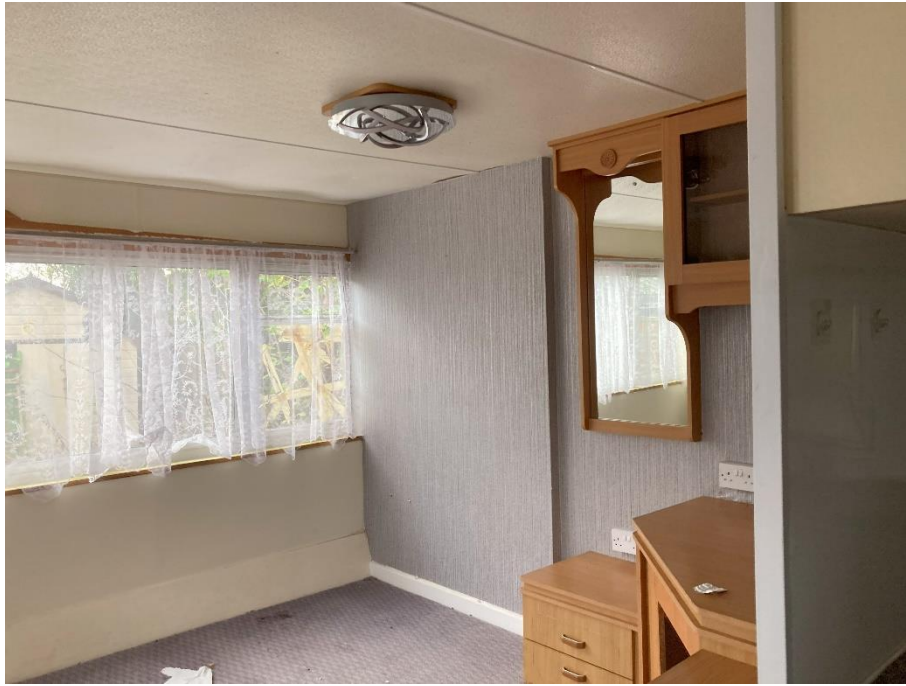
**Building 2**

B2	<p>Static caravan with flat roof clad in tightly finished single skin timber. The caravan windows and doors were tightly sealed with no ingress opportunities noted in association with timber cladding or metal walls/flat roof.</p>	N/A	Negligible Potential	No
