DAMPCURE

RE THE OLD GEORGE PUB/LITTLE WADLEY MAIN STREET DYMOCK

We thank you for your enquiry. Further to your instructions our Surveyor, Rob Brien, visited the property on the 30th August 2023 in order to inspect for rising and penetrating dampness and timber infestation and fungal decay. We now outline below his observations and recommendations. If there are any omissions or if we have misinterpreted your survey instructions, please let us know at once.

DAMPCURE SurveySheet

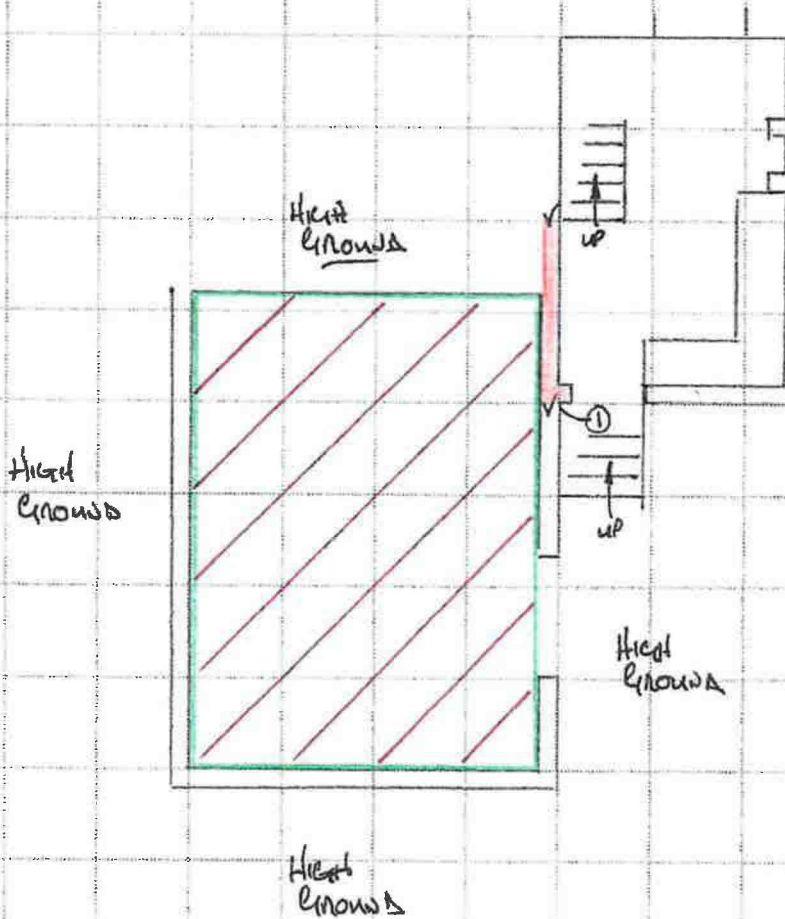
We confined our inspection to the above areas where tests conducted with an electrical moisture meter coupled with a visual inspection revealed evidence of both rising and penetrating dampness to the walls within the cellar. The dampness was noted both horizontally and vertically. Horizontally, through the walls which are earth retaining and vertically through the floor, which is original, and of brick construction and will not have the benefit of a damp proof membrane. Both of these factors allowing moisture to percolate into the atmosphere and then subsequently condense, in part, on the timbers.

In addition to the above, we were also asked to comment in regards to dampness to the separating wall between this and the adjoining property (Little Wadley). An inspection made of the separating wall from the inside of Little Wadley did reveal evidence of dampness to the wall immediately above the skirting boards. This dampness was more prevalent to the front elevation door area, however, a subsequent external inspection revealed that the area in question is located below a vertical mortar joint, which separates the two properties, that would appear to be perished and therefore it is inevitable that at times of heavy rainfall and wind, from a northerly direction, that water will be penetrating into the brickwork then subsequently, over a period of time, migrating down into the separating wall in question. The dampness levels dropped considerably the further we tested the wall surface away from the front door and towards the staircase.

As intimated, there would appear to be some evidence of rising dampness to the separating wall between yours and the adjoining property (Little Wadley). Some of this dampness may be attributed to the perished mortar joint noted where the two adjoining properties meet. We would, therefore, suggest that before any remedial works are carried out within the Little Wadley side of the premises, that the perished mortar joint is made good and it may then be found that subsequent to the area in question becoming watertight that the wall in question may dry out and no further remedial works may be necessary, however, if it should transpire that the wall does not subsequently dry out, then there is a probability that the dampness to the wall in question, in part, as a result of moisture from within the cellar and rising dampness in which case this would necessitate remedial treatments, again, we would suggest, in the first instance, that the wall is treated with a Dryzone Cream chemical damp proof course and subsequent to this we would suggest that the area is monitored to determine whether this resolves the rising damp issue. If you should wish to proceed on this basis, then it would be necessary, prior to our arrival on site, for yourselves to arrange for the removal of the radiator from the wall that requires treating.

- ✓ VERTICAL etc
- ① VERTICAL CRACK (PERFORATED MORTAR JOINT)

1. To the walls marked in green to supply and fit a Type C cavity drain membrane system. The membrane system to run from the underside of the existing ground floor joists down to the floor/wall joint. The membrane system to be fitted into position using sealed brick plugs (tack on).
2. To the walls marked in green, to the base of the walls, to then provide a condensation strip. The condensation strip to rise from the floor/wall joint up to a height of approximately 300mm. Again, the membrane system to be fitted into position using sealed brick plugs.
3. To the floor area, as indicated in red hatching, to overlay the existing floor again with a Type C cavity drain membrane system. The membrane system to be tied in with that already affixed to the wall surfaces.
