DESIGN AND ACCESS STATEMENT

20 Market Street Chipping Norton Oxfordshire OX7 5NA

This design and access statement has been prepared by CS2 Ltd on behalf of Lewis Silver of CHP Management Limited. The statement is submitted in support of the planning application for the remedial repair works to a retaining garden wall to the rear of 20 Market Street, Chipping Norton, Oxfordshire. OX7 5NA.

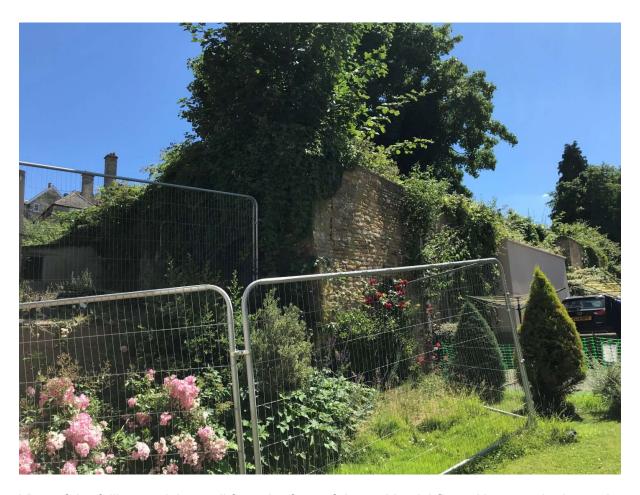
View of the failing retaining wall from the front of the residential flats. Note required security fencing in place and the obvious fracture lines in the retaining wall.

The proposal is for essential repairs to a 4m high retaining wall that is failing due to the root structure of self-seeding saplings. The retaining wall is coursed rubble stone bedded in lime mortar, which is to be removed where currently fracturing and causing a risk to life. The immature tree/shrubs in the rear garden area to 20 Market Street are to be removed and the ground locally behind the wall within the curtilage of 20 Market Street is to be raked out to a 20-degree slope, before the wall and capping stone are reconstructed using saved stone and hydrated lime mortar.
