Tree Re-survey  
Arboricultural Impact Assessment  
& Tree Protection Plan

Proposed Extension to  
Lowen House  
Roseland Parc  
Tregony  
Truro  
TR2 5PD

Reference: 2001-5-C

Report Date: May 2023  
amended Aug & September 2023

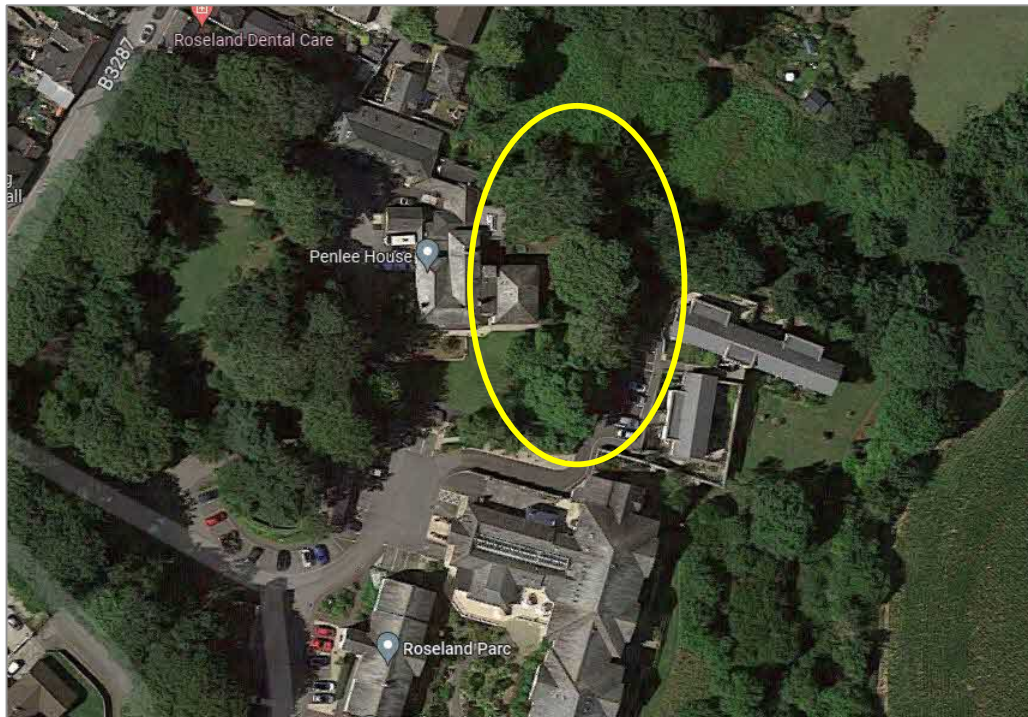
Image 1. Aerial view of approximate area of survey.  
©Google Map Data 2023.

- 5.1 I have restricted my survey to the area adjacent to Lowen House where the previous extensions were proposed. This area comprises several large and mature trees within formal gardens.
- 5.2 Access to the site is from the existing car park provision. The car parking to the east of the trees was recently constructed.
- 5.3 Surrounding land is a mix of residential, retirement complex and agriculture.

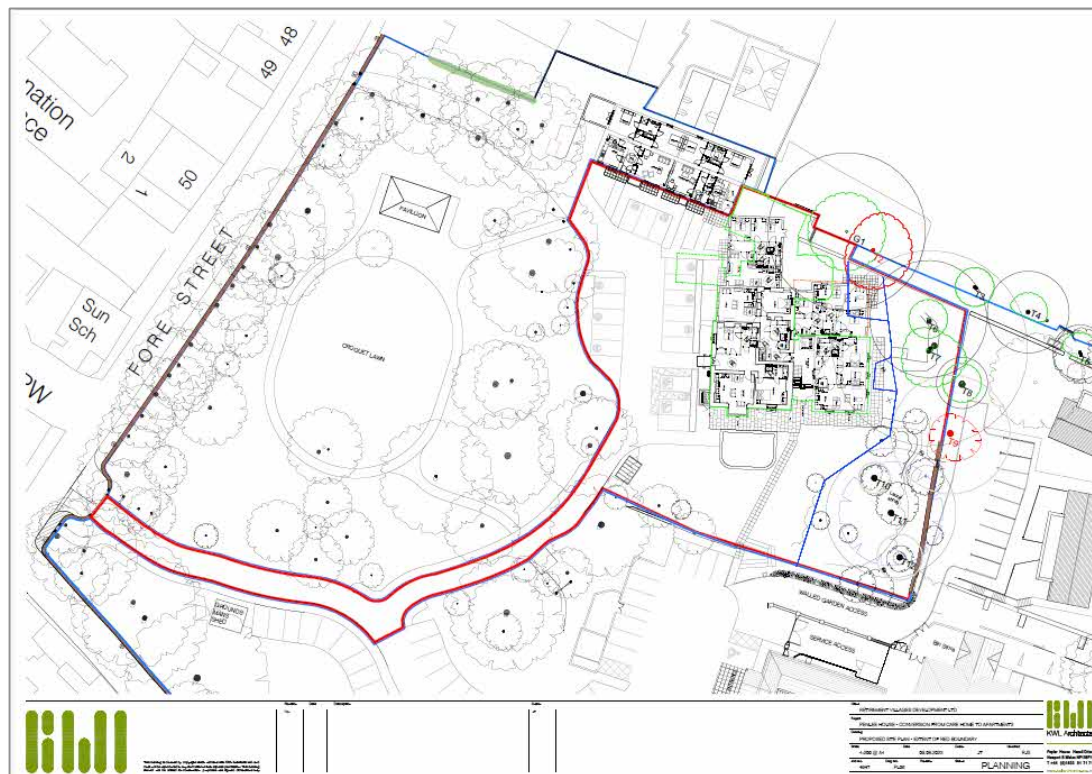
Image 2. KWL Architects Proposed Site Plan – Extent of Red Boundary Planning Drawing 4947-PL06 dated 09.08.2023.  
Extract Not to scale.

8.1 The proposals are to convert the existing care home buildings to apartments and extend to the east as shown in the plan below.

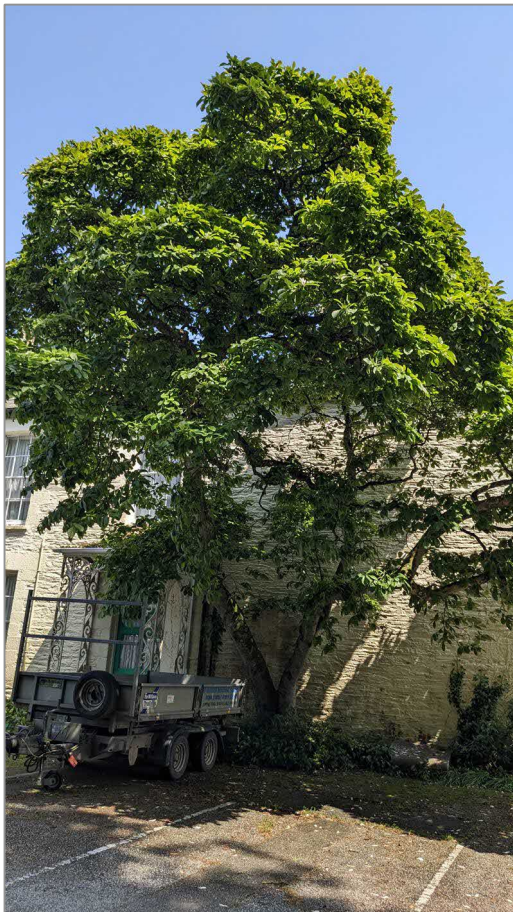
Image 3. Magnolia T13.

- 9.7 The Magnolia Tree T13: This tree is a twin-stemmed specimen growing from the wall adjacent to the door (Image 3) and, I have been informed, next to a cellar. Concerns have been raised with regards the potential for any damage to be caused by roots to either the wall of the house or the cellar.

- 9.7.1 The damage to the wall of the house is unlikely to be affected by tree root growth given the soils are not shrinkable. There may be some potential for minor damage as a result of radial growth of the stem though trees typically deform around the 'harder' object, this is particularly the case with magnolia.

- 9.7.2 The second issue is of root ingress into the wall of the basement. This is possible but unlikely to be significant. Given the tree has been there for many years in very close proximity to this wall, I would have expected some damage to be already evident. Should this become an issue, then tree management, probably removal, should be considered.

- 9.7.3 The potential for managing the tree to reduce the tree is not a realistic solution. There is no direct relationship between root growth and above ground growth so any pruning would have uncertain results at best. It would also reduce the natural form of the tree that provides much of its value.

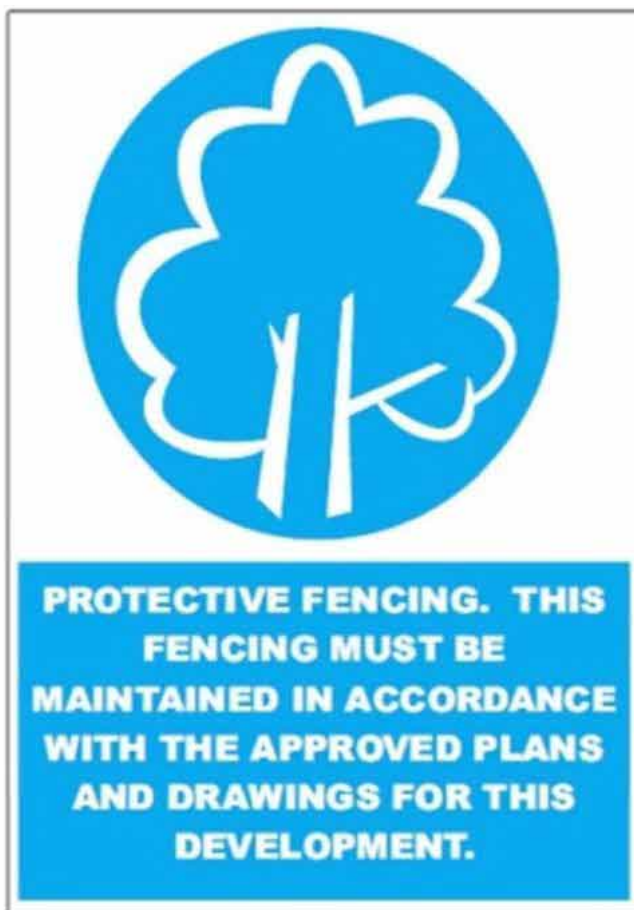
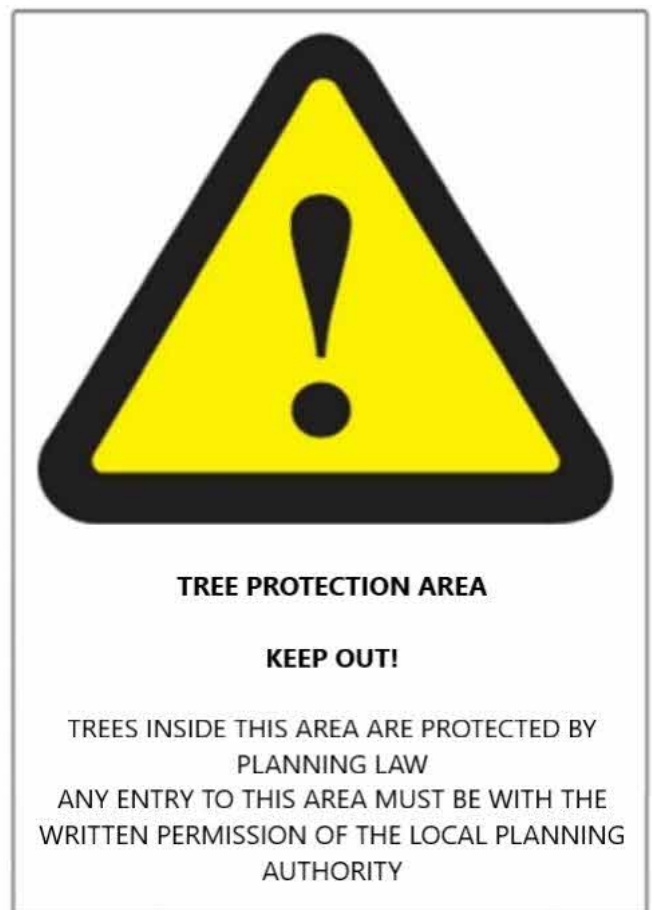
The fencing is to carry waterproof warning notices denying access within the RPA. The following signs or similar will be attached to the fence panels.

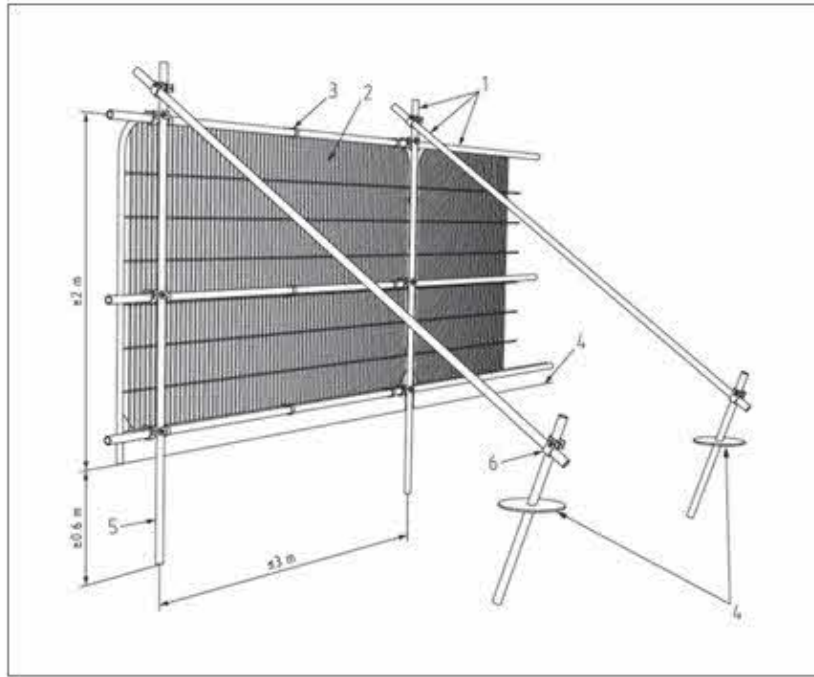
Below is the fencing specification reproduced from BS 5837:2012 Trees in relation to design, demolition, and construction – Recommendations.

- 1 Standard scaffold poles.
- 2 Heavy gauge 2 m tall, galvanized tube and welded mesh infill panels.
- 3 Panels secured to uprights and cross-members with wire ties.
- 4 Ground level.
- 5 Uprights driven into the ground until secure (minimum depth 0.6 m).
- 6 Standard scaffold clamps.

The areas forming the Construction Exclusion Zone are to be protected by Tree Protection Barriers as per the recommendations in BS 5837:2012 (Figure 2) or as specified below at Appendix I.

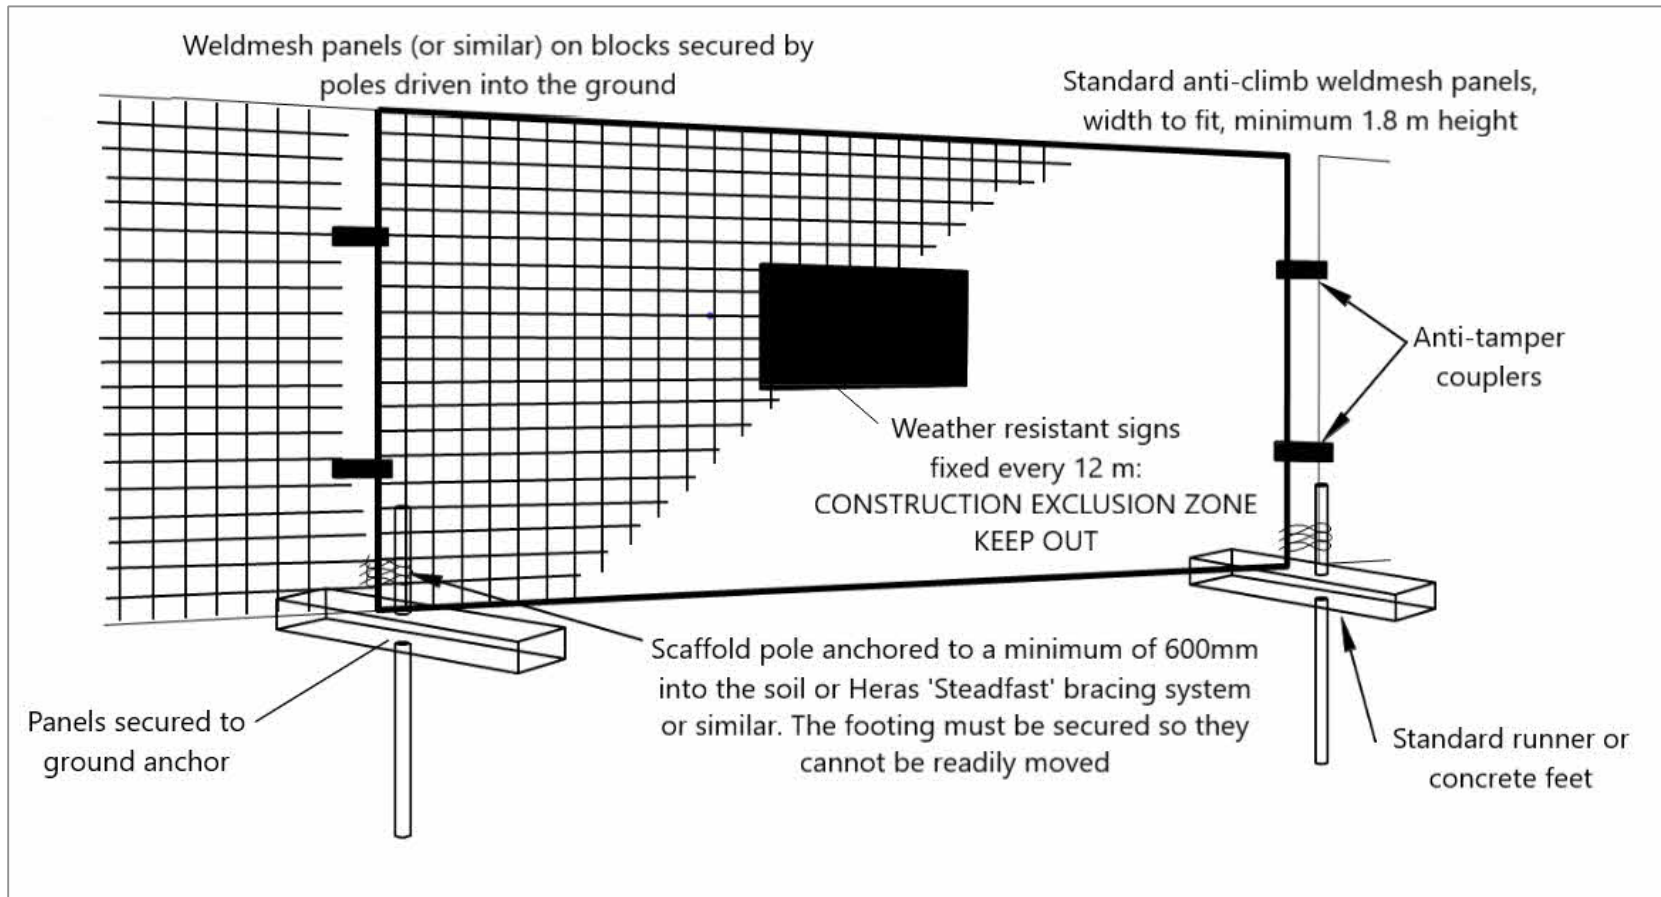
## APPENDIX G Tree Protection Barriers Medium Construction Pressure

Tree Protection Barriers (derived & amended from BS5837:2012 Figure 2) where there is insufficient space to install bracing. Examples of configurations for steel mesh perimeter fencing systems are given in BS 1722-18
