EXISTING ELEVATION EAST

1:100@A3

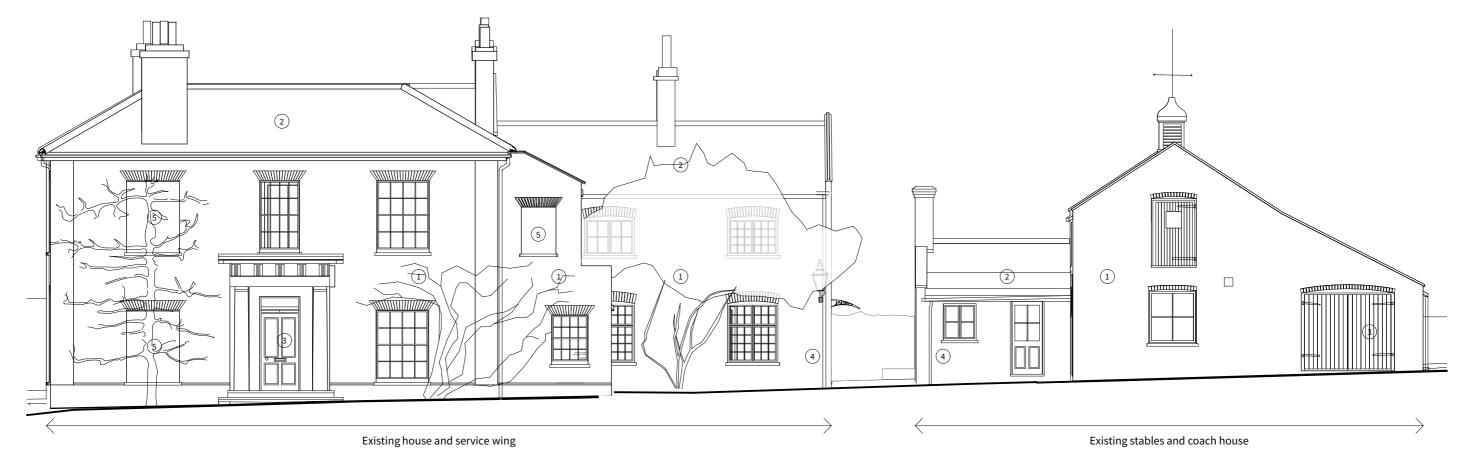
- Red brick in Flemish bond.
- Glazed black pantiles
 Painted timber door.
- Cast iron rainwater goods.
 Blind window (Flemish bond).
- Painted cementitious render.
- Stable partitions.
 Unpainted cementitious render
