Arboricultural Report

BS 5837:2012 Tree Survey

Little Hearn, Swains Lane, Bembridge

Ref: AS/DP/1023

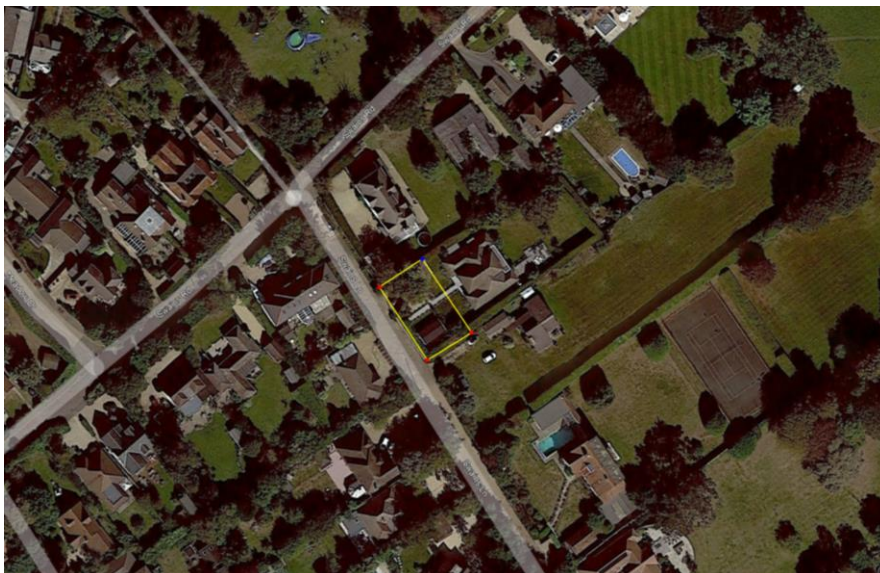
- 2.2 **Site Description:** The site is an existing residential curtilage, consisting of the dwelling, several outbuildings, gravel parking/turning area, lawn, shrub beds, small trees and hedges, and a single large mature tree (T1). T1 is the only tree of significance when considering the likely constraints to a new annexe, although the next nearest off-site tree was also included in the survey, and other minor vegetation cover was noted on the survey plan for completeness. The survey area measured approximately 0.04ha as shown in Figure 1.

Figure 1. Aerial view showing area covered within this survey (Google 2023)

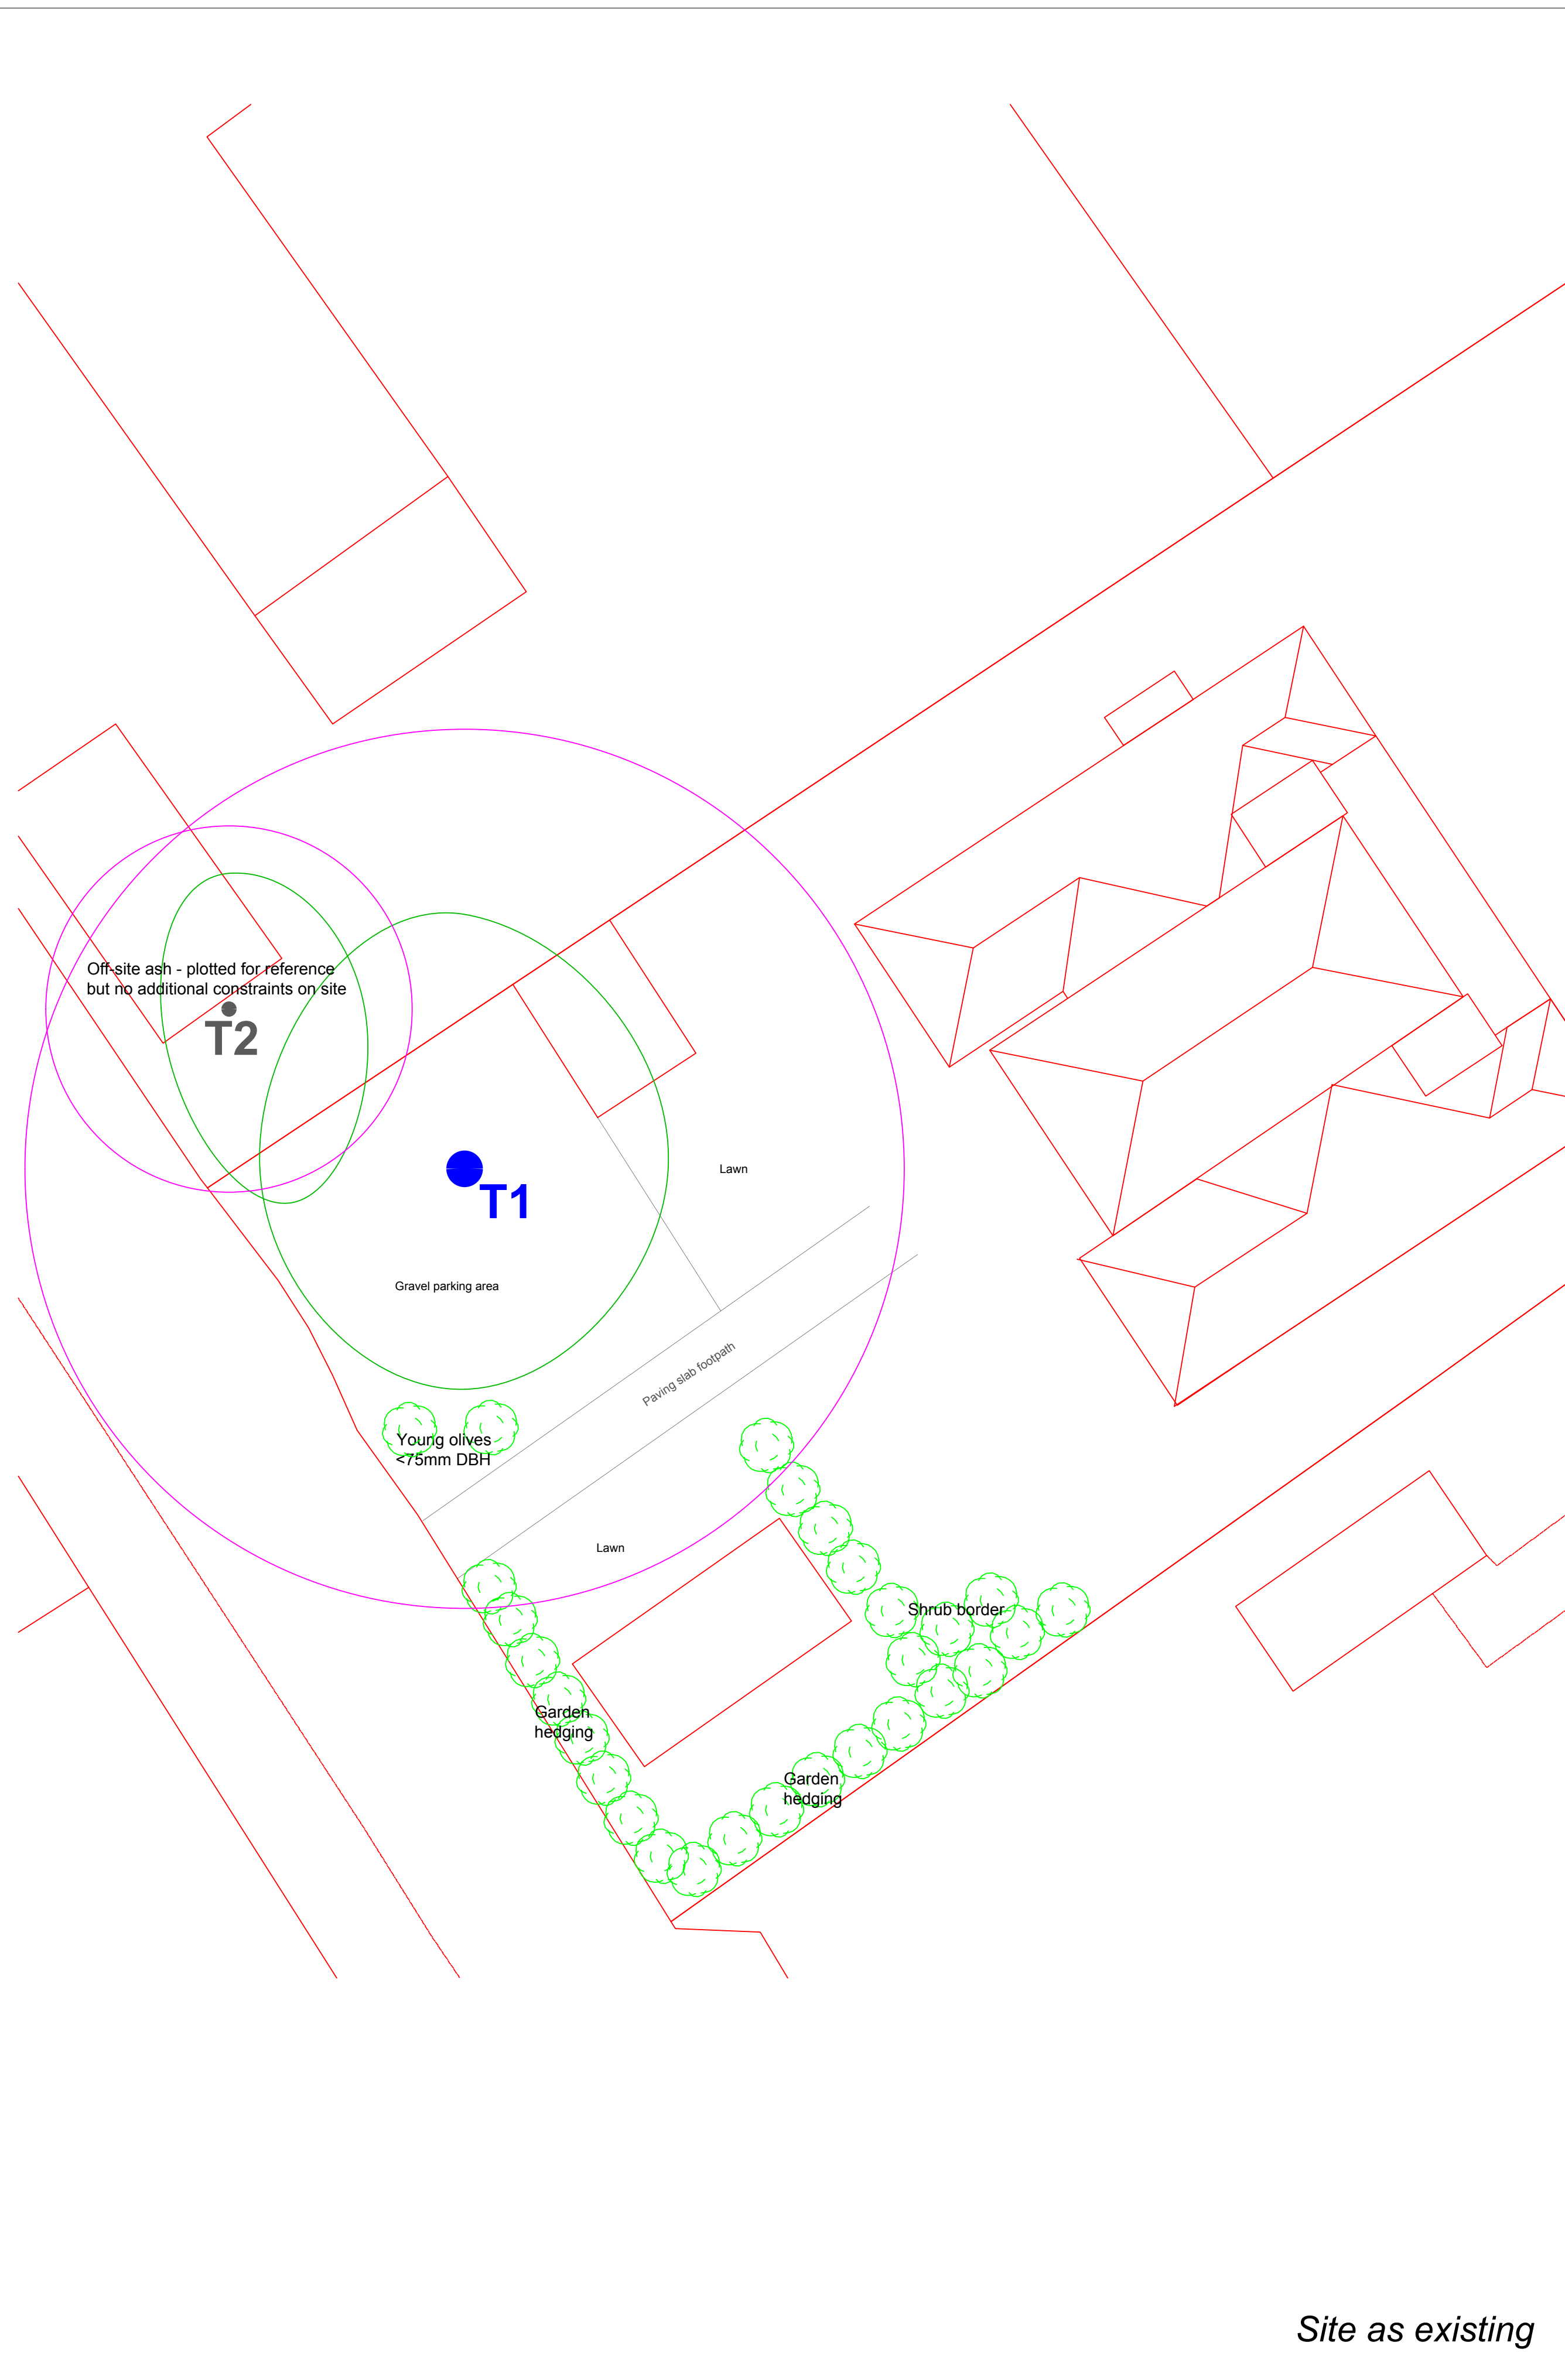
Site as existing

2.4.2 The calculated extent of each RPA is used to identify any design constraints within the site, and is visually represented on the Tree Survey & Constraints Plan (TSCP - Appendix 4). The TSCP shows the above-ground constraints (*i.e.* branch spread), and the below-ground constraints (the anticipated extent of significant root spread depicted as the calculated RPAs).

3.2.2 The TSCP visually represents the required RPA for retained trees as a magenta circle centred on each stem. It is quite possible, depending on soil conditions and tree species characteristics, that roots will extend beyond this zone, hence this area should be carefully protected during the planning and execution of site works.

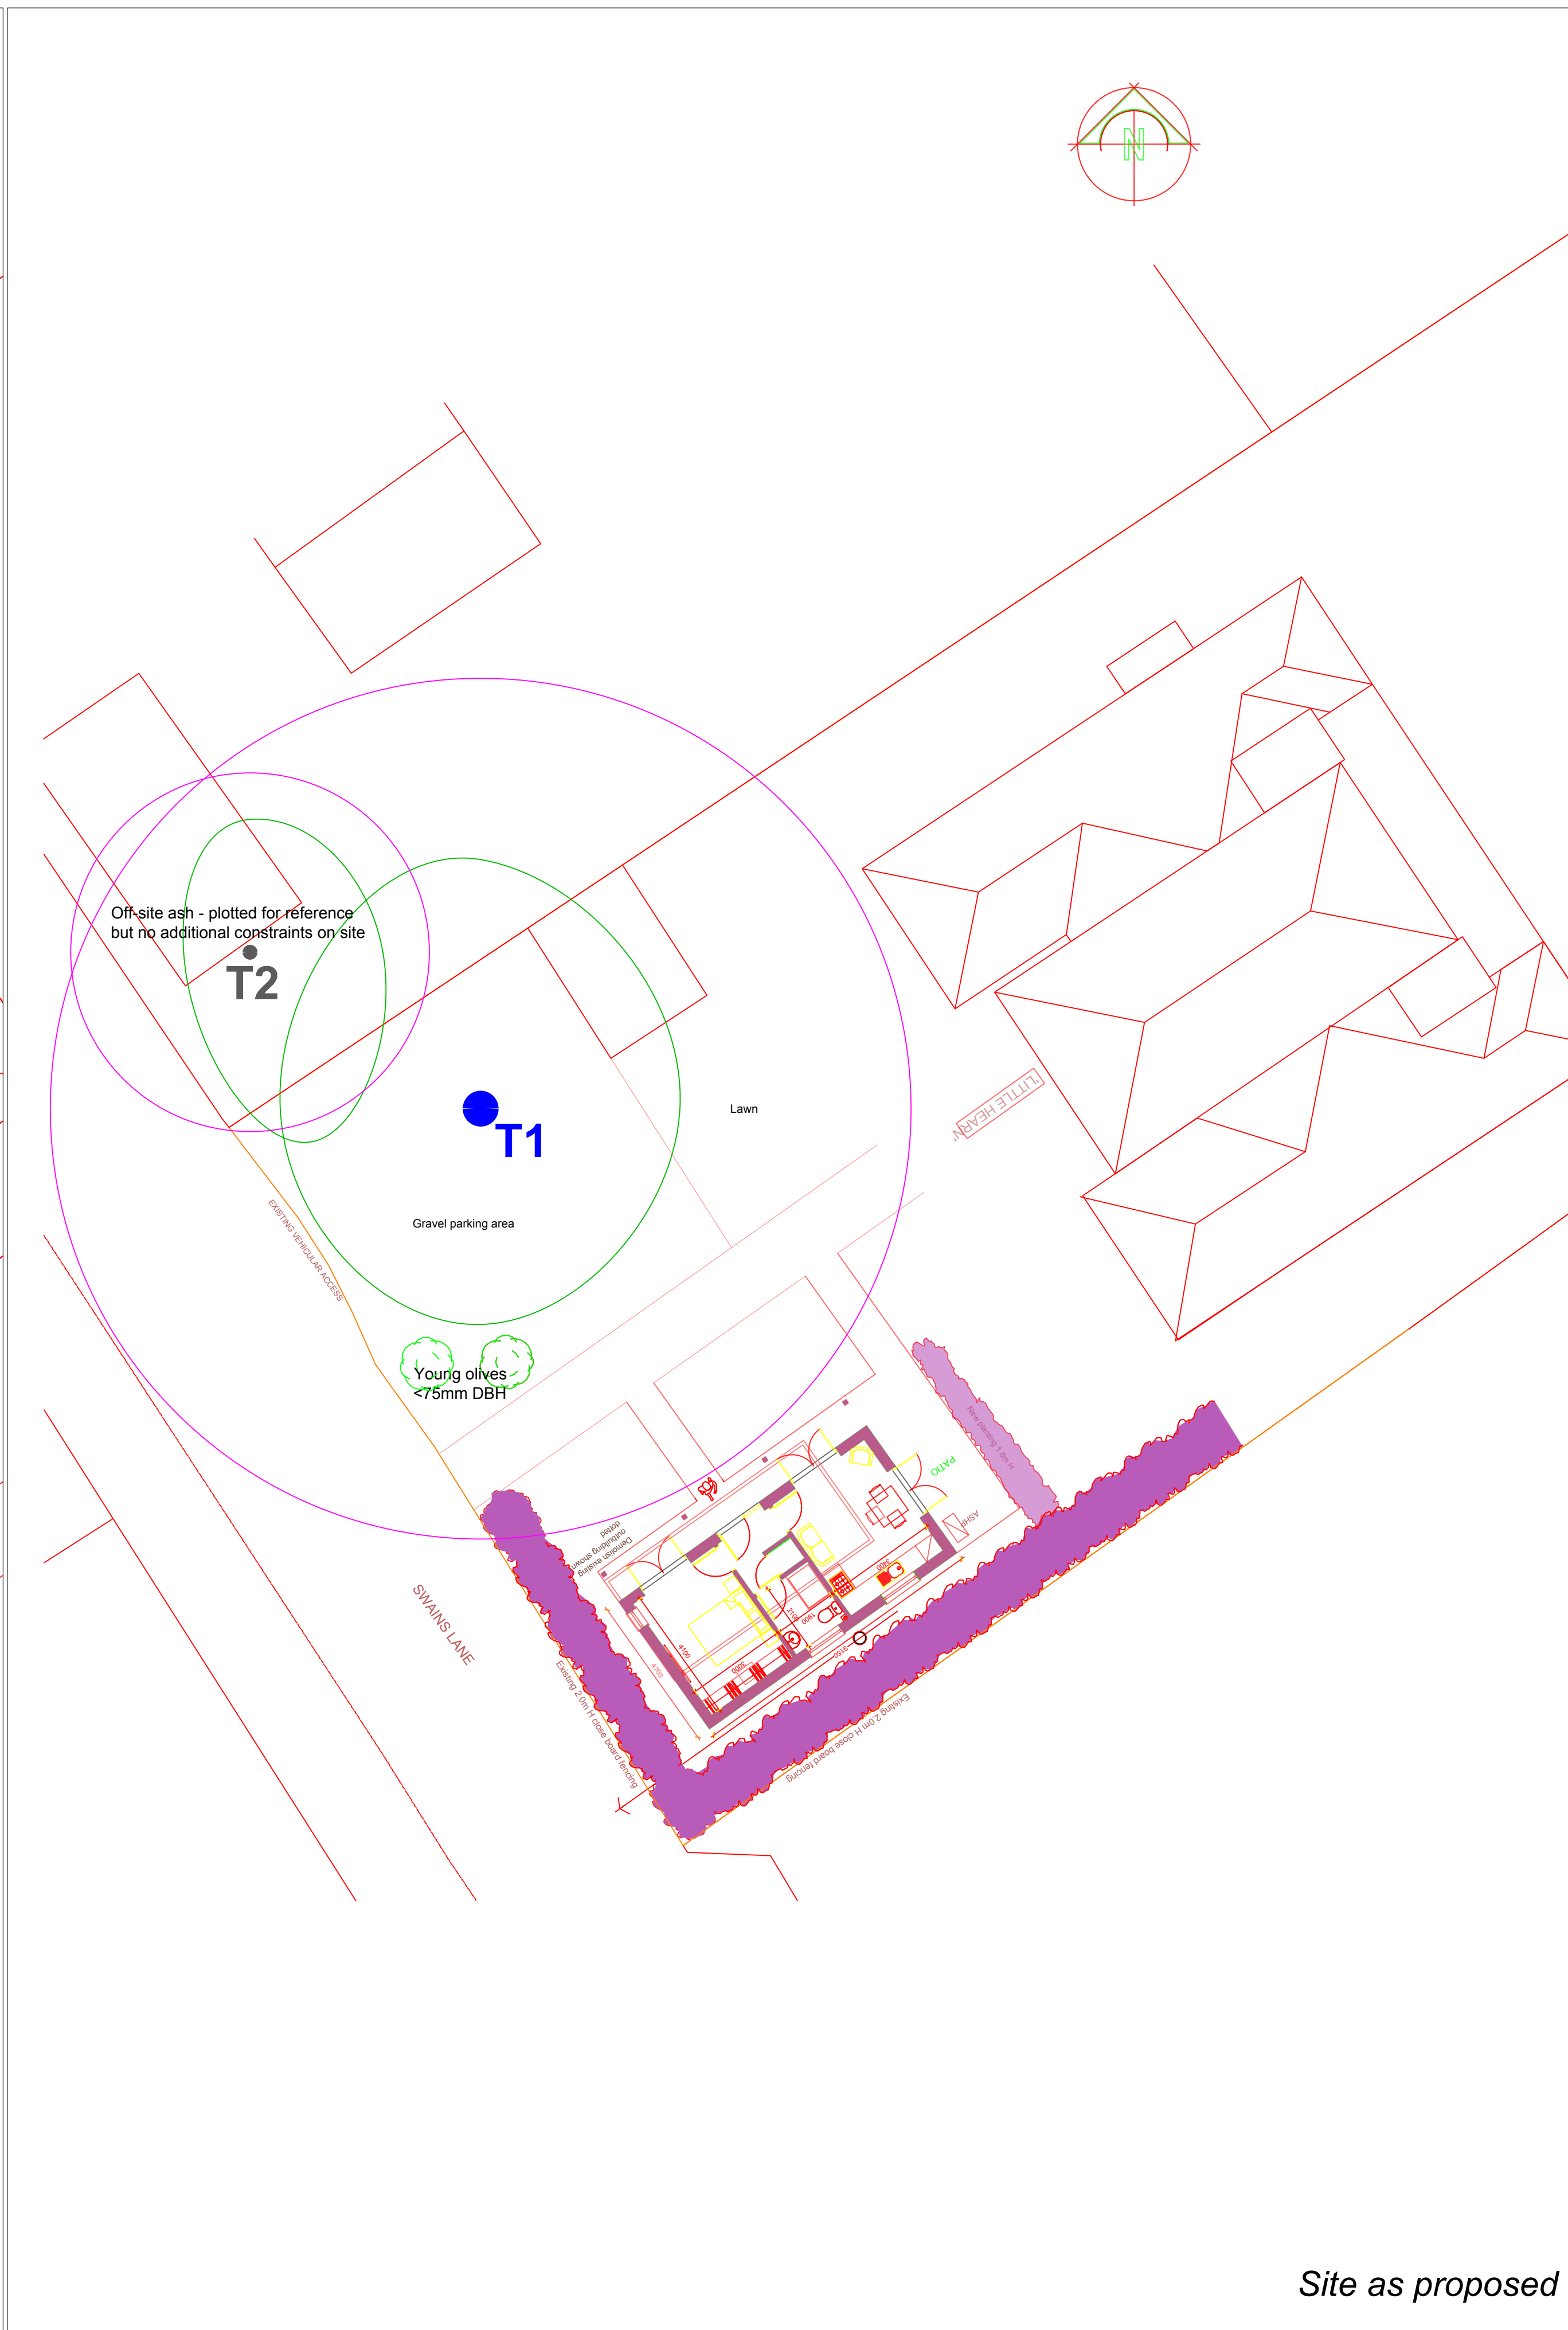
Site as proposed

- 3.2.3 As shown on the TSCP, the proposed annexe will be located outside of T1's RPA, and is positioned slightly further back than the existing chalet building. As such, there will be no direct subterranean impacts from this scheme. The only alterations within the RPA would be the addition of new surfaced footpaths leading to the annexe from the existing main footpath running NE to the dwelling. This will not result in any significant disturbance within the RPA, however in order to minimise potential impacts, this new surfacing should be permeable and gas porous. Paving slabs and block paving are available with built-in infiltration spaces between the slabs/blocks. These are ideal, though they should be laid dry jointed on a sharp sand foundation to allow air and moisture to penetrate to the rooting area.

- 3.3.2 The nearest trees will have ample crown clearance from the proposed annexe. The canopy of T1 will be >8m away, and boundary hedgerows around the rear and side of the annexe will continue to be regularly trimmed as they currently are to maintain sufficient separation from the outbuilding.

- 3.2.4 To ensure that T1 is adequately protected from other potentially damaging actions such as storage of materials/plant, ground level alterations etc.; the full extent of RPAs not covered by existing hard surfacing should have protective fencing and/or temporary ground protection erected in line with BS5837 for the duration of site works. It is possible that details pertaining to the placement of protective barriers may be required as a condition of any planning approval.
