Design and Access Statement for Glebe Cottage ref PP-12194615

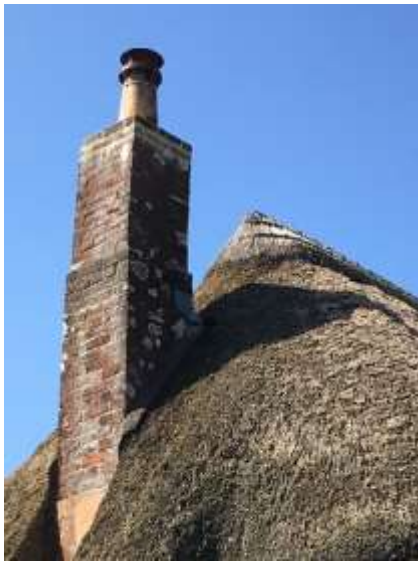
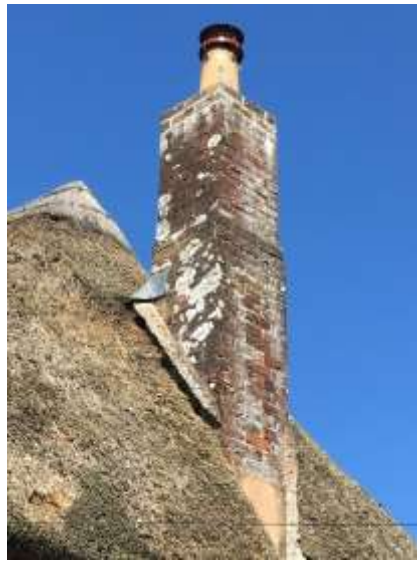
The reason for the chimney works is the current lime mortar has been acid eroded through many years of coal and wood fires and has now left the stack unstable and unsafe. Many bricks have been found to be rotten with movement seen at the lowest course to the upper most. There are also multiple holes where the render and mortar has completely eroded leaving thatch to be in direct contact with potential combustible materials. The owner has been made aware in its current state this chimney is not fit for purpose. A picture of the chimney in question is below.

The chimney design will mirror what is currently there to minimise the impact to the property when it has been re-built. It will be higher by around 8 to 10 courses to obtain the 1.83 M height above the thatched ridge. The original pot appears to be in good condition and will be re-used if this is the case. If not a like for like pot will be fitted. Bricks are going to be either reclaimed, re-used where possible from the original chimney or new handmade local bricks. Currently we are looking to source from Winkleigh Timber. Lime mortar and lime render will be used. A yogurt wash will be applied to encourage Lichen to re-grow as it currently is to further reduce the impact to the property. Internally a plywood front will be temporarily put up in-front of the inglenook to protect any falling debris and dust from getting into the property. This will then be safely disposed of in a skip. A twin wall stainless-steel flue liner will be fitted inside the chimney by a Hetas registered engineer with the end cowl recommended by them (potential no cowl needed depending on draw obtained post installation). Only the end cowl will be visible from the outside. Internally the twin wall will be seen dropping into the inglenook terminating onto a wood burning stove.

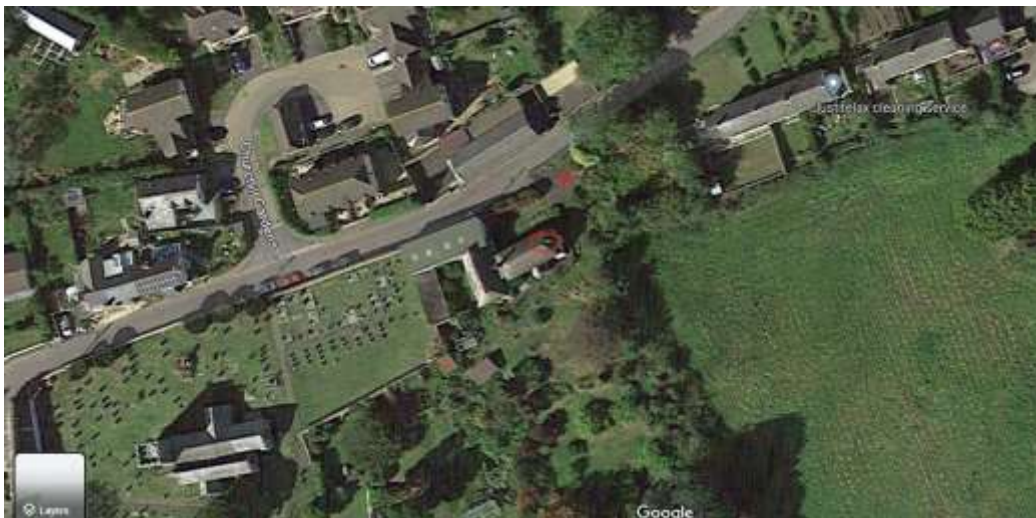
Scaffolding will be erected for the works to comply with all health and safety requirements. All scaffolding will be within private property so no adverse effects to any others will be incurred. Work will be during daylight hours so no need for lighting and working hours will be between 08:30 and 19:00 at worse. Noise will be minimal as a hand hammer and chisel will be used to remove the old chimney. Waste rubble is to be stored on site in the corner of the garden or a skip will be placed on the driveway entrance. No blocking of the road will be required. The picture bellow shows a red circle depicting the chimney in question and the red X shows the location for material storage.
