These drawings show the elevation of the McLaren Wall on the outside of the park boundary. Refer to drawings 5001 to 5016 for details of the repairs.

Reawakening Brighton Royal Estate
Phase 2

McLaren Boundary Wall Details

Job Ref Dwg No Revision
P1154-RHP-ZZ-00-DR-A-5019 P

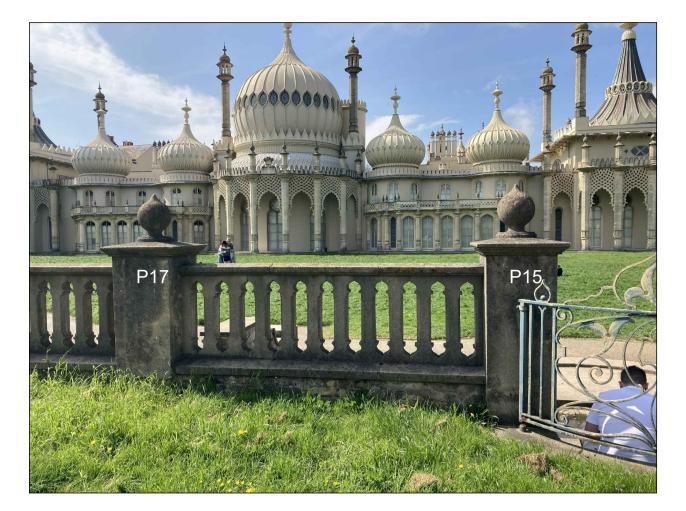
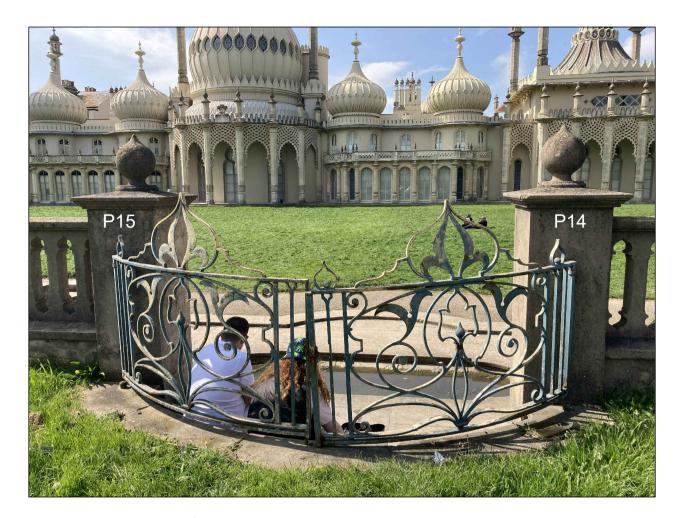
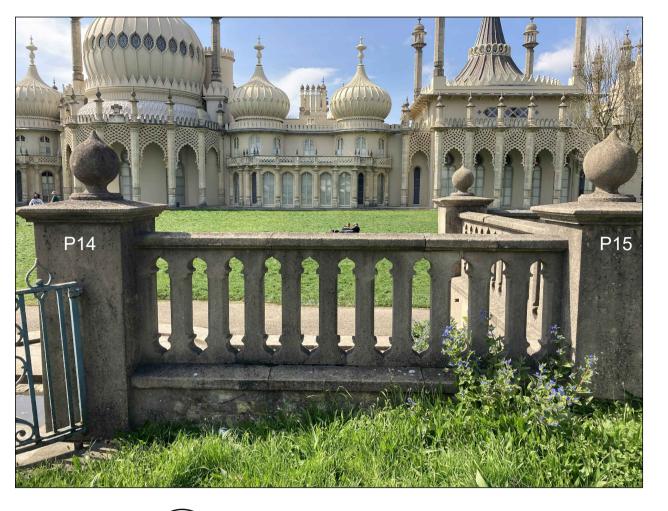
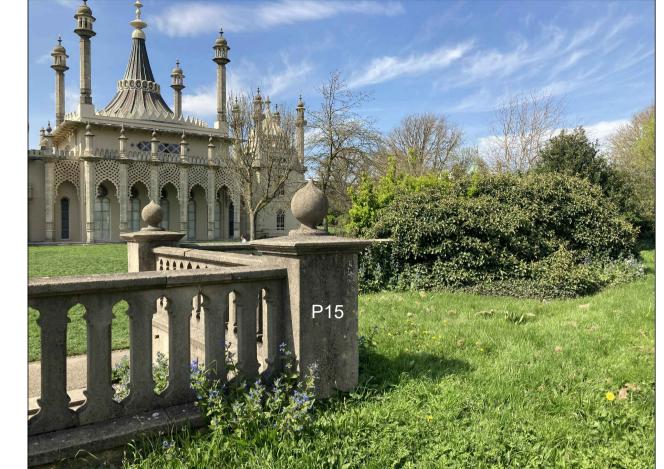
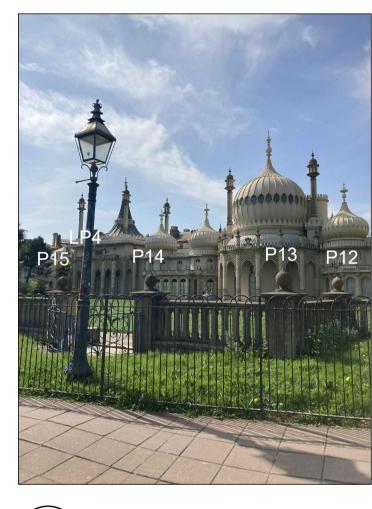
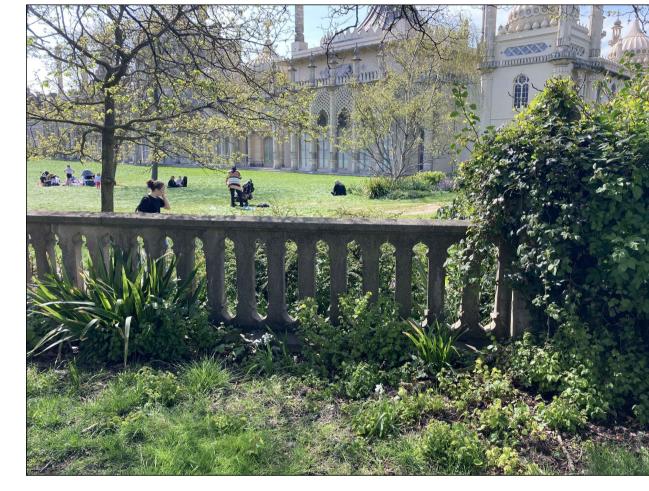
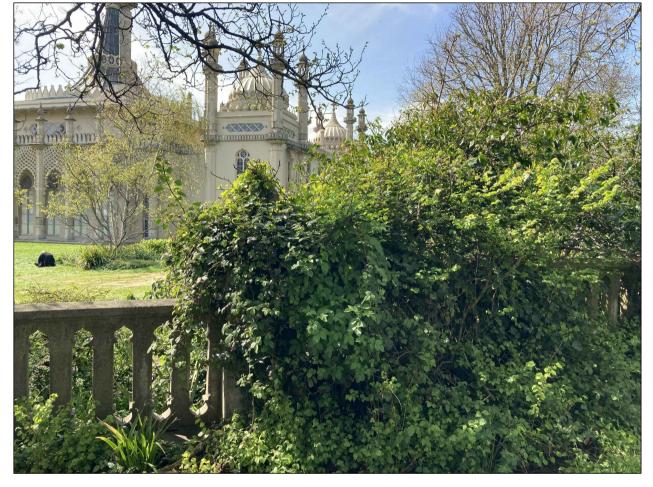
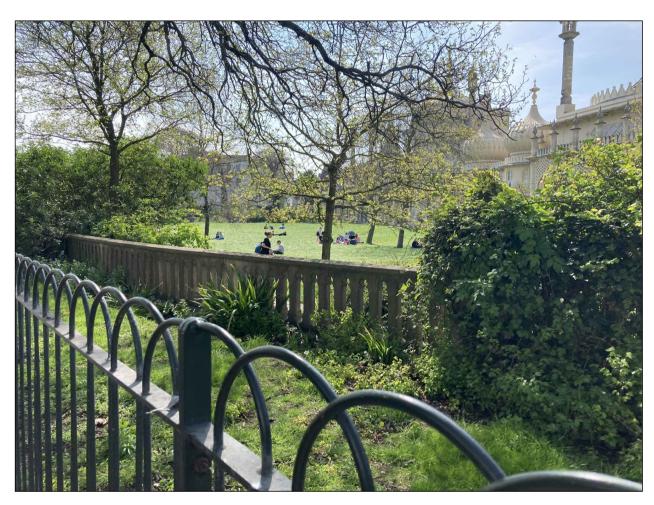
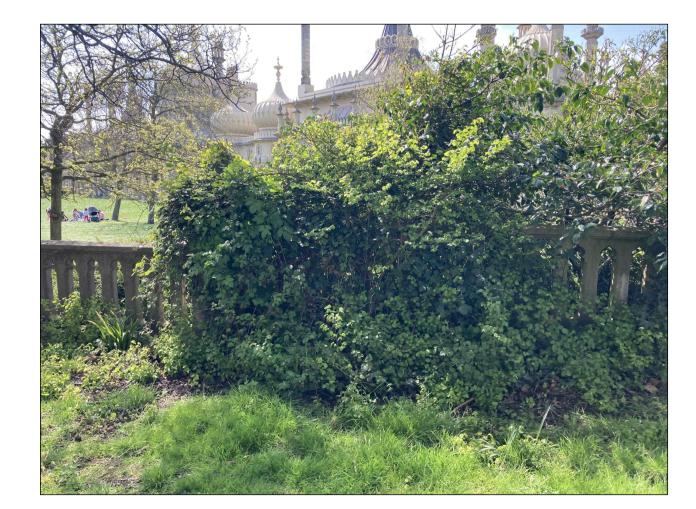
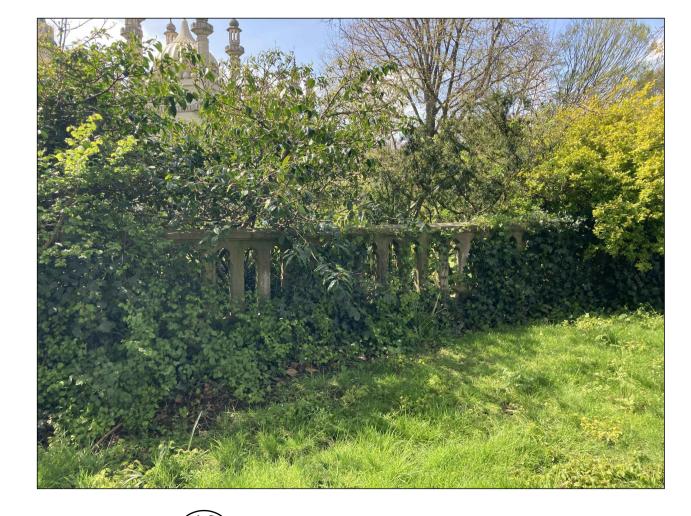
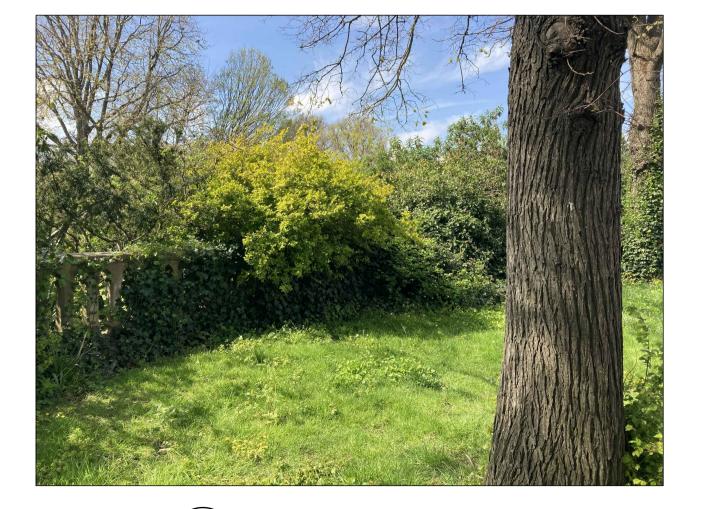
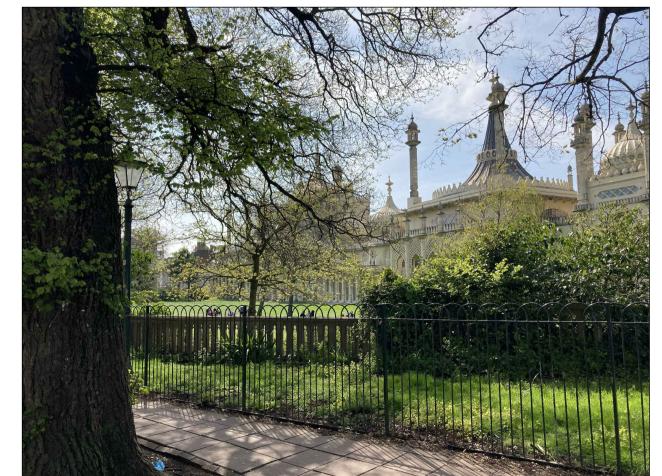
3. It is likely that the majority of the

McLaren wall has horizontal cracking

mortar to brickwork core. Allow for

due to the contentious render and lime

2. Condition varies and in some cases, extensive plant growth has prevented full access and survey. It may be that the condition deteriorates further.

repairs than this are likely to be

noted on the drawings.

repairing cracks and new sacrificial

carried and can be seen, these are

coat throughout. Where more intrusive

Remove cracked render, carry out brickwork repairs and new lime render render.

Lime leeching from retaining wall behind. Consider new french drainage system behind. See drawing P1154-RHP-ZZ-00-DR-DR-A-5000

Lime render patch repair and sacrificial coating

Cut out existing cracked/
damaged stone and carry out
stone indent repair. Sized to suit,
profile and type to match existing.

New stone coping. Sized to suit, profile and type to match existing.

F Localised motar patch repair profiled and colour matched to existing. Provide sample for approval.
