P1154-RHP-ZZ-00-DR-A-1000

Reawakening Brighton Royal Estate

McLaren Boundary Wall Details

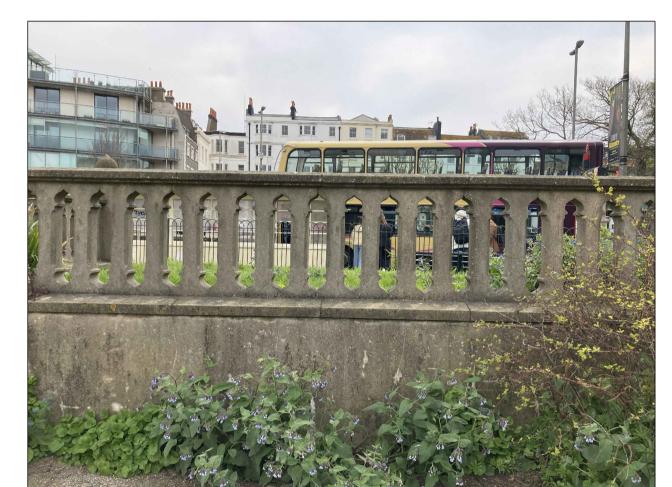
Part Elevation of McLaren Wall 5015 NTS

Carefully apply protection measures and apply biocide to plinth to remove moss

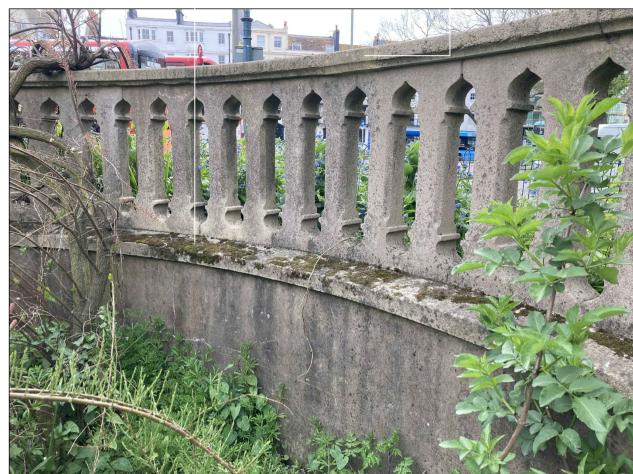
2 Part Elevation of McLaren Wall 5015 NTS

Check integrity of previous repair. Provisionally allow for replacement subject to CA instruction

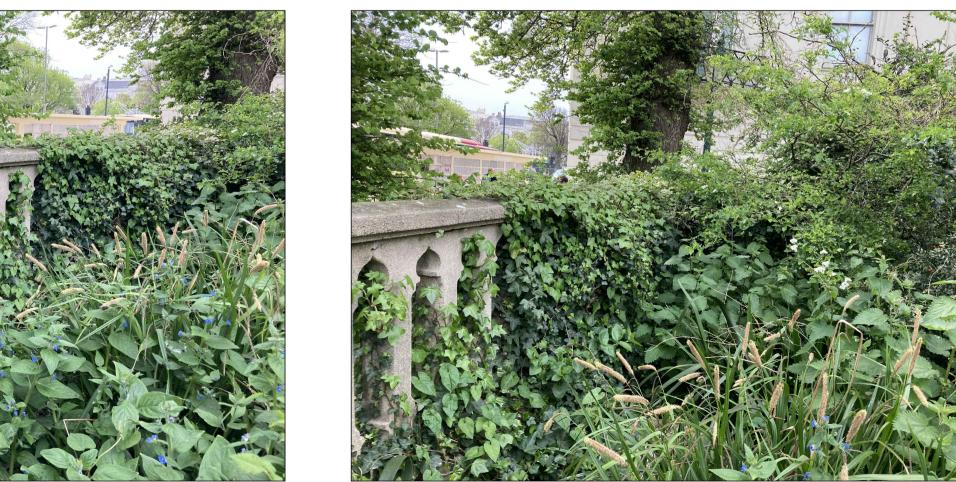
10 Part Elevation of McLaren Wall

Remove cracked render, carry out brickwork repairs and new lime render render.

Lime leeching from retaining wall behind. Consider new french drainage system behind. See P1154-RHP-ZZ-00-DR-DR-A-5000

Lime render patch repair and sacrificial coating

Cut out existing cracked/ damaged stone and carry out stone indent repair. Sized to suit, profile and type to match existing. Provide stone sample for each type of stone sample for approval.

> New stone coping. Sized to suit, profile and type to match existing. Provide stone sample for each type of stone sample for approval.

Localised motar patch repair profiled and colour matched to existing. Provide sample for approval.
