Royal Pavilion Gardens

Sections -

Sunken Footpath

Brighton & Hove Museums Job No.: 22-725 as shown @ A2 Drawing No.: 725-214 18.05.22

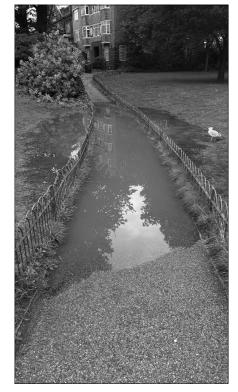
Existing drainage issue

Sunken footpath (Western Lawns)

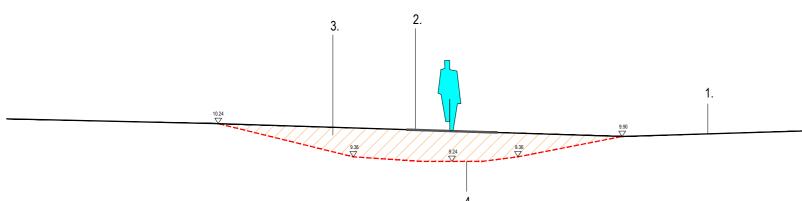
SCALE 1:100 (SECTION A-A)

## **SUNKEN PATH (WESTERN LAWNS)**

- Existing footpaths to be renewed
   Proposed new footpath (1:55)
   Proposed fill
   Existing footpath level

NOTE: Existing soak away to be replaced with new soakaway to engineers detail

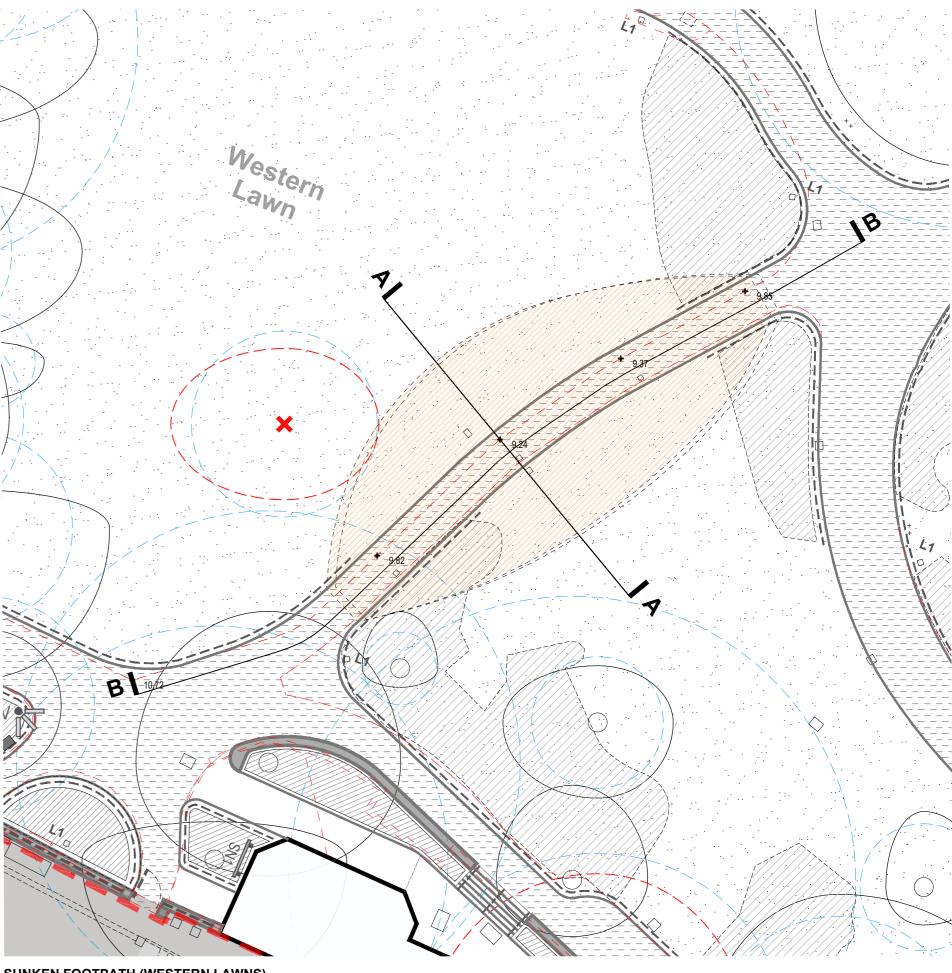
SUNKEN FOOTPATH (WESTERN LAWNS) SCALE 1:200 (PLAN)

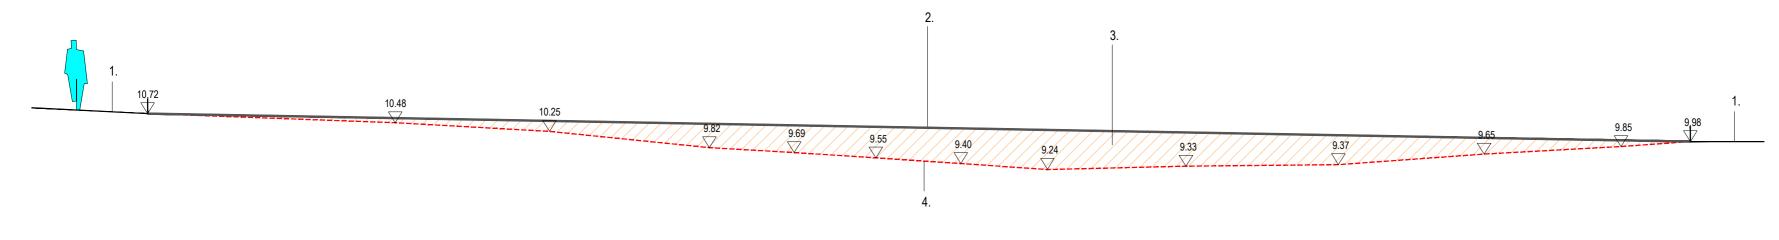
## SUNKEN PATH (WESTERN LAWNS) SCALE 1:100 (SECTION B-B)
