McLaren Boundary Wall Details

Reawakening Brighton Royal Estate

Preliminary

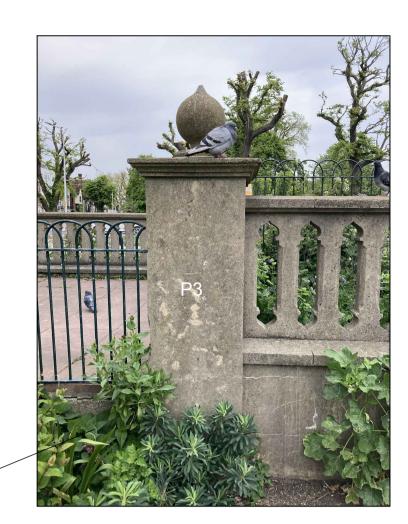
Potential location for outfall 1 Part Elevation of McLaren Wall for any new drainage 5011 NTS through brickwork below railings

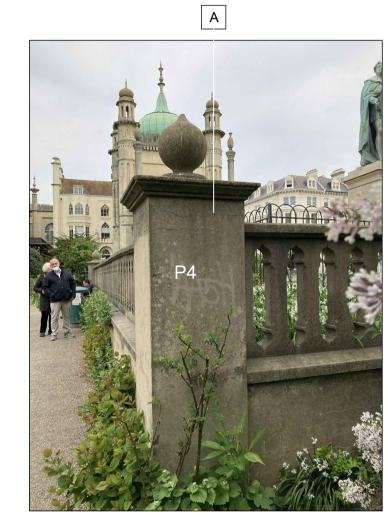
8 Part Elevation of McLaren Wall 5011 NTS

Crack

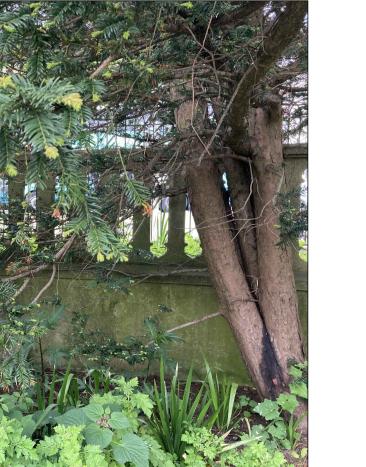
McLaren wall has horizontal cracking due to the contentious render and lime mortar to brickwork core. Allow for repairing cracks and new sacrifical coat throughout where exposed. Where more intrusive repairs than this are likely to be carried and can be seen, these are noted on the drawings.

Remove cracked render, carry
