These drawings show the elevation of the McLaren Wall on the outside of the park boundary. Refer to drawings 5001 to 5016 for details of the repairs.

Reawakening Brighton Royal Estate Phase 2

McLaren Boundary Wall Details

P1154-RHP-ZZ-00-DR-A-5018 P1

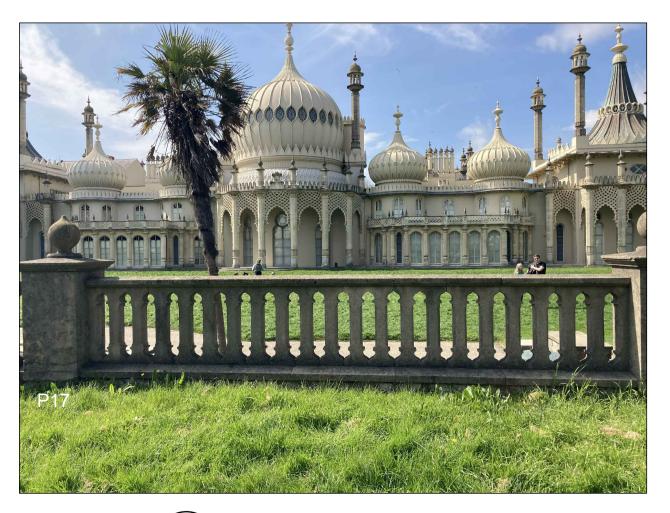
11 Part Elevation of McLaren Wall 5018 NTS

Lime leeching from retaining wall behind. Consider new french drainage system behind. See drawing P1154-RHP-ZZ-00-DR-DR-A-5000 for typical details.

McLaren wall has horizontal cracking due to the contentious render and lime mortar to brickwork core. Allow for repairing cracks and new sacrificial coat throughout. Where more intrusive

Remove cracked render, carry out brickwork repairs and new lime render render.

Lime render patch repair and sacrificial coating

Cut out existing cracked/ damaged stone and carry out stone indent repair. Sized to suit, profile and type to match existing. Provide stone sample for each

New stone coping. Sized to suit, profile and type to match existing. Provide stone sample for each type of stone sample for approval.

Localised motar patch repair profiled and colour matched to existing. Provide sample for
