Heritage Statement
Including
Design and Access Statement

Proposed Boundary Wall Repair

SITE:
The Vicarage,
High Street
Blockley
Moreton-in-Marsh
Gloucestershire
GL56 9ES

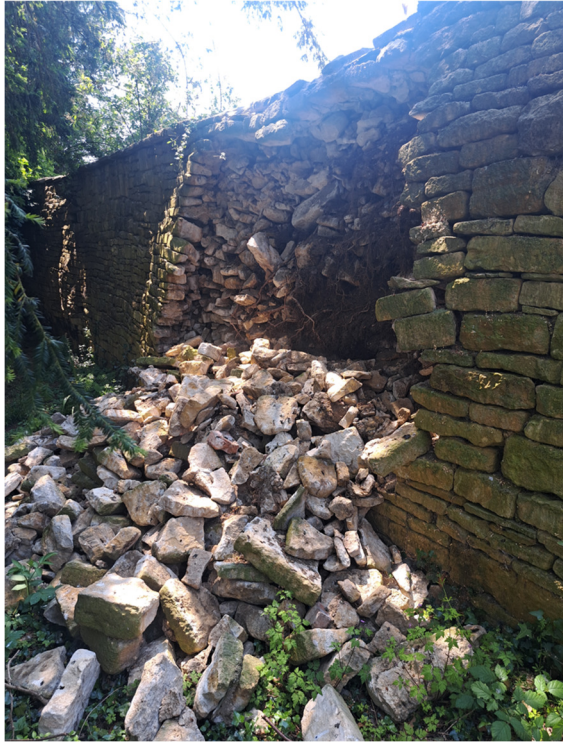
Pic 1

The wall is constructed of ashlar stone and is approximately 3.2m in height at the tallest section but is very narrow with very little depth, and no through stones.

The cause appears to be a result of trees located in close proximity to the wall which have now been removed and most significantly the original wall construction not having sufficient depth for the height retaining.

I have attached picture below of the wall following the collapse.

A Structural Engineer, Martin Hewett of O'Brien and Price has reviewed the wall and ground conditions to establish the cause and a suitable means to repair the wall whilst trying to maintain the overall aesthetics of the structure. The proposal as shown on drawing C406 / 01 will be to install temporary shoring system whilst the wall is rebuilt. The wall will be rebuilt using the existing materials on site, only bringing in new materials to replace any defective stone as a result of the collapse. The ground behind the wall will be excavated to remove ground loading whilst this work is undertaken and backfilled on completion with a well graded granular material to improve drainage behind the wall.

Due to the height of the retaining structure and the depth of the wall, it has been calculated that simply rebuilding the wall would not create a stable structure and as a result additional ground anchors have to be introduced to the section of the wall retaining ground to the full height of the wall. The proposed ground anchors would have recessed pattress plates and be finished with either a stone, buff or dark finish depending on the required finish. I have attached examples of

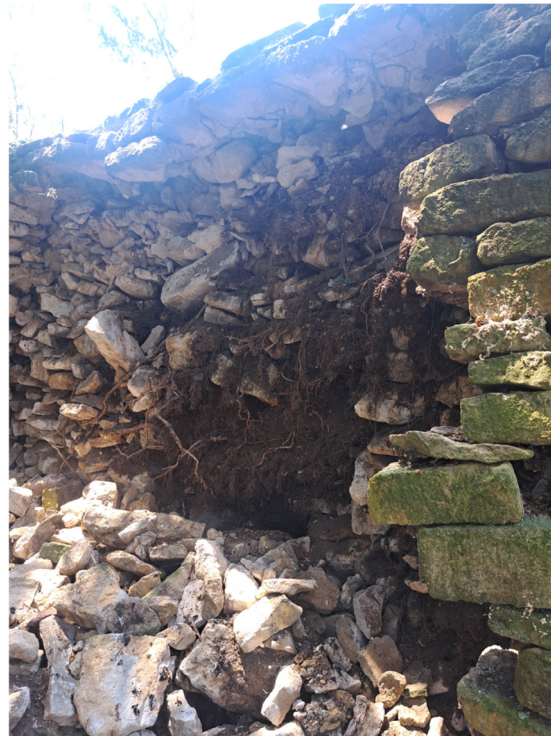
Pic 2 – shows tree roots in the wall
