<b>DESIGN SERVICES</b>		
Client Mr C.Roach	Address 15 Belvedere Road Ainsdale Southport PR8	
Description Proposed front Porch Construction Details		
Date Oct 23	Drng.No. 002	REV.
Scale. as shown

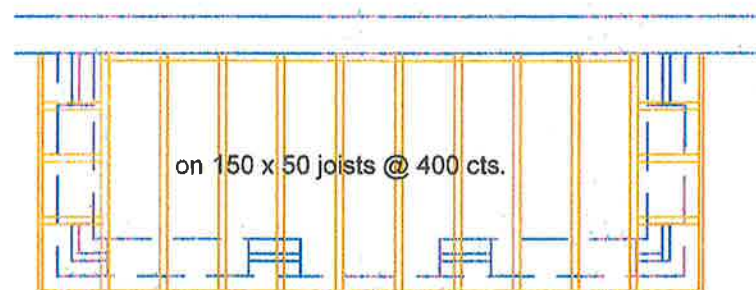
**ROOF PLAN**

upvc gutter & fascia  
on timber support  
upvc gutter falls  
to outlet discharging  
to garden area
