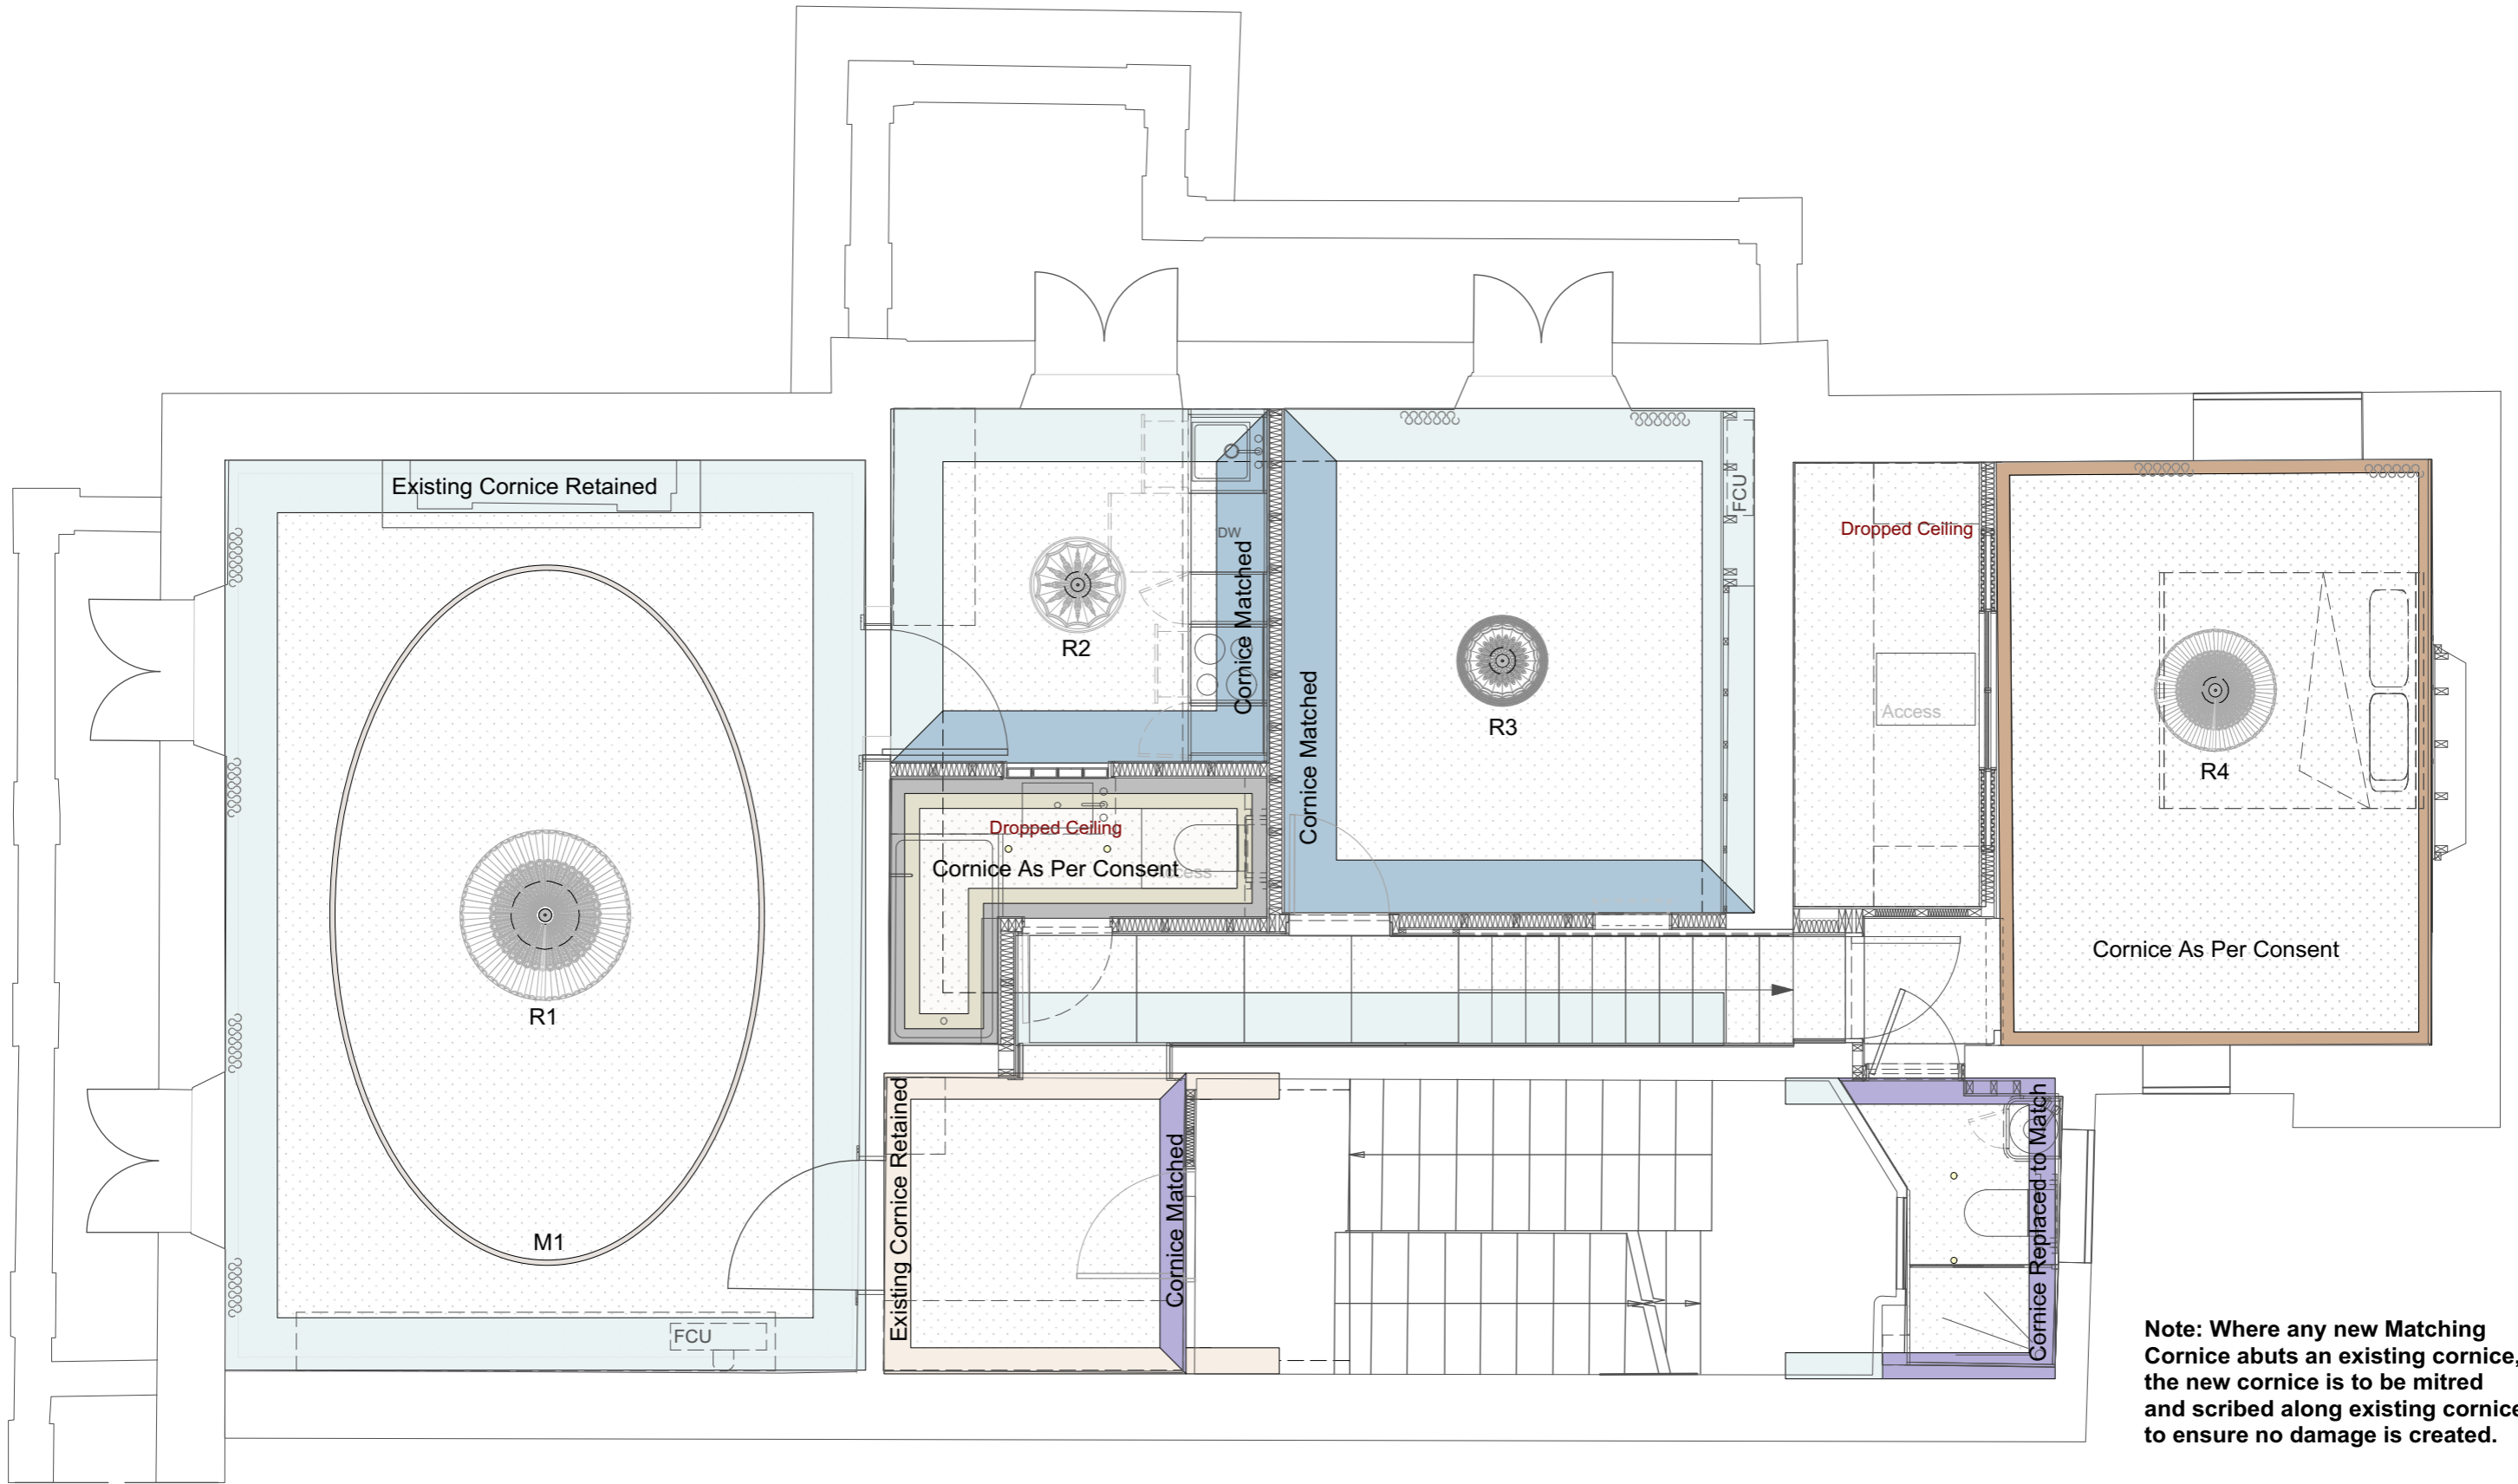
Note: Where any new Matching Cornice abuts an existing cornice, the new cornice is to be mitred and scribed along existing cornice to ensure no damage is created.
