Pardon Chambers Architects

Project Address
1-3 Ash Cottages
Albury Road
Little Hadham SG11 2DQ

Drawing Title
DETAIL
Main House: Loft
Typical Condition: Proposed

Drawing No.:	2212_2313	Revision:	
Scale@A1:	10	Scale@A3:	20
Scale@A3:	20	Rev. Date:	
Drawn by:		Date:	29/06/2023
Status:			PLANNING

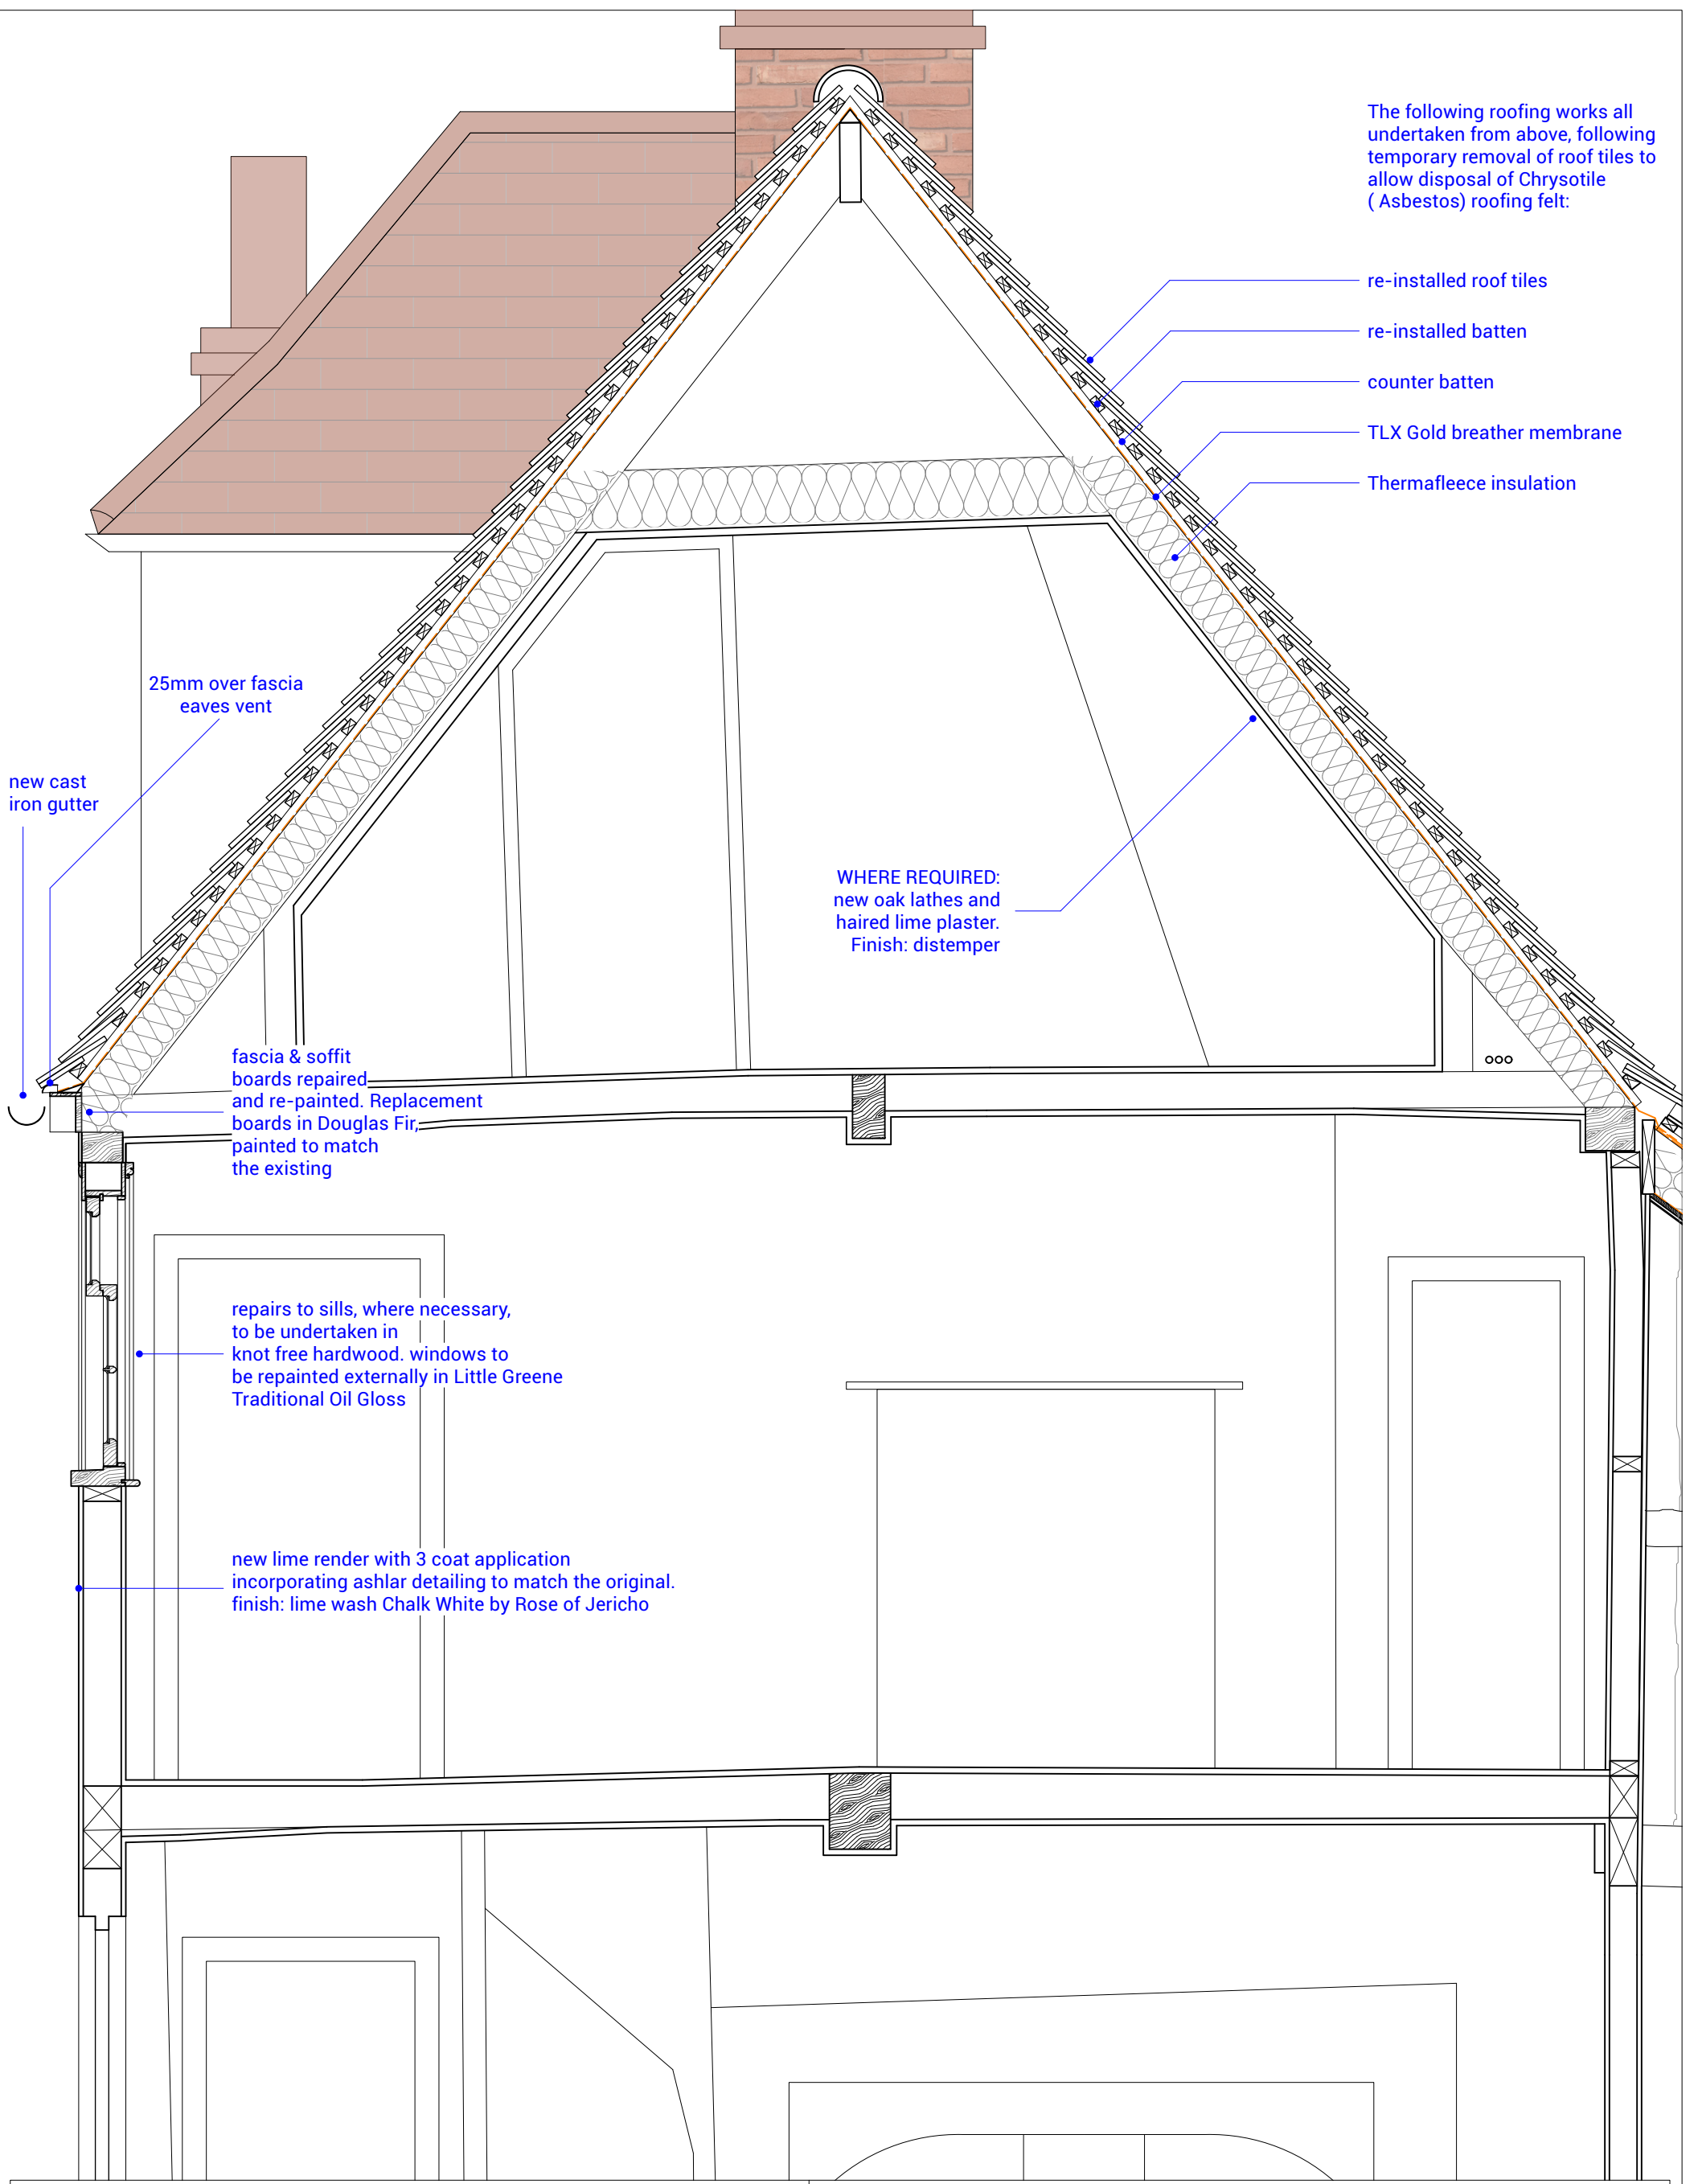
The following roofing works all undertaken from above, following temporary removal of roof tiles to allow disposal of Chrysotile (Asbestos) roofing felt:

- re-installed roof tiles
- re-installed batten
- counter batten
- TLX Gold breather membrane
- Thermafleece insulation

25mm over fascia eaves vent

new cast iron gutter

WHERE REQUIRED:
new oak lathes and haired lime plaster.
Finish: distemper

fascia & soffit boards repaired and re-painted. Replacement boards in Douglas Fir, painted to match the existing

repairs to sills, where necessary, to be undertaken in knot free hardwood. windows to be repainted externally in Little Greene Traditional Oil Gloss

new lime render with 3 coat application incorporating ashlar detailing to match the original. finish: lime wash Chalk White by Rose of Jericho
