Project Title
Cookham Dene House

Drawing Description
**Existing Main House
 East Elevation**

30558A/106

Proposed Works at Cookham Dene

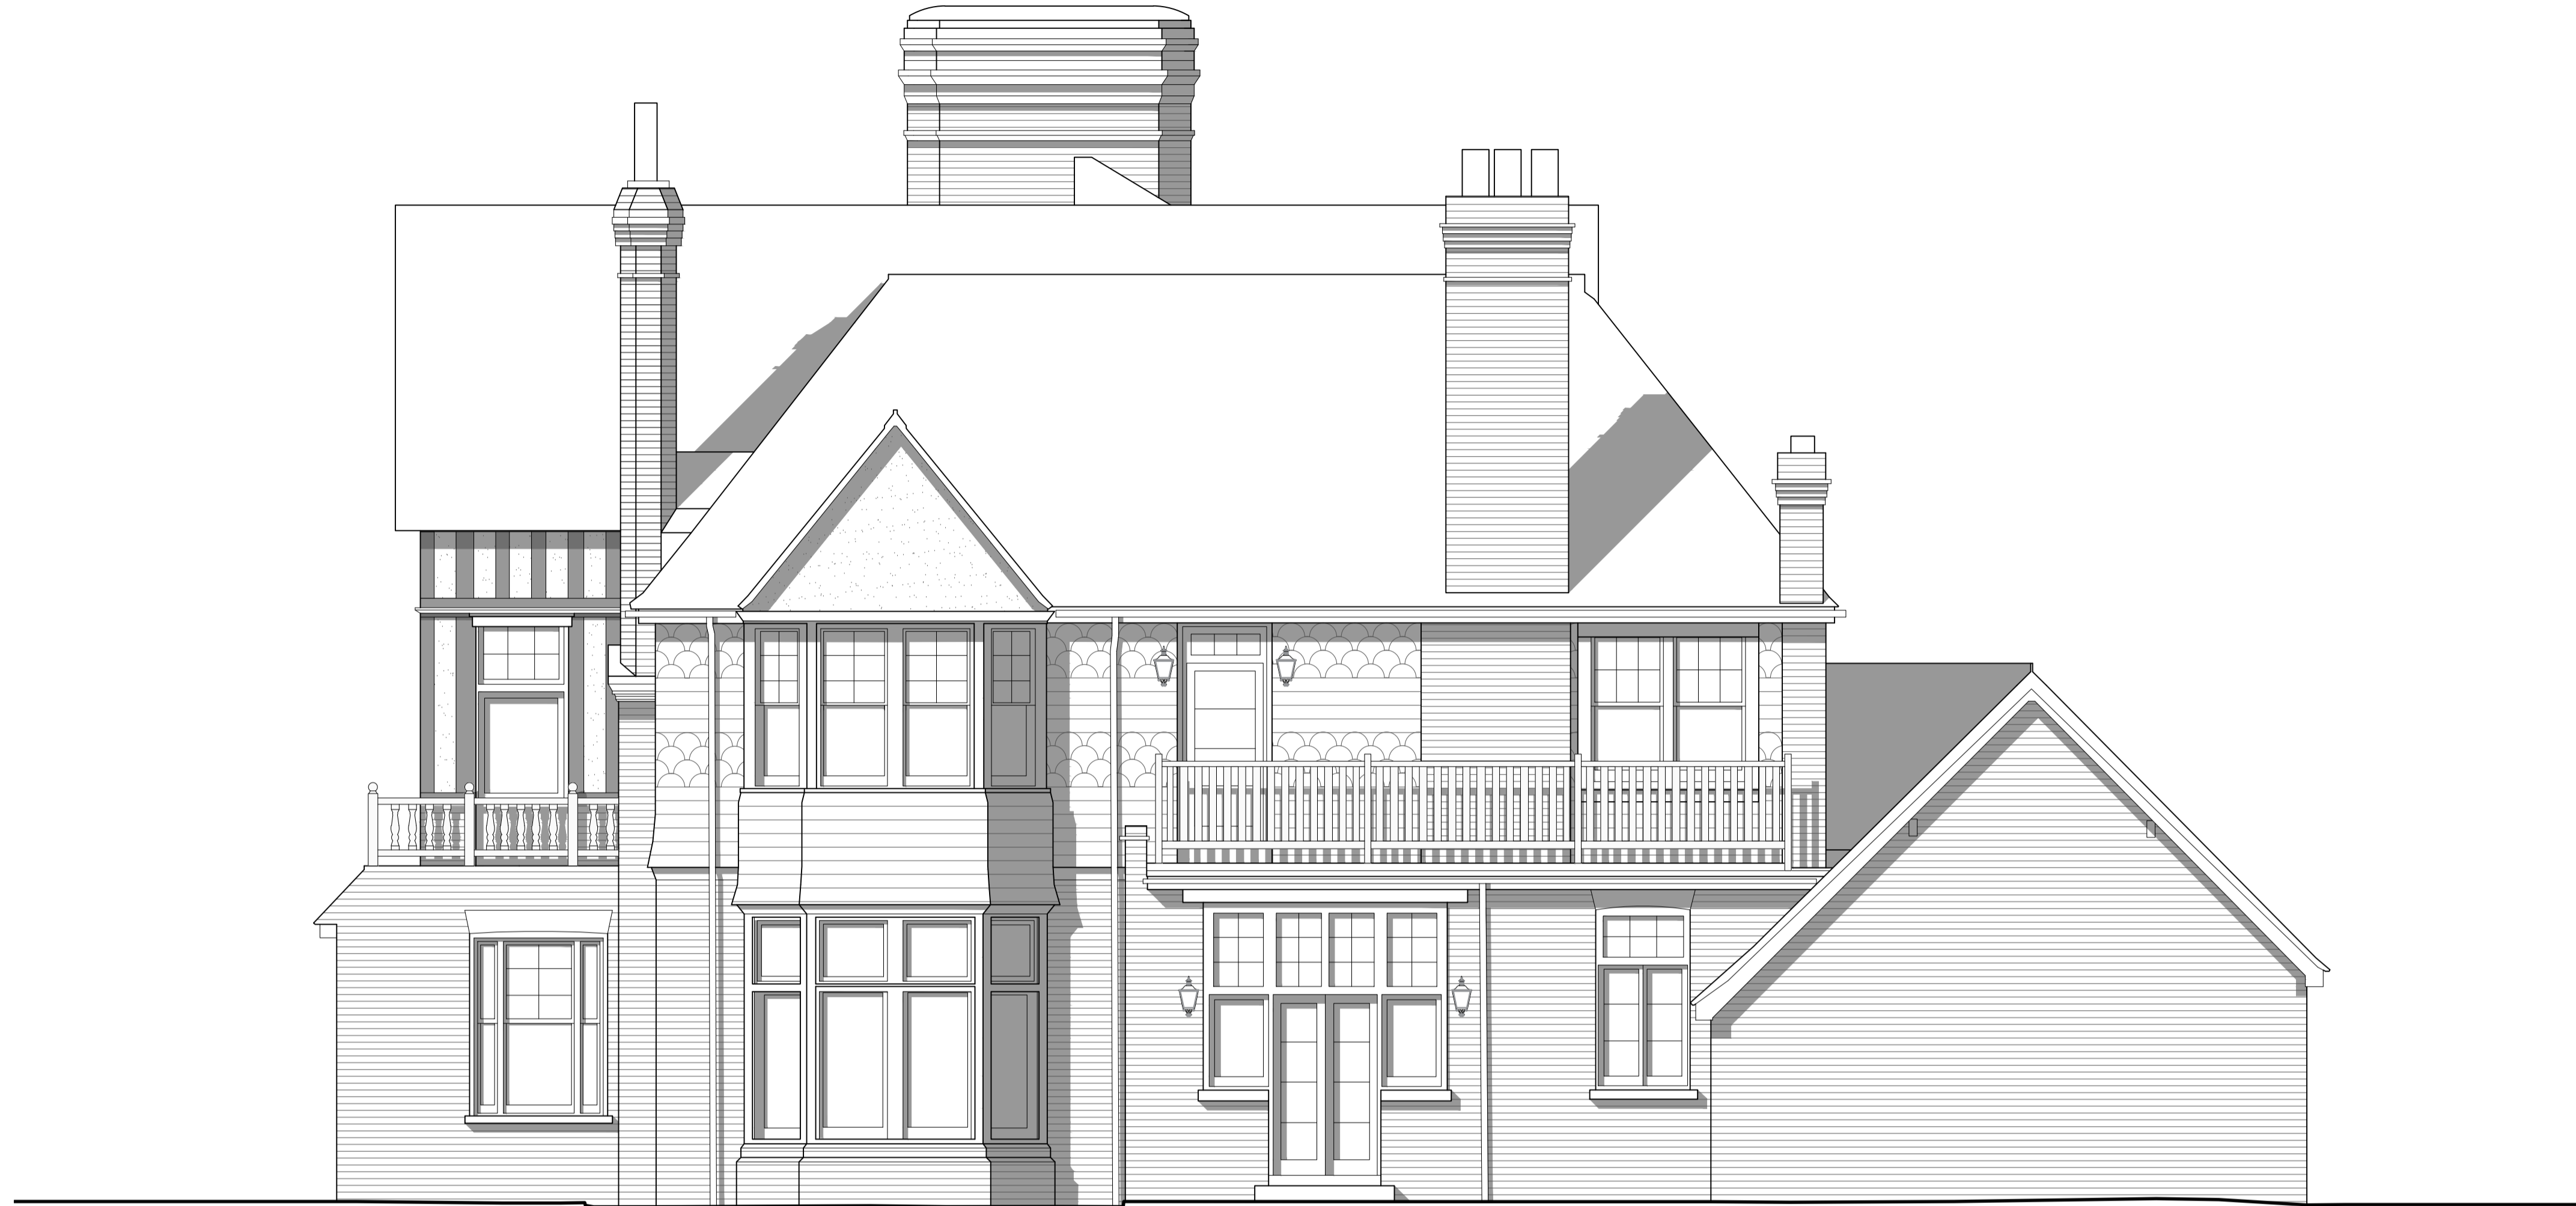
Schedule of repairs and improvements to the main house:

- Existing roof finishes to be carefully removed and retained. Existing timber battens to be removed where rotten and replaced with new treated timber battens
- New sheeps wool or hemp fibre insulation to be installed between the existing rafters.
- Roof tiles to be reinstated. New clay tiles to match existing to be used to replace broken tiles
- Existing lead flashings and weatherings to be removed and replaced with new lead flashings and weatherings
- Existing concrete haunching weatherings to be removed and replaced with new lead flashings
- Existing timber fascias and soffits to be removed and replaced with new painted timber fascias and soffits to match the existing
- Existing Velux windows to be removed and replaced with conservation style rooflights
- Existing Cast Iron and Upvc gutters to be removed and replaced with new metal gutters to match the existing

- Existing lead and substrate to be removed
- Sheeps wool or Hemp fibre insulation to be installed between the existing joists
- New tongue and groove boarding and lead roof finish to be installed

- Top 1200mm of all chimneys to be carefully dismantled and rebuilt using existing bricks and pots
- Lightning conductors to be removed and replaced
- Cracked chimney pots to be replaced with new clay pots to match the existing

- All vegetation attached to the external walls to be removed or cut back to allow for repairs
- Existing pointing to be raked out and replaced with new lime mortar pointing

- Existing clay tiles to be carefully removed. Existing timber battens to be removed and replaced with new treated timber battens
- Tiles to be reinstated with new clay tiles to replace any broken tiles. New tiles to match the existing
- New lead flashings to be installed

- Damaged areas of render to be removed and new lime render to be installed

- Existing sash windows to be eased, repaired and made operable. All existing windows that have been converted to Sprung sash windows to have sash chords, pulleys and weights reinstated
- Existing casement windows to be repaired
- All timber casement windows and sash windows to have existing glazing replaced with slim-line double glazing in existing timber frames. All windows with leaded glass and stained glass to remain as existing.
- All windows to be repainted to match the existing

- All external joinery to be repainted to match existing
