Planning & Heritage Statement

Town Farmhouse 25 Church Lane

Nether Poppleton York YO26 6LF

From Commencement of Building ~ Also Issues with Structure

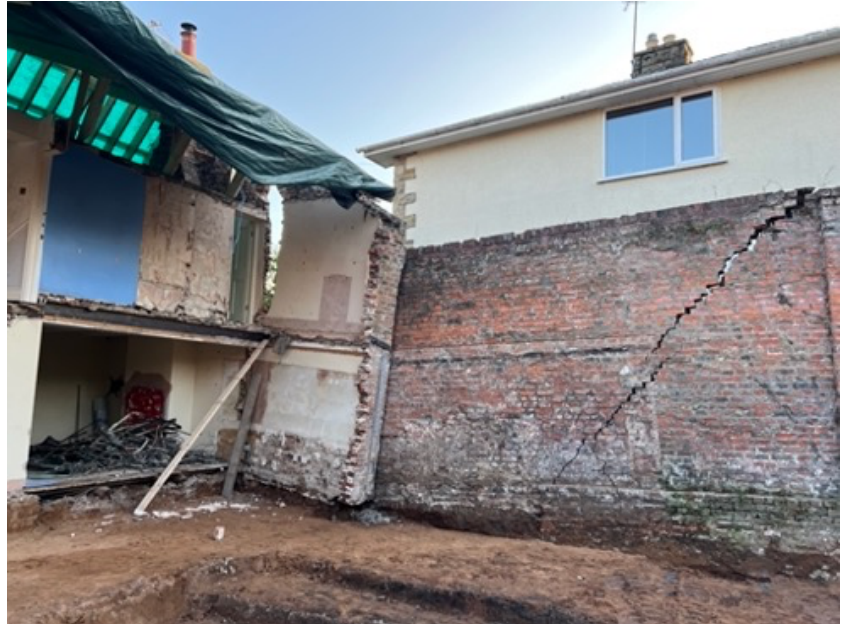
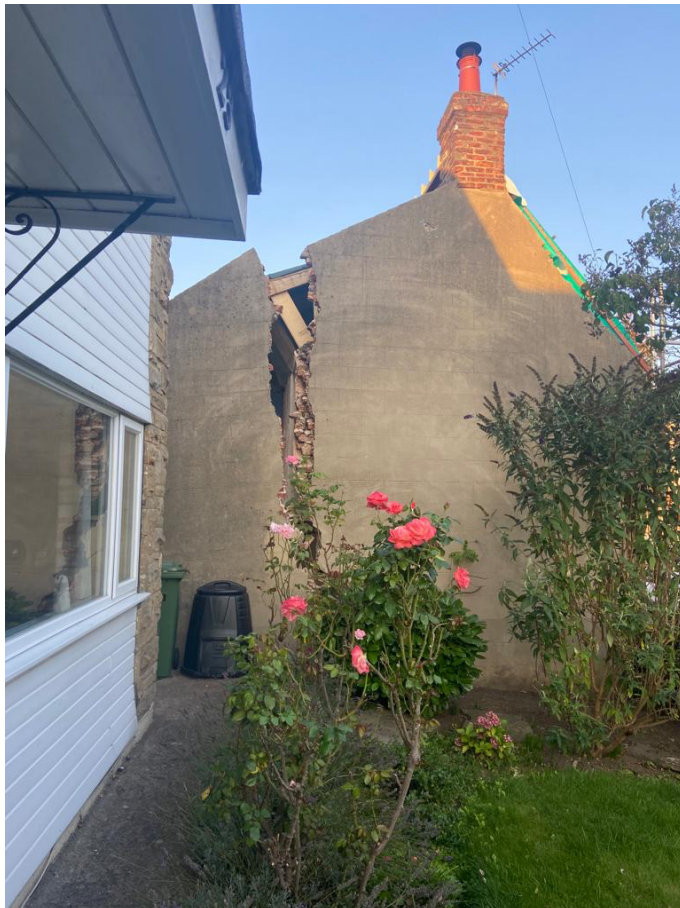
The side boundary wall and the rear section of the East gable wall went into partial collapse.

The external render to the gable wall hid the poor joint between the original gable and the extended 1800's rear section.

The 1960's ground floor removal of the lower wall exasperated the situation by weakening the structure. Also, the steel supporting the first-floor rear wall of the bedroom was dislodged by the falling gable section so that wall had to be removed by hand to prevent further collapse.

The contractor set to and carefully removed the sections leaning into the site, then when cleared prepared to rebuild. As the adjacent garden level is some 1.2 m (4 feet) higher than this property, we had an Engineer designed footings to be installed and a new perimeter garden and house wall were quickly constructed to support the adjacent property.

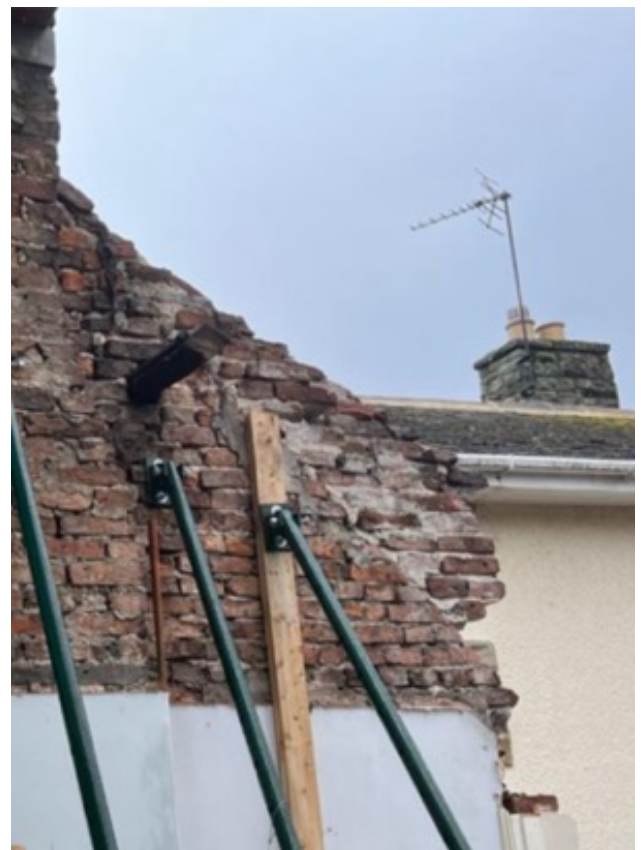
This picture shows where the rear roof had been lifted when the 1800's extension was done. The supporting purlin for the original roof was cut off as the new roof timbers were at least 5 courses above it. The masonry is just mortar bedded on the existing wall, with no tying or tothing in. This portion of the gable end will need to be carefully removed, all by hand and reconstructed.

The brickwork below the slates at the gable ends was in an appalling state as the slates didn't over sail enough to be pointed properly and the weather has been entering the masonry for well over 100 years. This brickwork was friable in structure and the bricks crumbled when handled, from the reclamation of the collapsed structure we will have enough original bricks to make good the side cheeks of the roof.

Where historically the roof was extended all the masonry is in a precarious condition, at the point when access can be achieved it needs checked by an engineer, to be either removed and rebuilt or made secure.
