Project
Old Burfa Barns

Layout Title
Cast iron Windows_Installation Details

Drawing Number	project	number	rev
	2019	DT.70	01

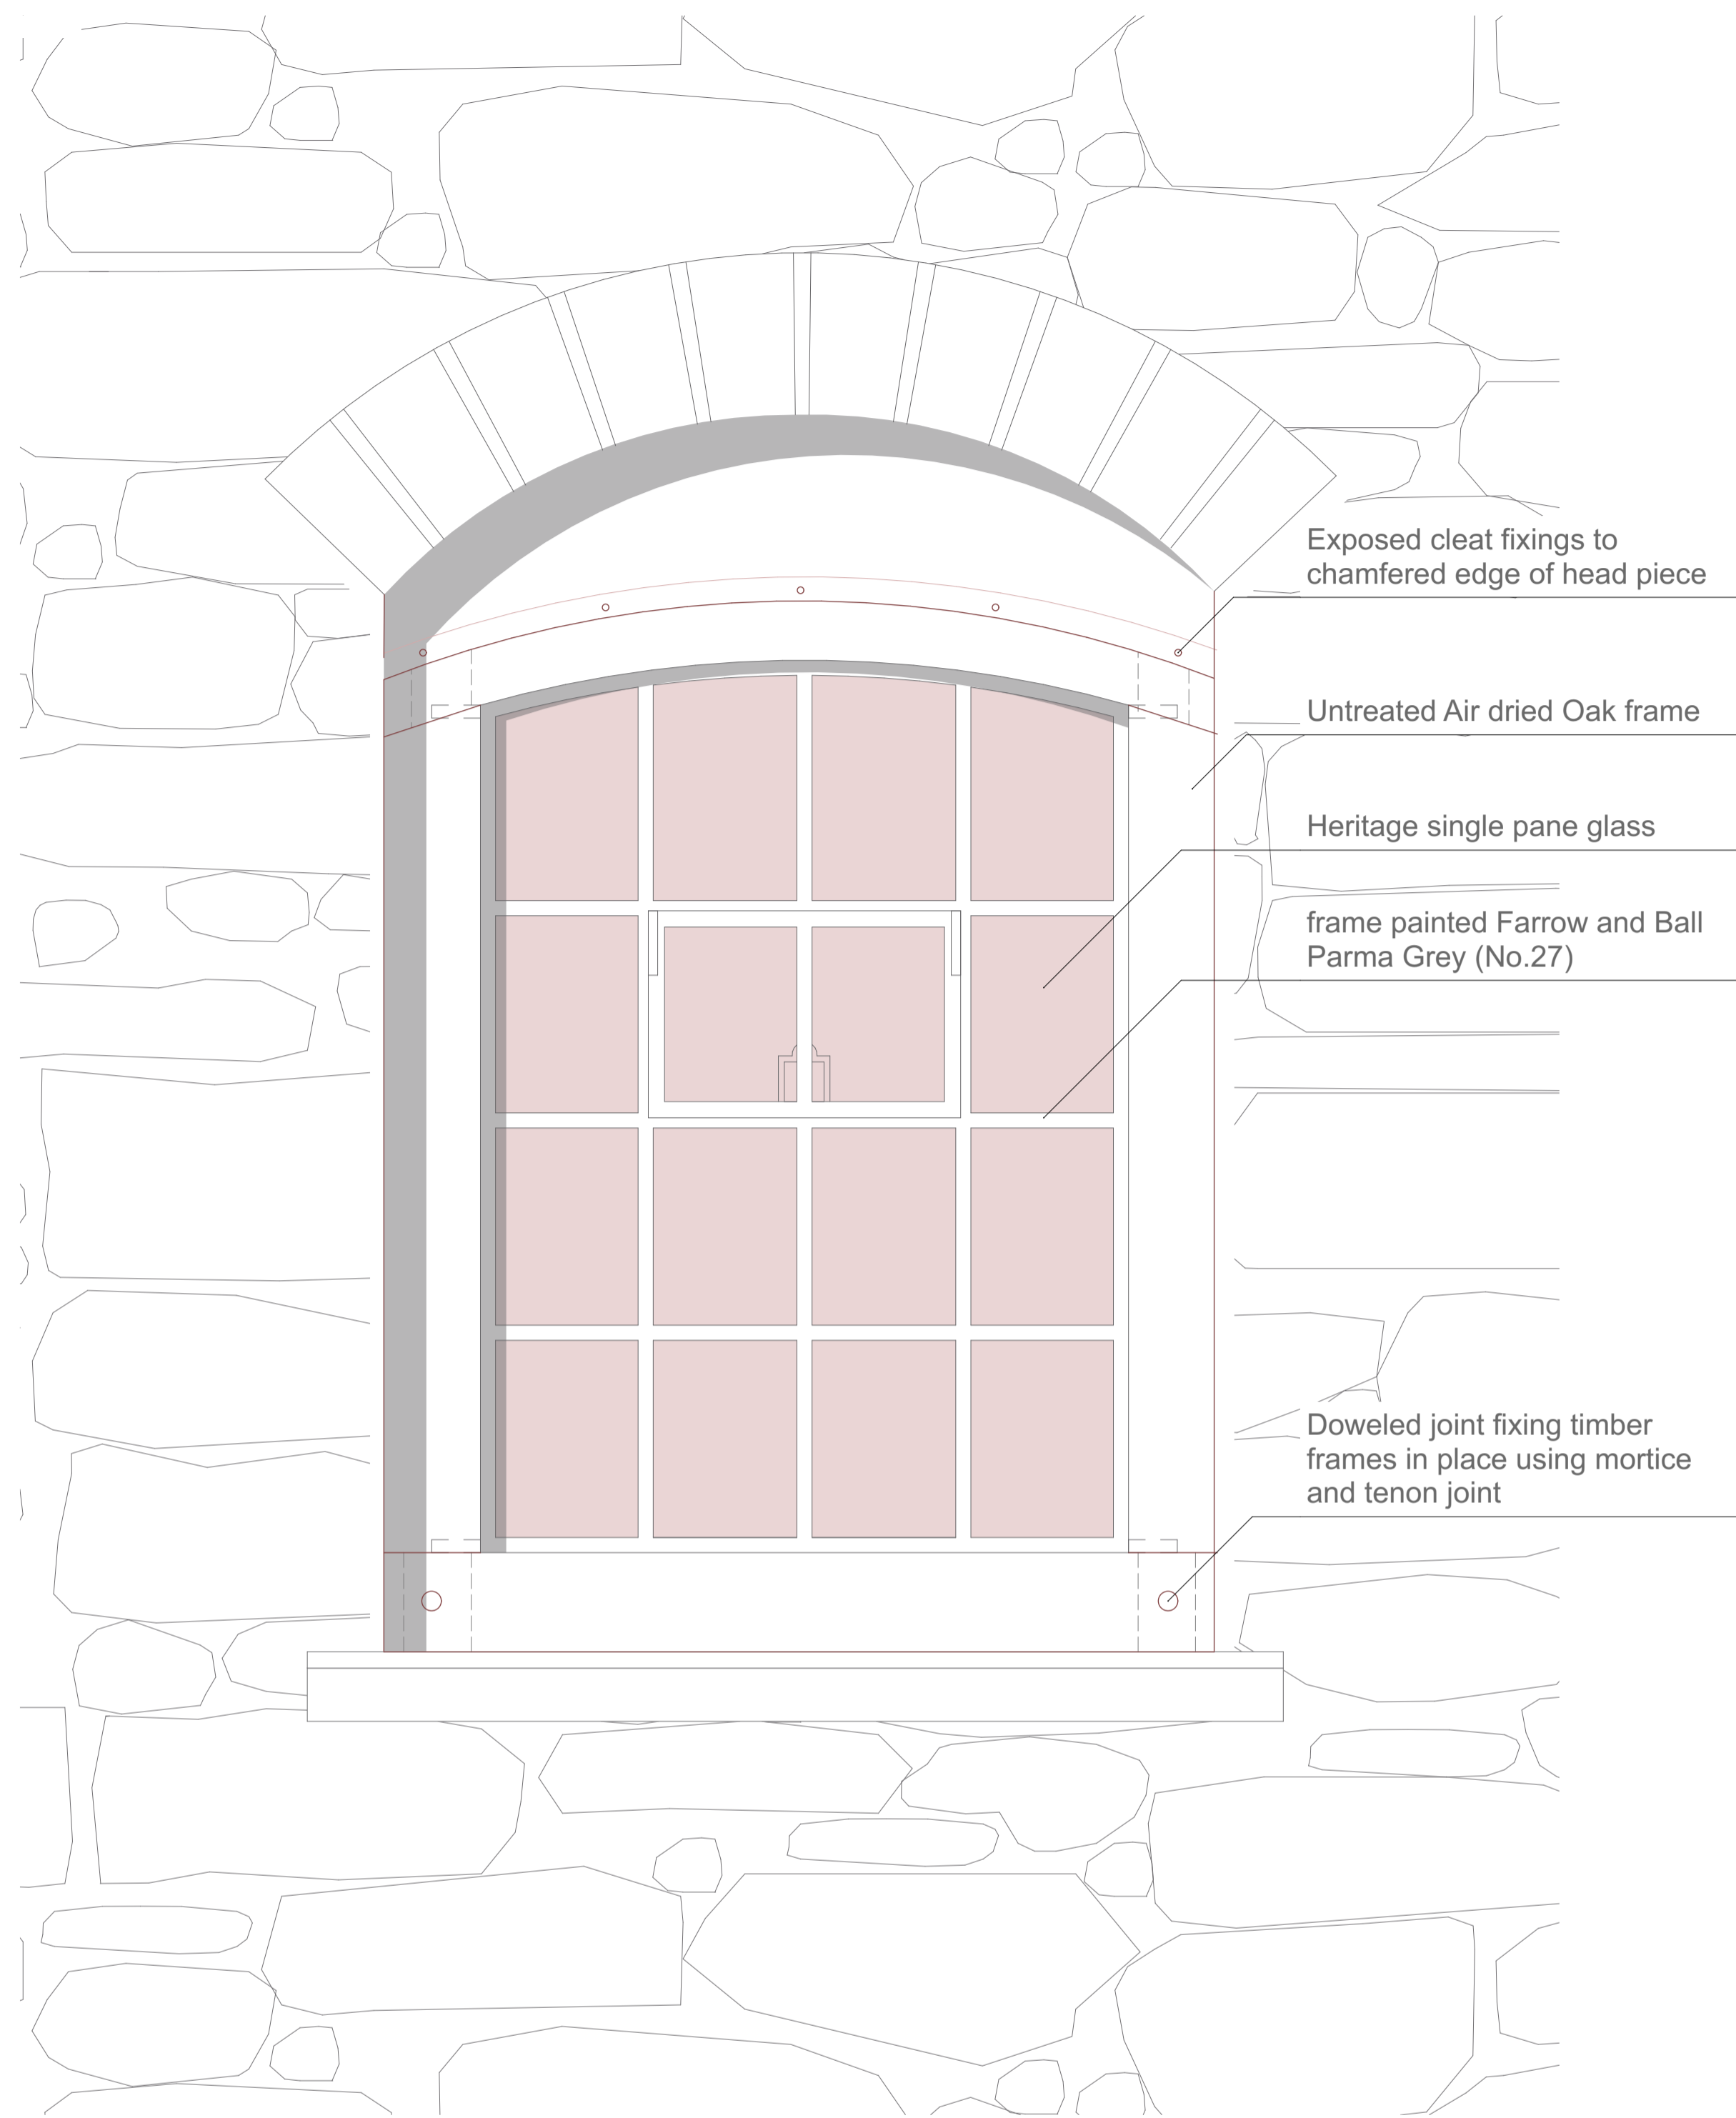
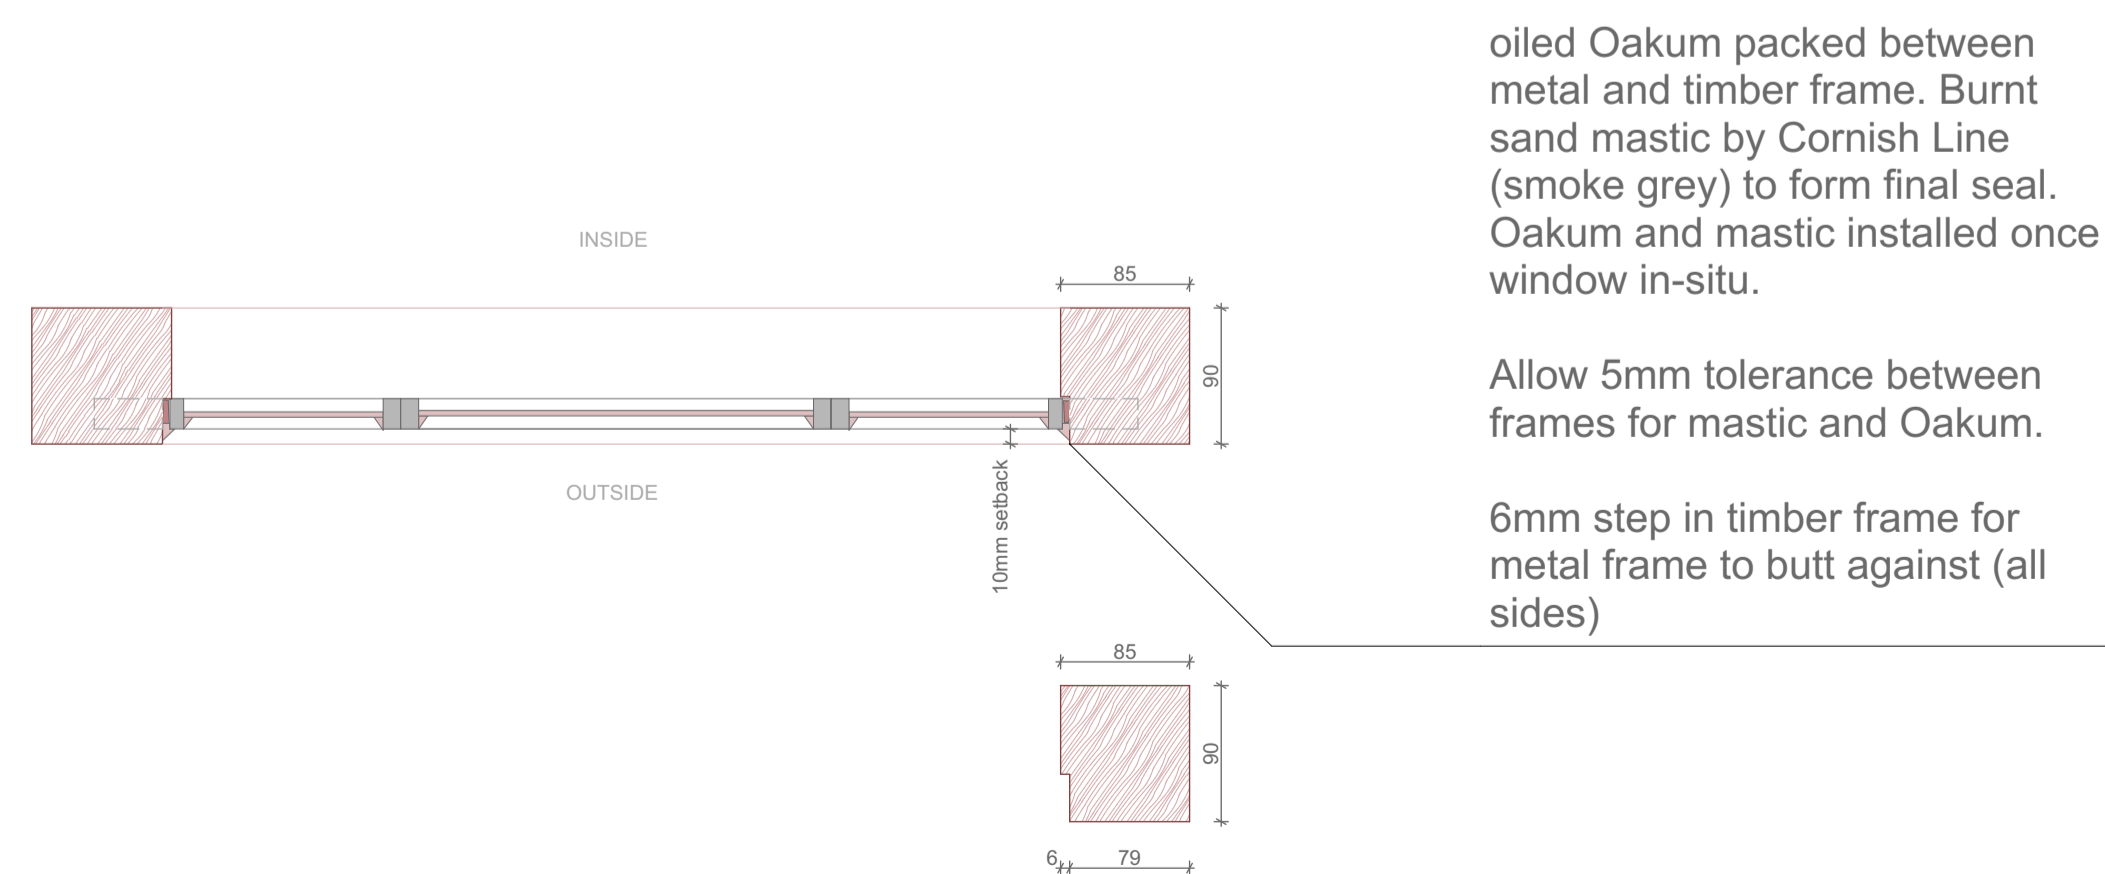
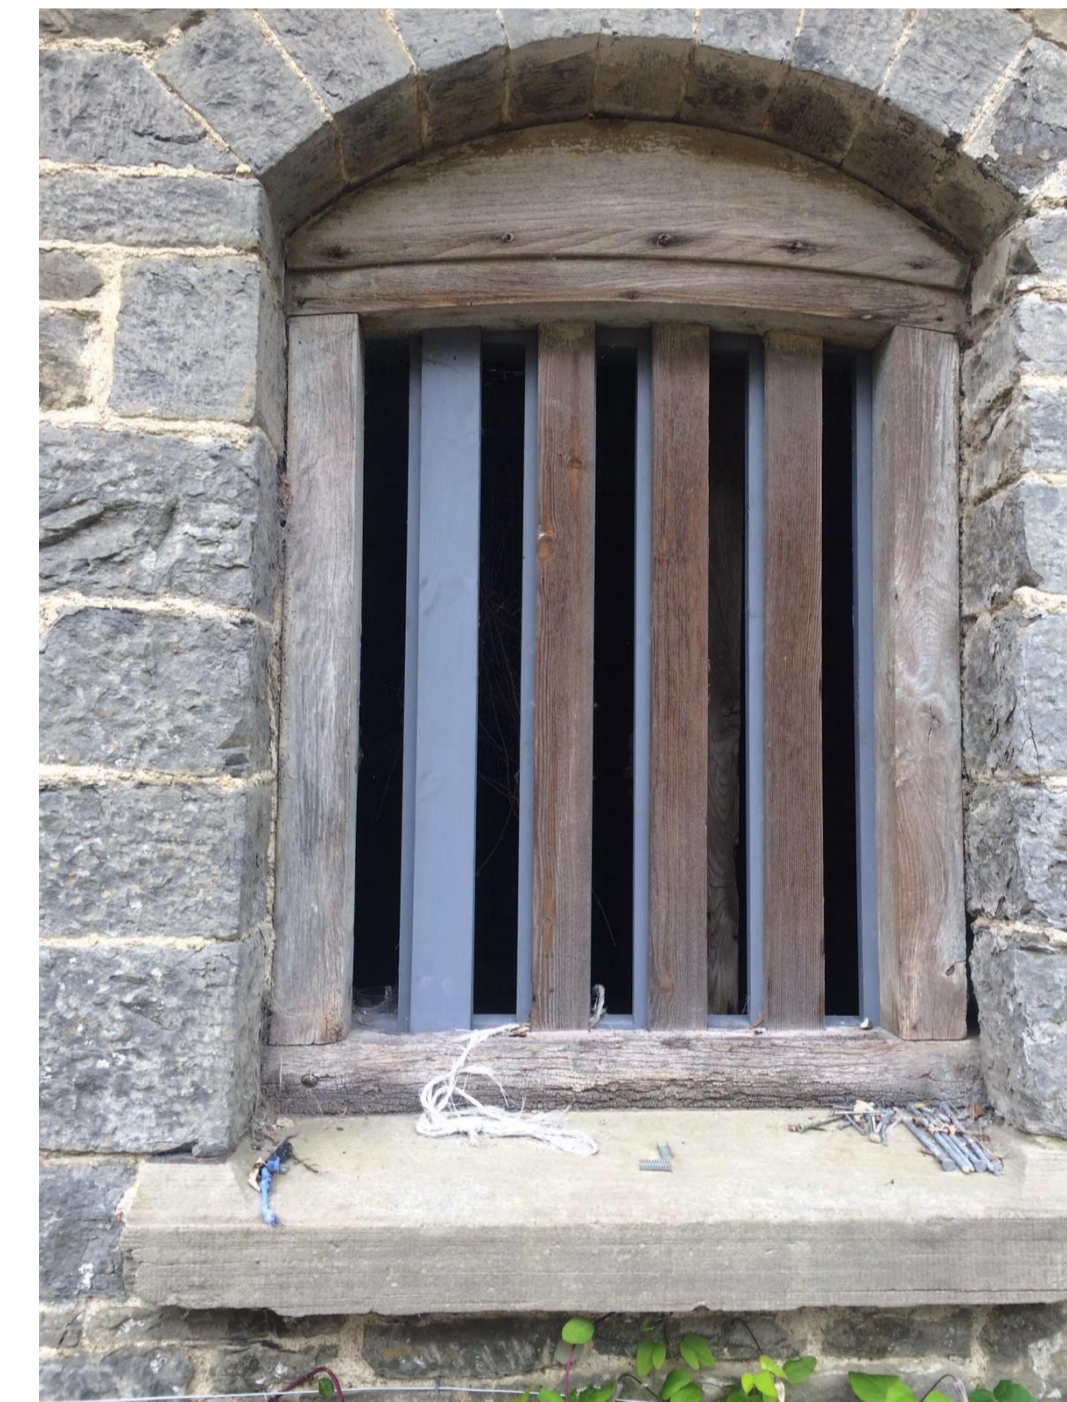
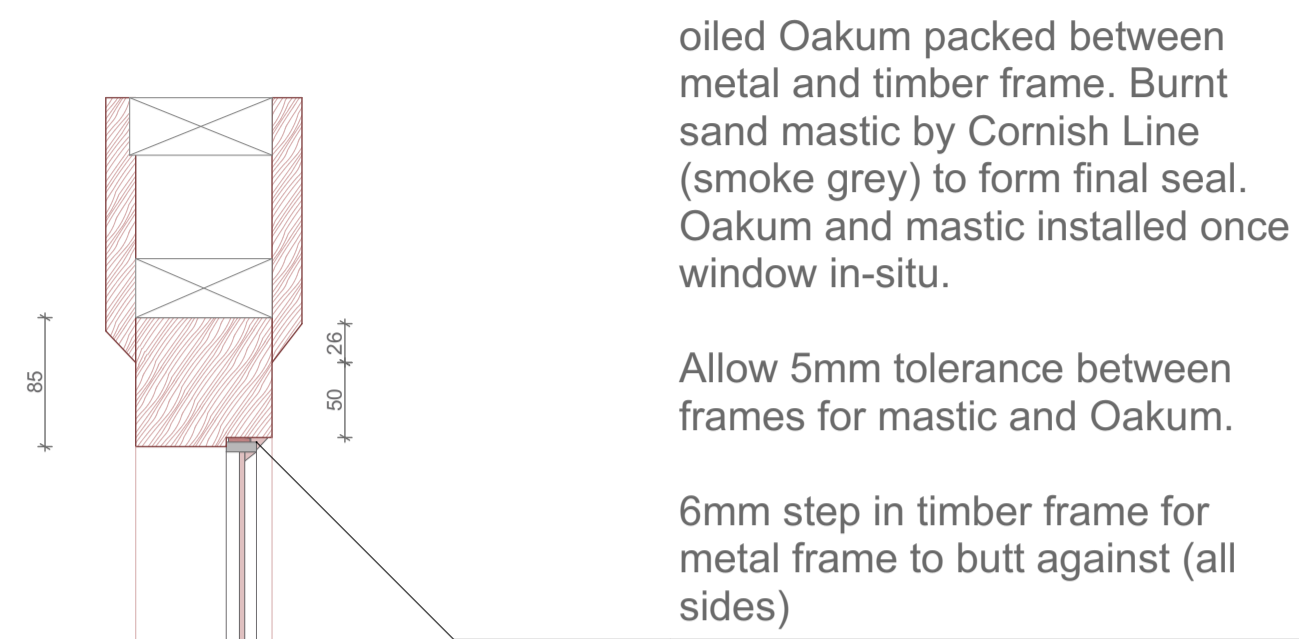
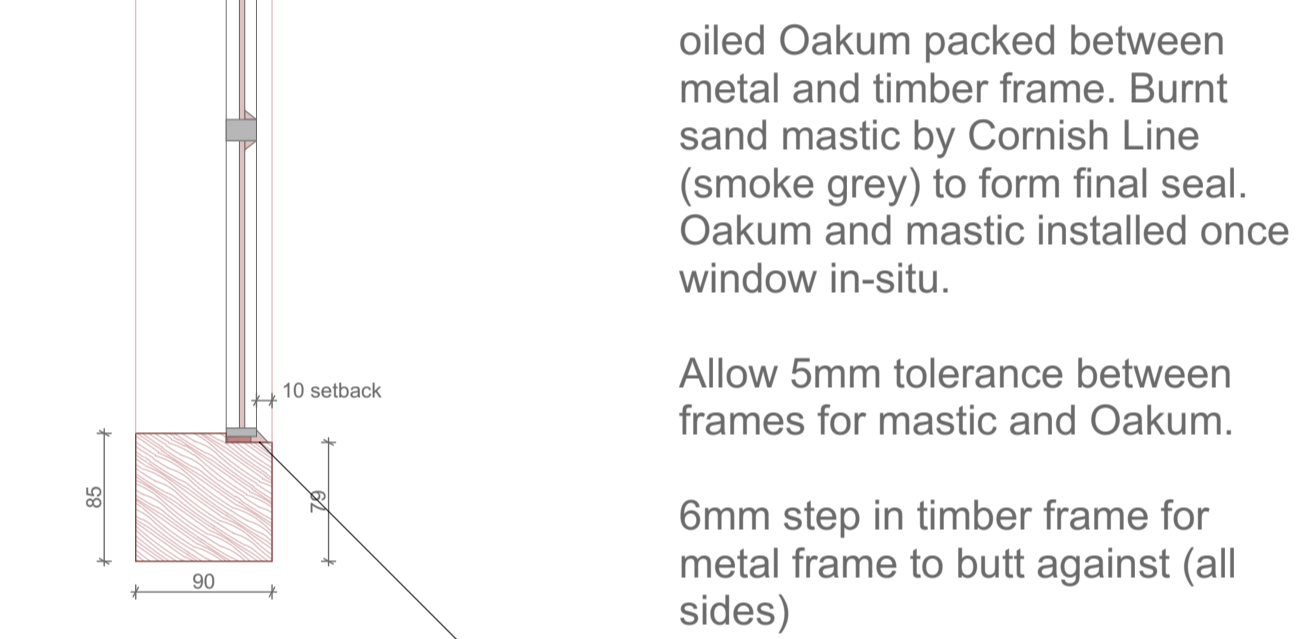
Template
Surviving oak frame in barn 2
New Oak frames to match
