Schedule of replacement doors/windows

Strategy Drawing - Openings to East and West Elevations

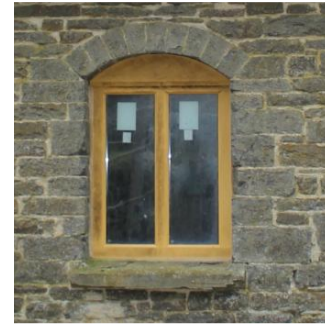
T1: Unauthorised work for removal
Original windows removed in 2017 and replaced with modern painted timber double glazed windows. Cast iron windows reported to be from these openings stored on site.

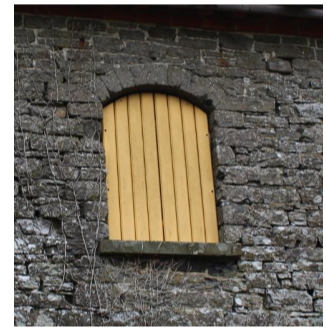
T1A: Unauthorised work for removal
opening reported to be blocked prior to installation replaced with modern painted timber double glazed windows. It is proposed to remove these windows and replace with cast iron windows to match those removed from openings designated T1.

T2: Unauthorised work seeking approval:
Original window removed due to being rotten, replaced with like for like.

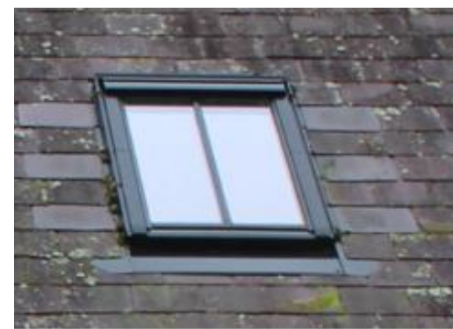
T3: Unauthorised work seeking approval:
Original doors removed due to being rotten, replaced with like for like.

T4: Unauthorised work for removal:
Rooflights installed without LBC. Removal proposed with roof slates to match existing reinstated. Modern rafters repaired as required.
