Proposed Extension and Alterations
 Low Farm Barn, High Street
 Clifford
 for
 Mr P Gilman

Existing and Proposed North East Elevation

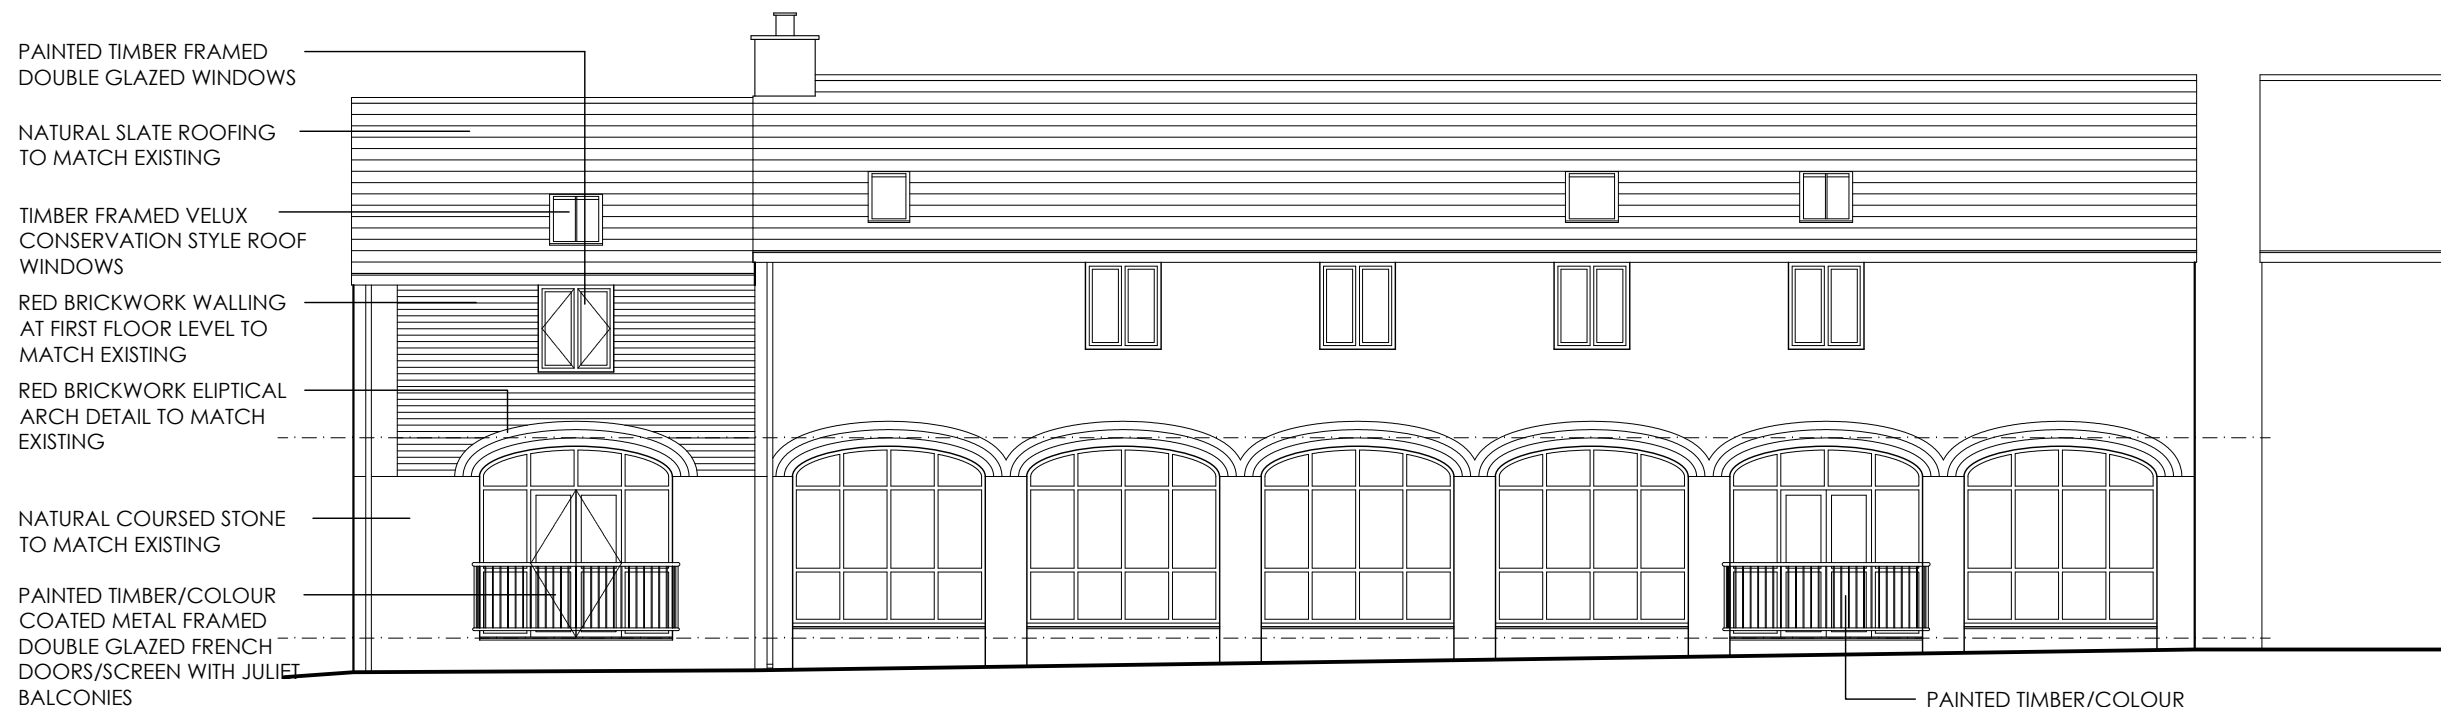
PROPOSED NORTH EAST ELEVATION

PAINTED TIMBER FRAMED
 DOUBLE GLAZED WINDOWS
 NATURAL SLATE ROOFING
 TO MATCH EXISTING
 TIMBER FRAMED VELUX
 CONSERVATION STYLE ROOF
 WINDOWS
 RED BRICKWORK WALLING
 AT FIRST FLOOR LEVEL TO
 MATCH EXISTING
 RED BRICKWORK ELLIPTICAL
 ARCH DETAIL TO MATCH
 EXISTING
 NATURAL COURSED STONE
 TO MATCH EXISTING
 PAINTED TIMBER/COLOUR
 COATED METAL FRAMED
 DOUBLE GLAZED FRENCH
 DOORS/SCREEN WITH JULIET
 BALCONIES

PAINTED TIMBER/COLOUR
 COATED METAL FRAMED
 DOUBLE GLAZED FRENCH
 DOORS/SCREEN WITH JULIET
 BALCONIES

REV A - 31.10.23 Omission of new FF window, to reflect 'as built'.

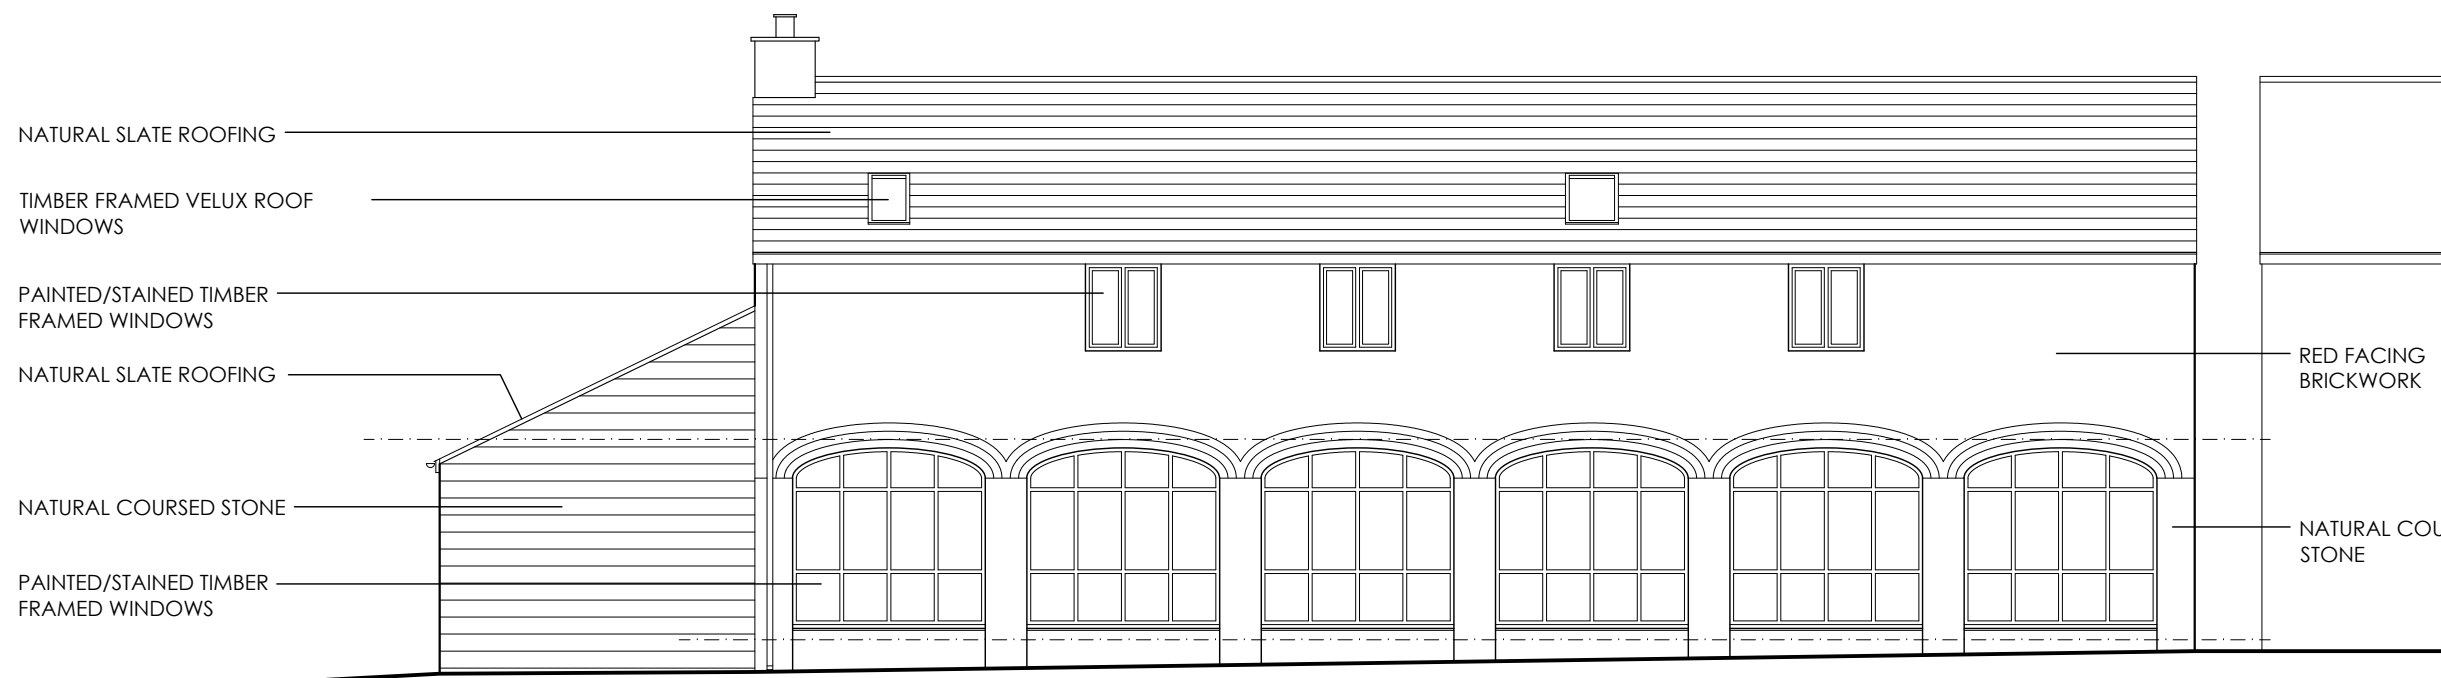
EXISTING NORTH EAST ELEVATION

NATURAL SLATE ROOFING
 TIMBER FRAMED VELUX ROOF
 WINDOWS
 PAINTED/STAINED TIMBER
 FRAMED WINDOWS
 NATURAL SLATE ROOFING
 NATURAL COURSED STONE
 PAINTED/STAINED TIMBER
 FRAMED WINDOWS

RED FACING
 BRICKWORK
 NATURAL COURSED
 STONE
