Flood Risk Assessment

**For Proposed Replacement Dwelling at
Meadow View
Sherfield Road
Bramley
RG26 5AG.**

November 2023

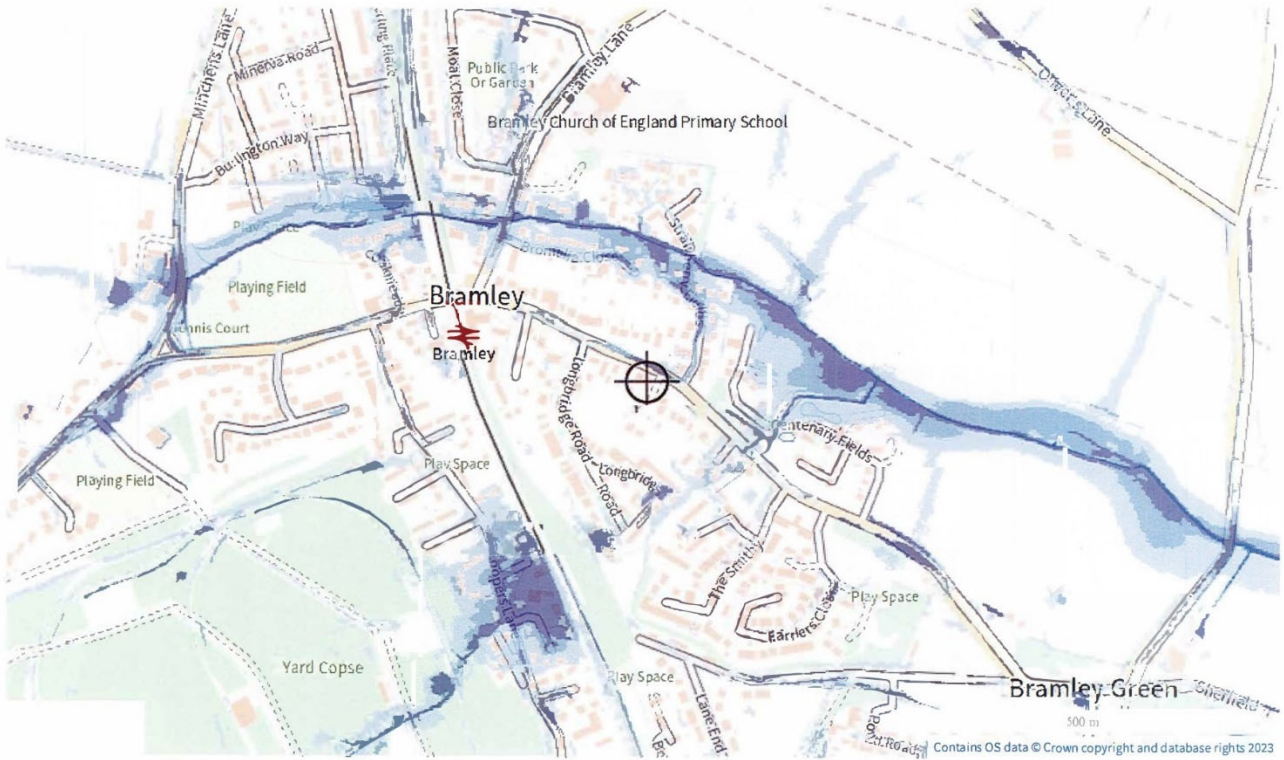
Extent of flooding from surface water

High
 Medium
 Low
 Very low
 Location you selected

Flood Risk. The possibility of the site flooding was checked on HM Governments Flood Risk Website and was found to be situated in a very low risk area, a copy of the print out is contained within this assessment.
