Re: Gas Addendum Letter for Lichfield Drive / Blaby Golf Course, Blaby

P7791 Gas Monitoring Location Plan
P7791 Gas Monitoring Results

CLIENT:	Andrew Granger & Co
PROJECT:	Lichfield Drive/ Blaby Golf Centre
TITLE:	Gas Monitoring Plan

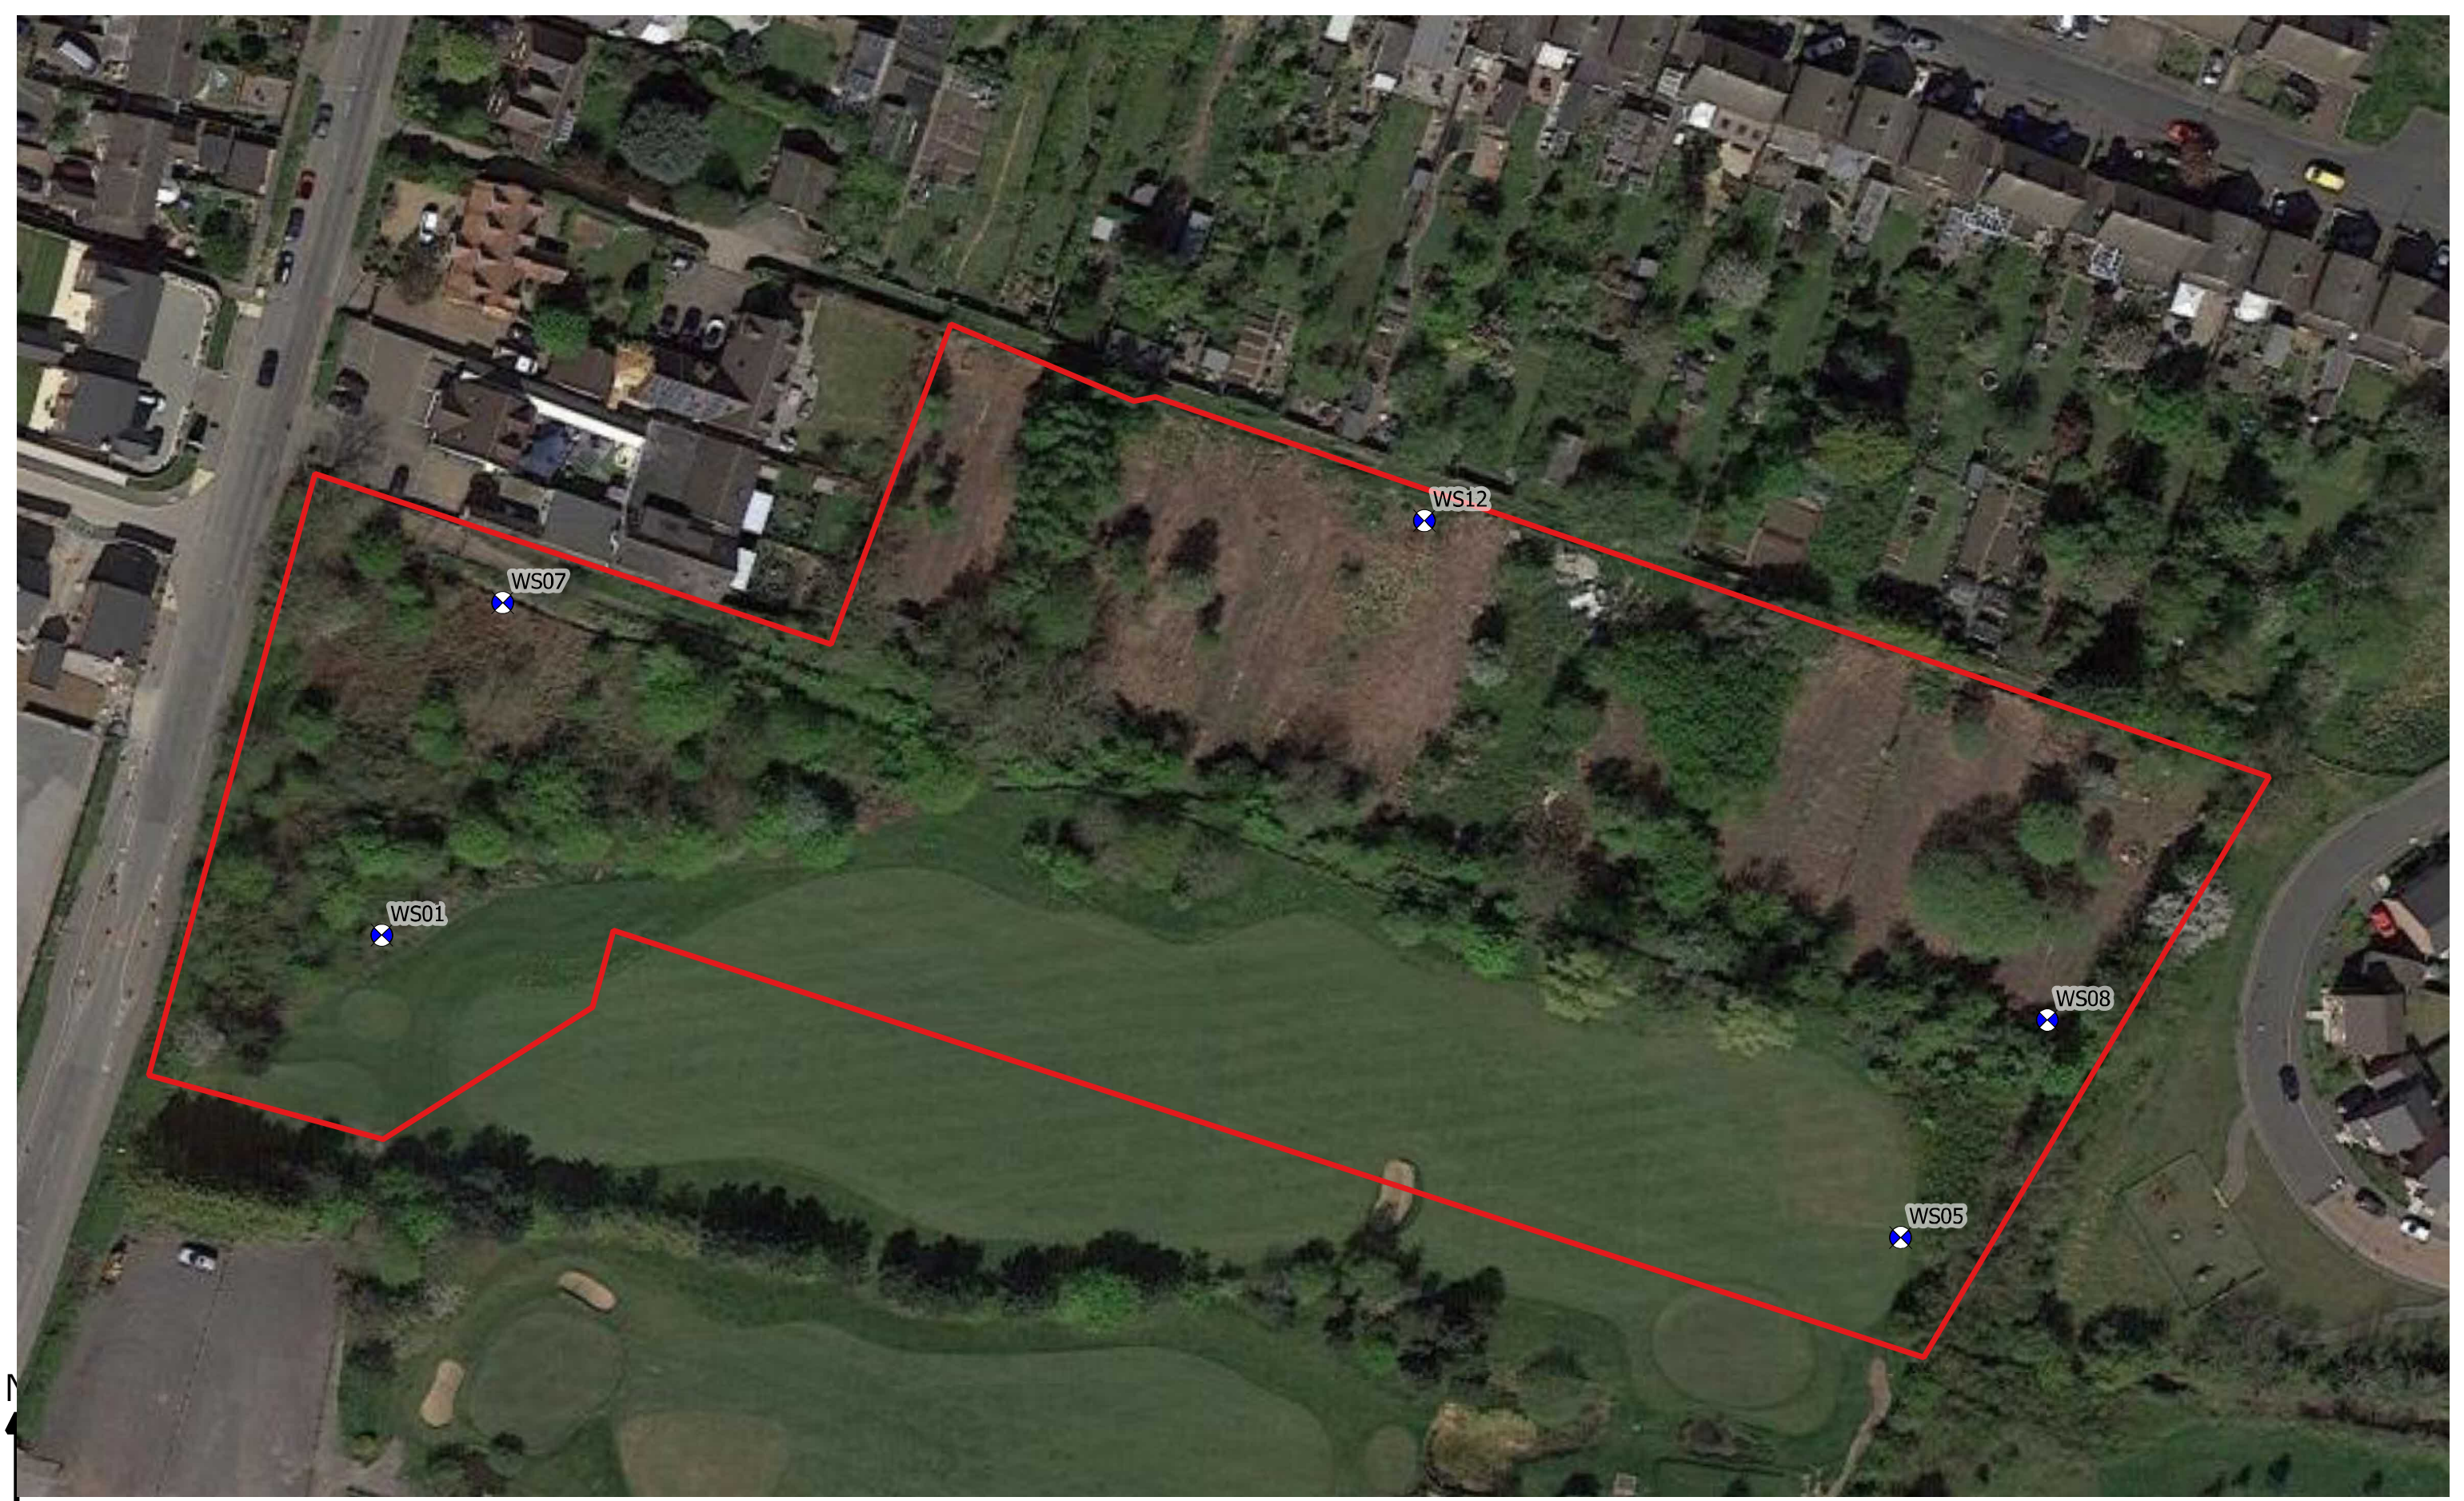
DRAWING NUMBER:	1
-----------------	---

As the proposed end use has been classified as high sensitivity (residential with gardens), five 35mm diameter gas/water monitoring standpipes have been installed across the site within the window sample boreholes (WS01, WS05, WS07, WS08 and WS12) and targeted at the natural strata given the lack of any significant thicknesses of made ground.

The results of the monitoring period to date have revealed depleted oxygen levels within the vicinity of WS08 situated at the eastern boundary of the site. This is considered to pose an asphyxiation risk to site workers in subfloor and confined spaces. It is recommended that there is no unnecessary entry in excavations and if man entry is required, it is recommended that gas monitoring is conducted during operations to ensure adequate concentrations of oxygen are present and ventilation of excavations is undertaken.
