# Arboricultural Consultancy for Prestige

Insured	Mrs Yvonne Olive Walters	Address	Woodstock, COTTESMORE ROAD, ASHWELL, Oakham, RUTLAND, LE15 7LJ		
Client	Subsidence Management Services	Contact	Scott Rue	Claim No.	IFS-PRE-SUB-22-0104778
ES Ref	SA-253349	Consultant	Kirk Thompson	Contact No.	0330 380 1036
Report Date	22/06/2023

## 5. Technical Synopsis

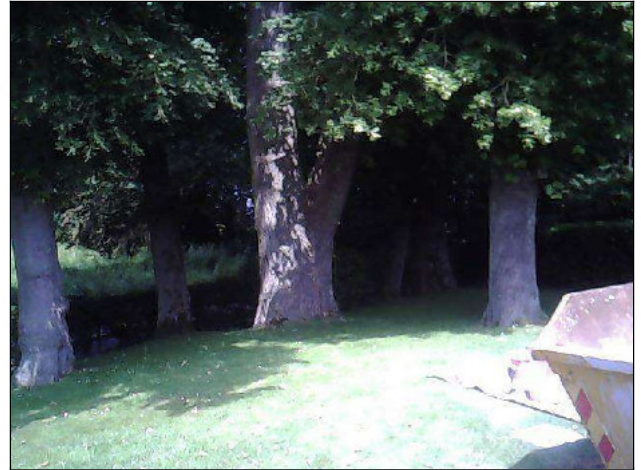
T8 - Poplar

With due regards to species profile, size and proximity, T3 & T8 (Poplar) are considered the dominant features proximate to the focal area(s) of movement and accordingly, where vegetation is confirmed as being causal, we have identified them as the primary cause of the current subsidence damage.

Consequently, we have advocated the complete removal of T3 & T8 (Poplar) as it will offer the most certain arboricultural solution likely to restore long-term stability.

Tree No.	Species	Age Cat	Approx. Height (m)	Distance to Building (m) *	Ownership	Action	Requirement
T3	Poplar	3	28	16.8	C - Insured	Remove	Remove close to ground level; do not treat stump due to translocation risk. Where such a risk exists, we advise that any emergent regrowth is removed annually.
T8	Poplar	3	28	11	C - Insured	Remove	Remove close to ground level; do not treat stump due to translocation risk. Where such a risk exists, we advise that any emergent regrowth is removed annually.
