LEVEL MONITORING

for Subsidence Management Services

Oakfield, Saint John's Avenue, Thorner, West Yorkshire, LS14 3BZ

Our Ref: M19641

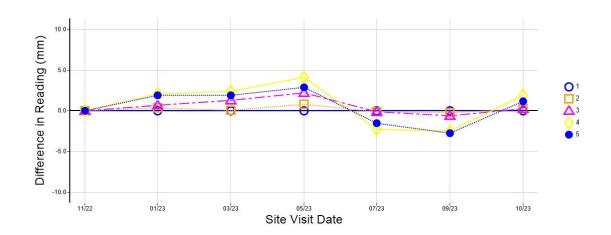
Level Monitoring Difference Graphs

The following graphs display the progressive movement that each Level Monitoring Station recorded at each separate site visit date to give an overall look at how much the property is moving.
