PROJECT : HOCKLEY SOLE
CLIENT: MR AND MRS SNAPE
DRAWING: HARD LANDSCAPE PROPOSALS

DATE : 30th January 2023

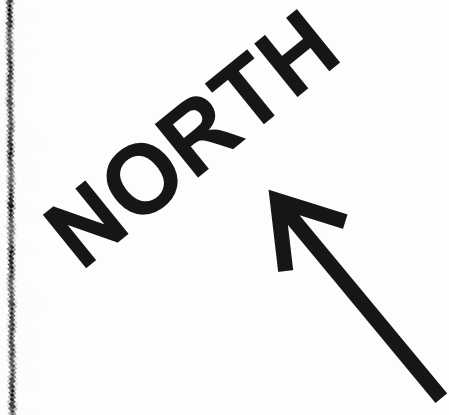
- Green roof to new building see detail 353-02-11
- Existing potting shed restored
- Existing garden wall restoration to include rebuilding of buttresses and repointing all with lime mortar
- Access to car parking bays permeable gravel finish see detail 353-02-12
- Gravel paving to match kitchen garden see detail 353-02-13
- Exposed aggregate PCC Non slip paving see detail 353-02-14
- Gabion retaining wall battered back to 60degrees from horizontal 1M high see detail 353-02-14
- Existing reinforced grass track retained and maintained
- Existing gravel track retained and maintained / made good.
- Garden protection/ site boundary fence
