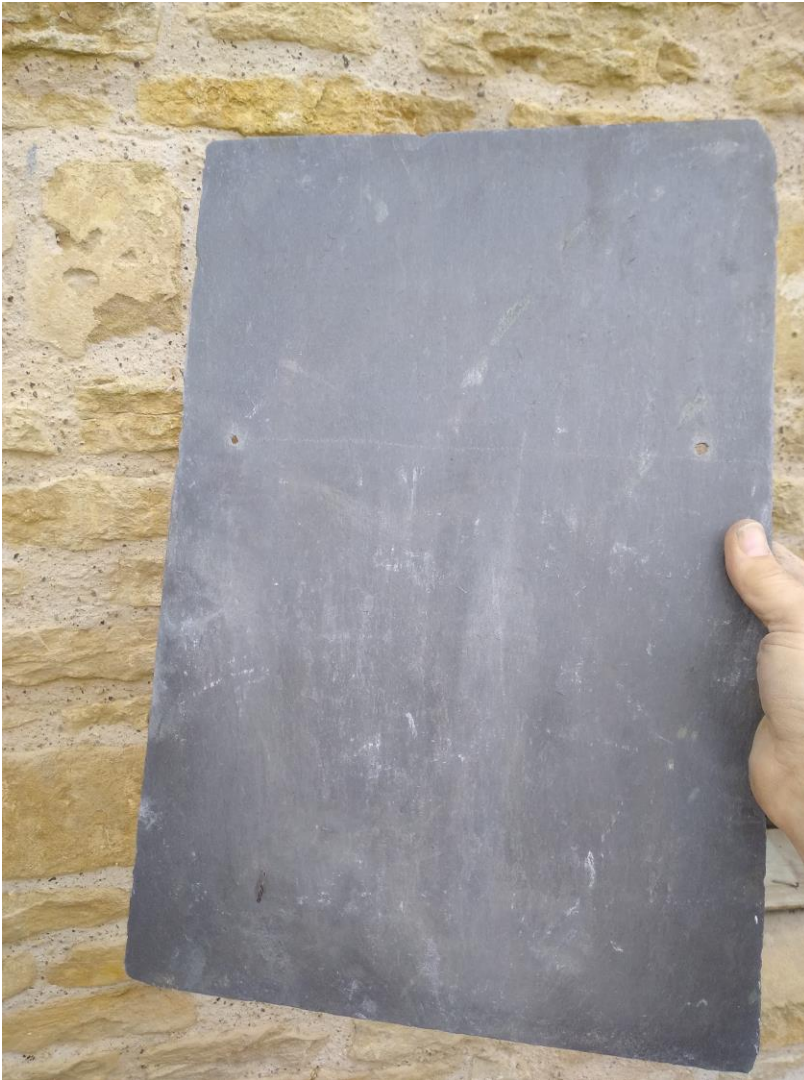
Penrhyn reclaimed roof slates – from Heritage Roofing, Stamford

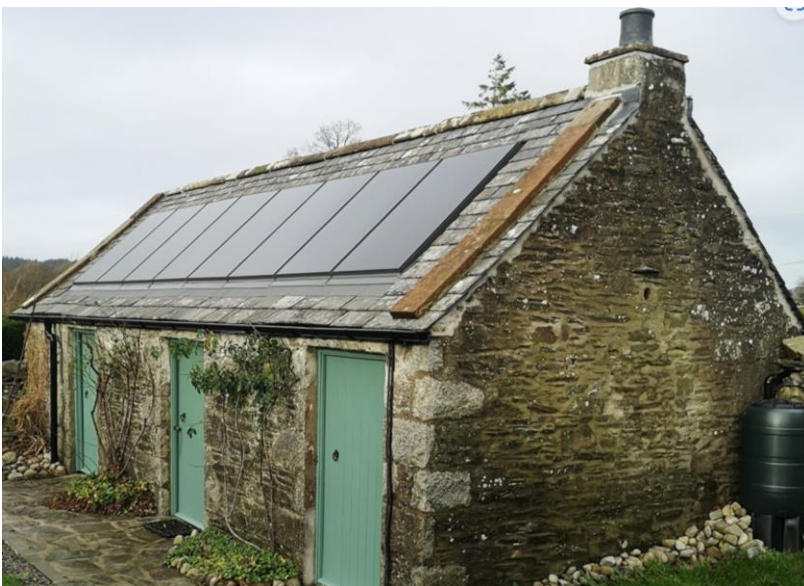
In-roof integrated solar PV panels

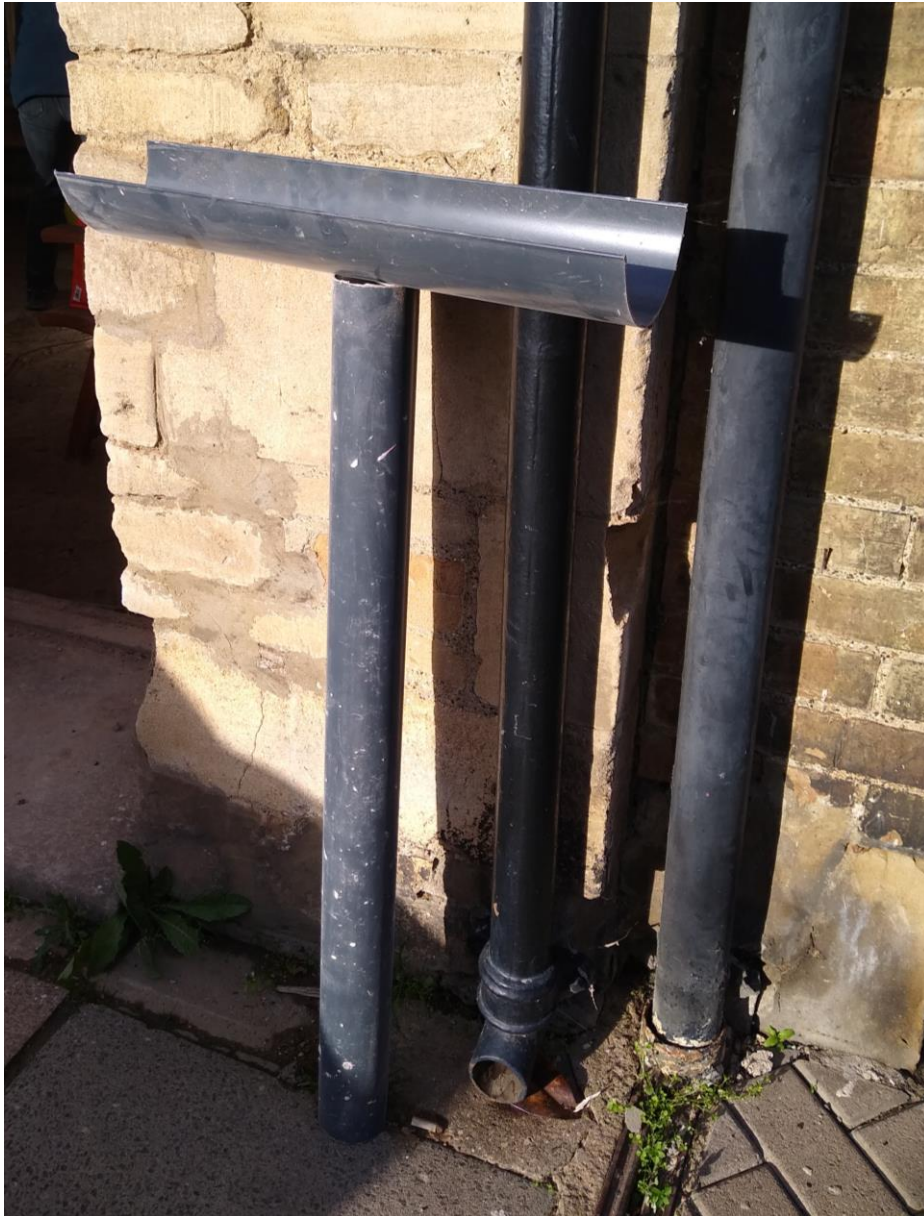
Conservation cast deep profile rainwater goods – will be painted black

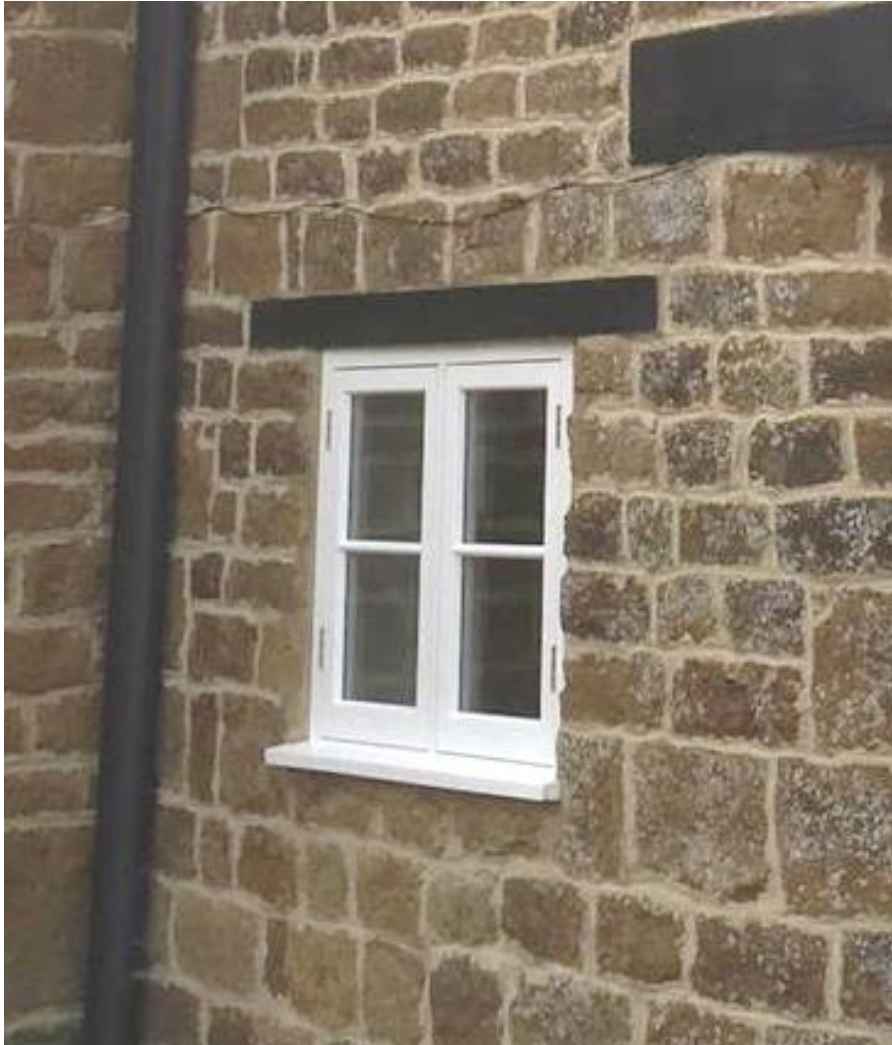
Wooden casement windows with Northampton glazing bar and conservation double glazing

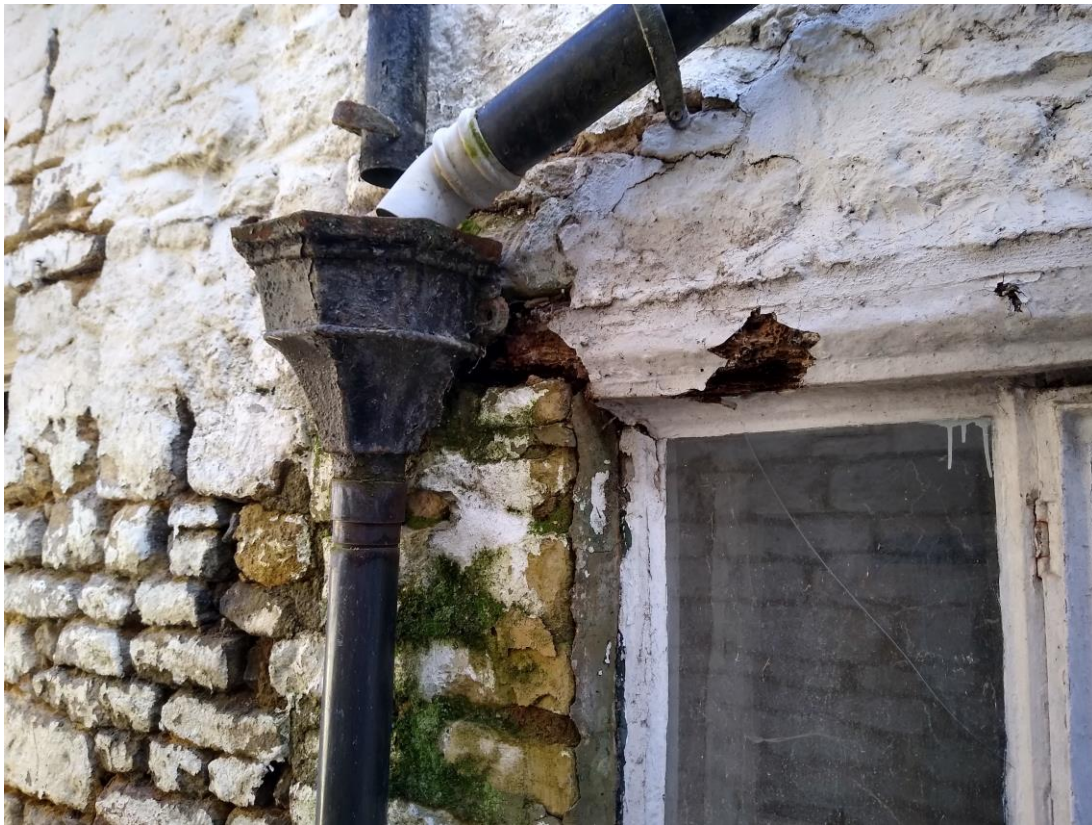
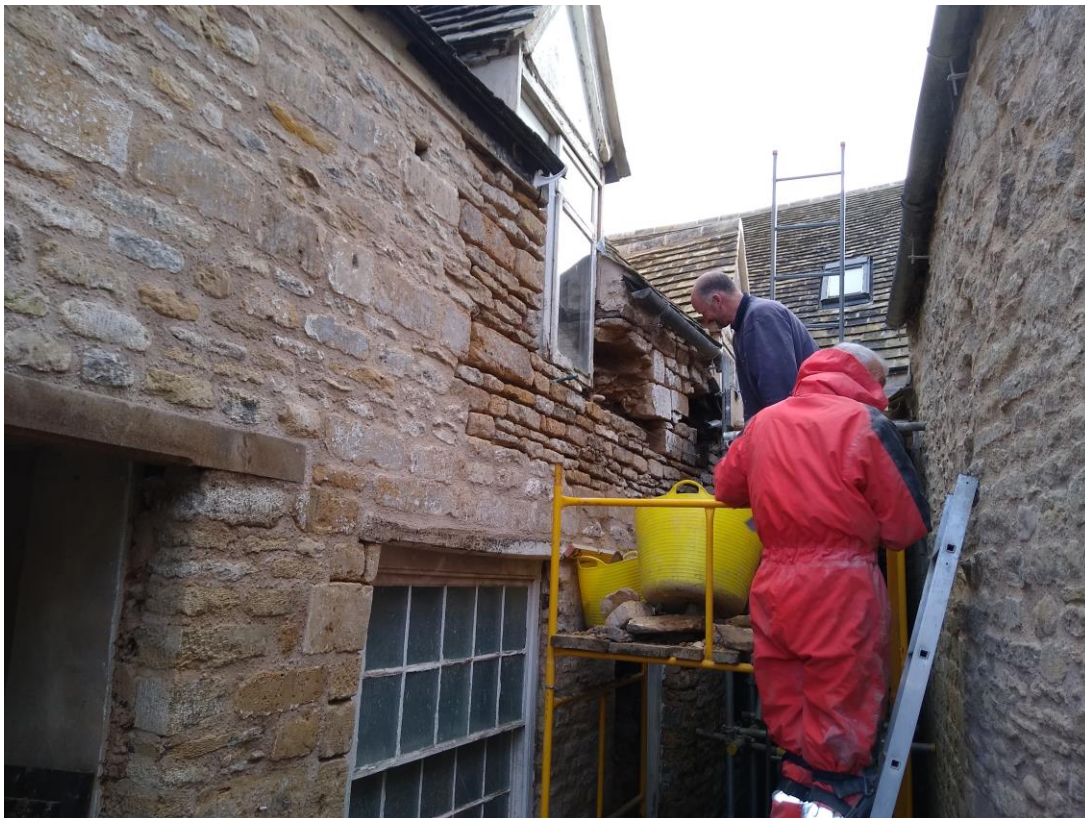
Coursed limestone repairs and lime mortar – to illustrate proposed new stonework quality

Before

After

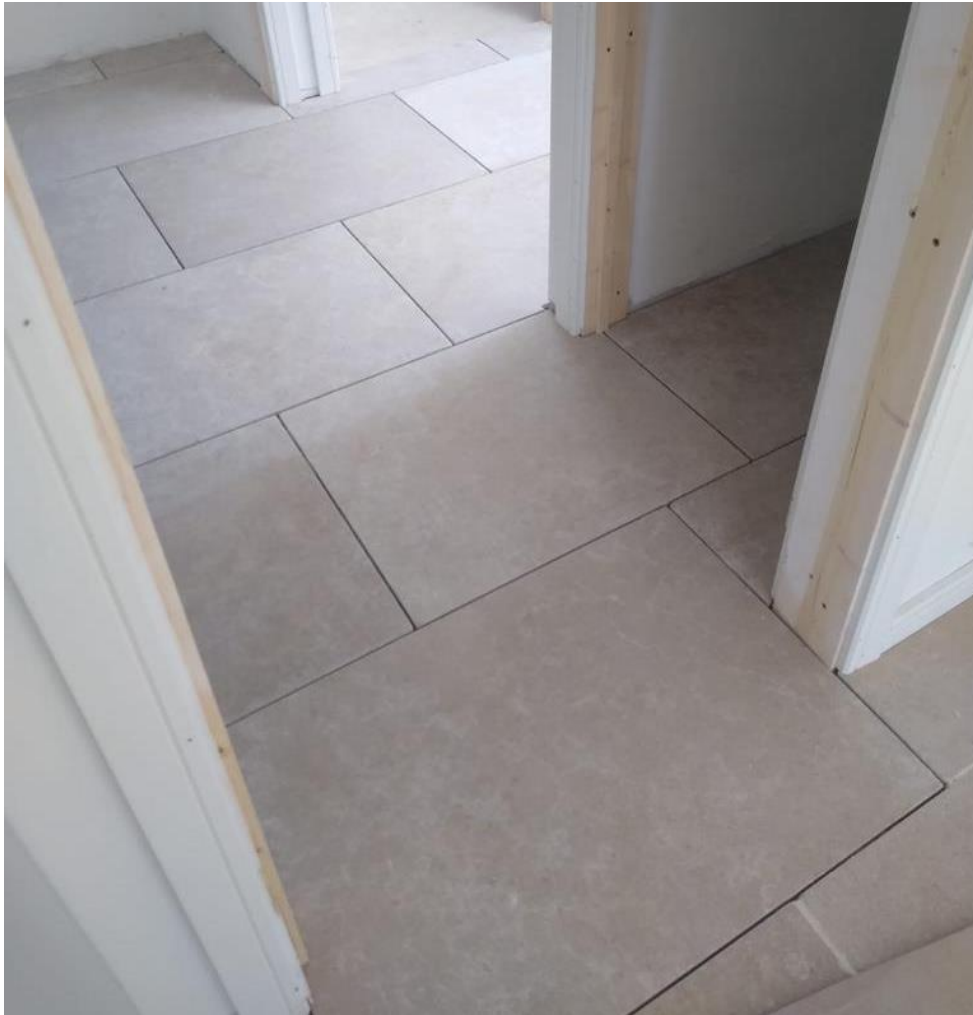
Milled limestone flagstones for kitchen and alleyway floor
