Stage: **PLANNING**
PROJECT

Class Q conversion of existing Farm Workshop/Storage Shed to domestic accommodation at Longstone Farm, Trenear, Helston, TR13 0HG

TITLE
Indicative Site plan and supporting information

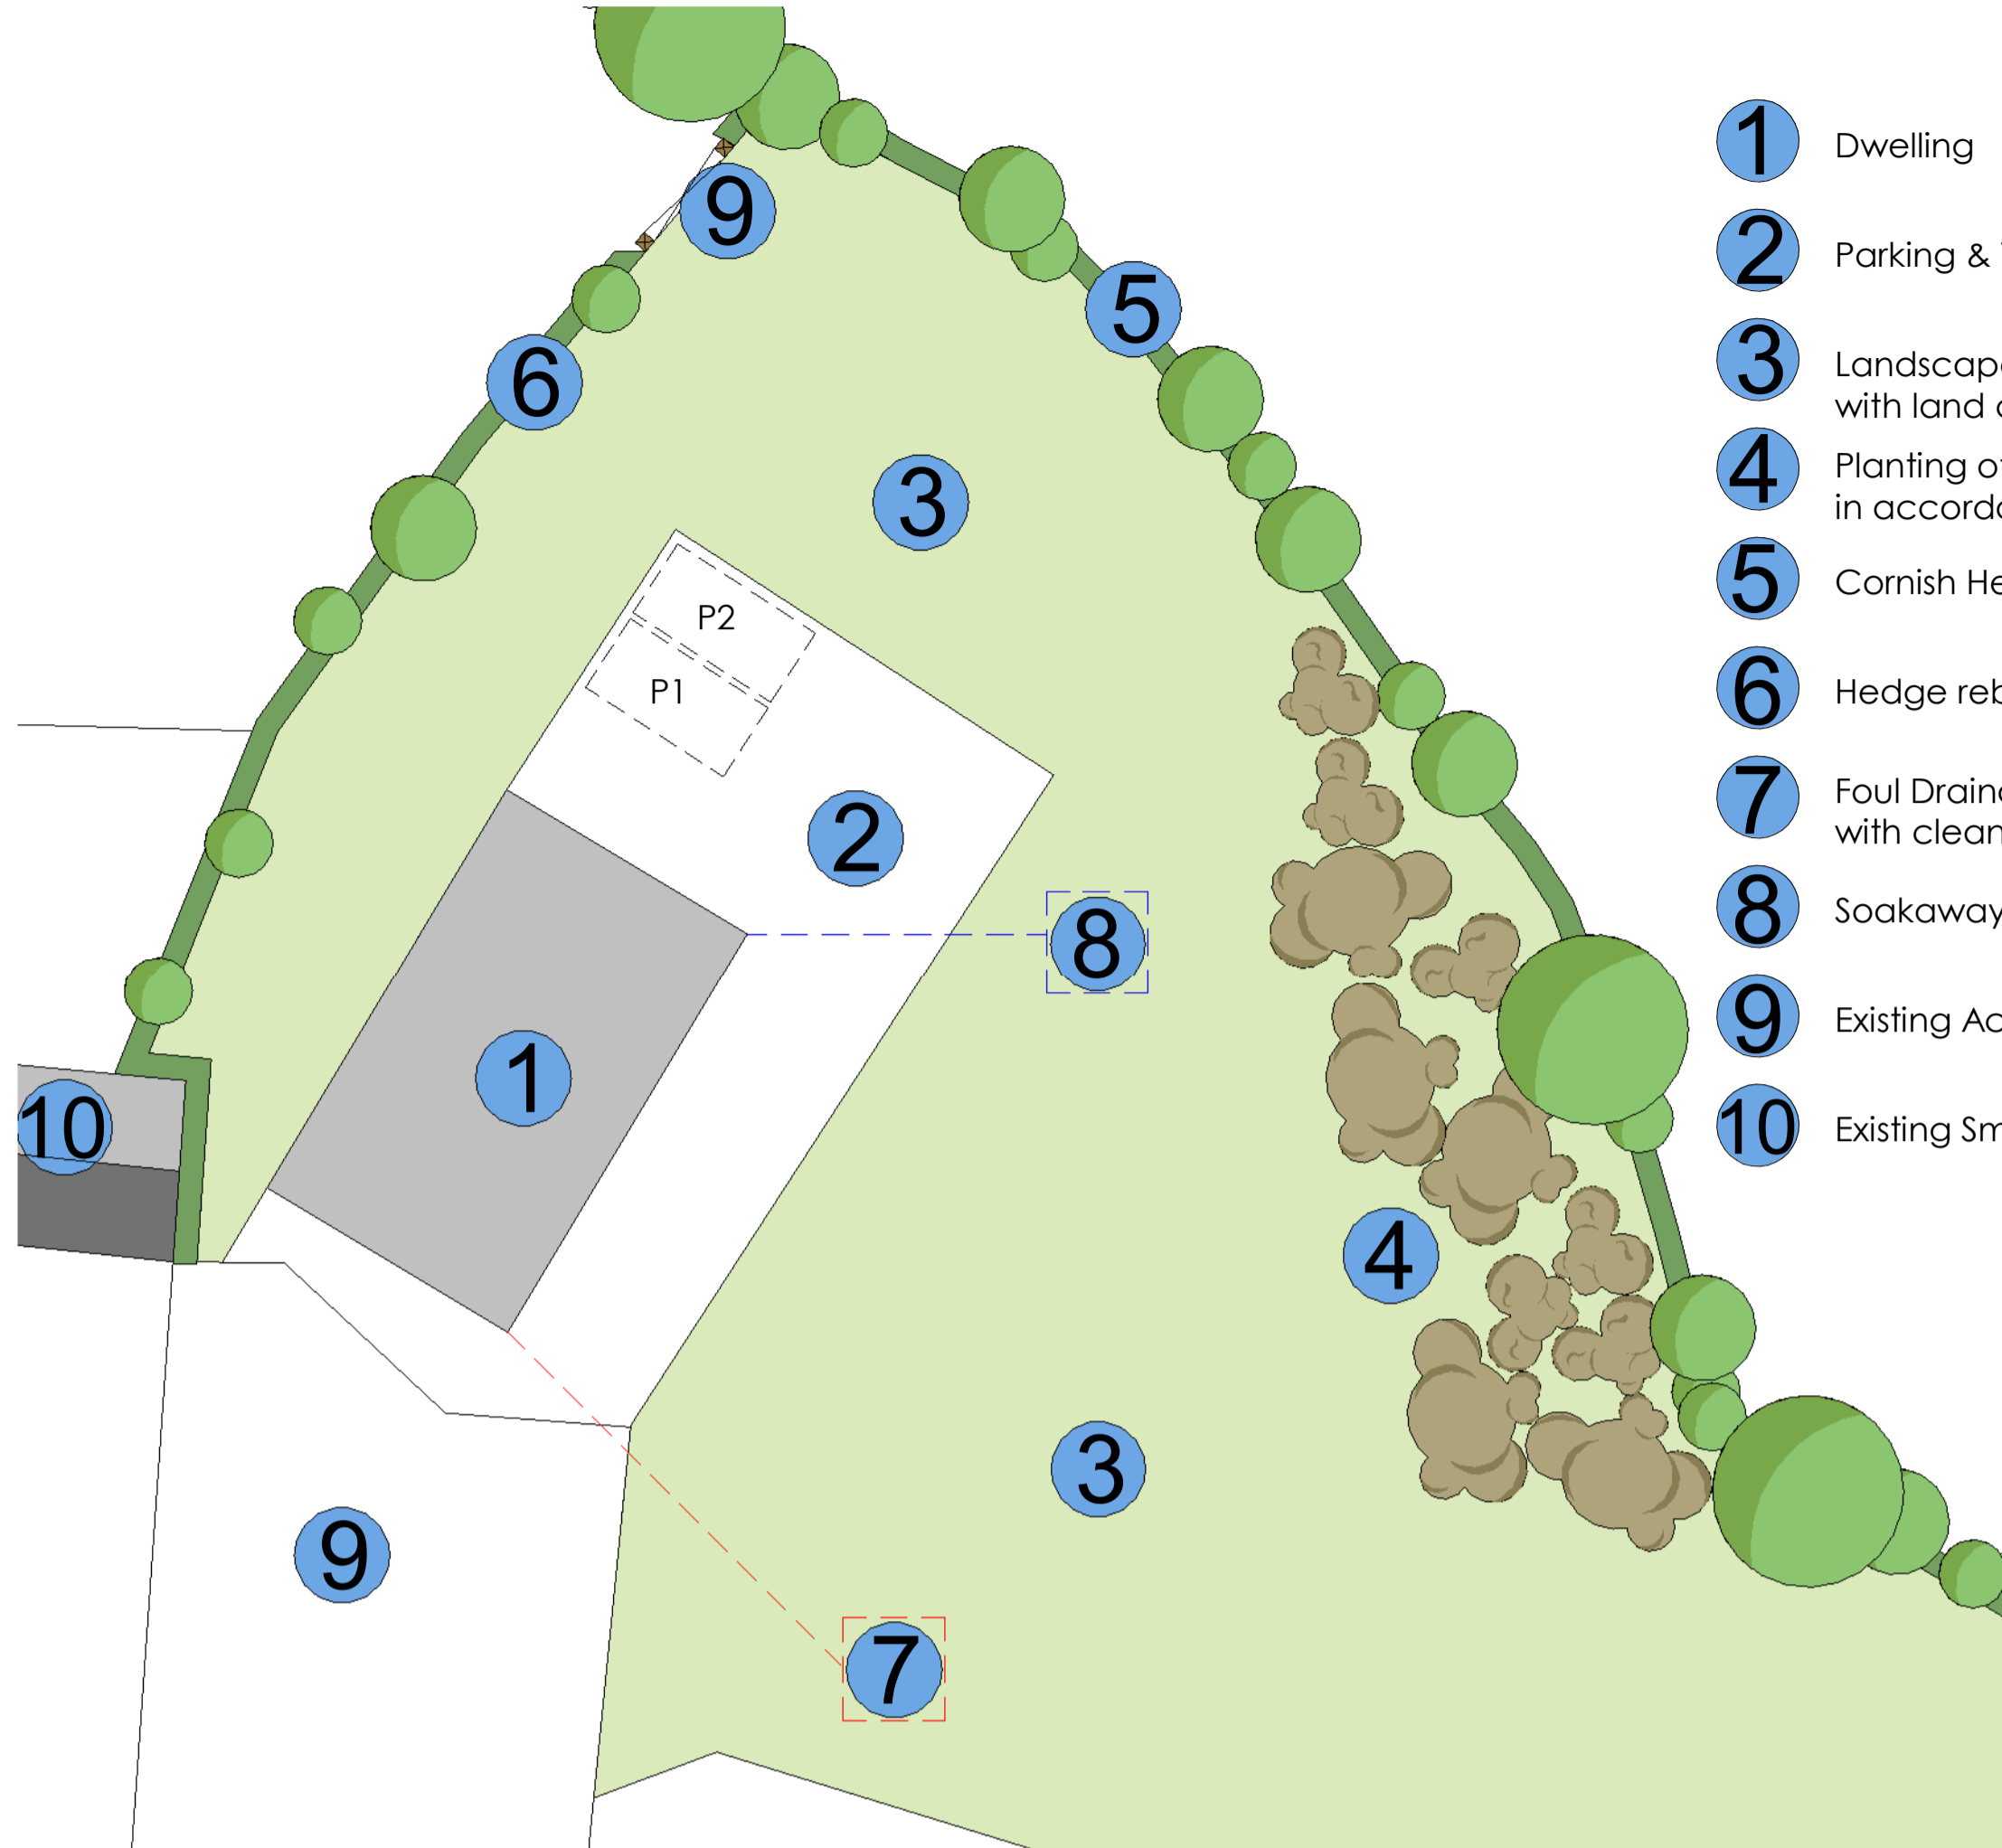
Indicative Site Plan This Site plan is indicative only and Illustrates how the site could be presented
1 : 200

- 1 Dwelling
- 2 Parking & Turning
- 3 Landscaped Garden to be in accordance with land contamination report
- 4 Planting of good Quality Brush & Scrub in accordance with Ecology report
- 5 Cornish Hedge repaired
- 6 Hedge rebuilt and planted where required
- 7 Foul Drainage Treatment plant (klargester or similar) with clean water discharge
- 8 Soakaway
- 9 Existing Access
- 10 Existing Small Workshop/Storage

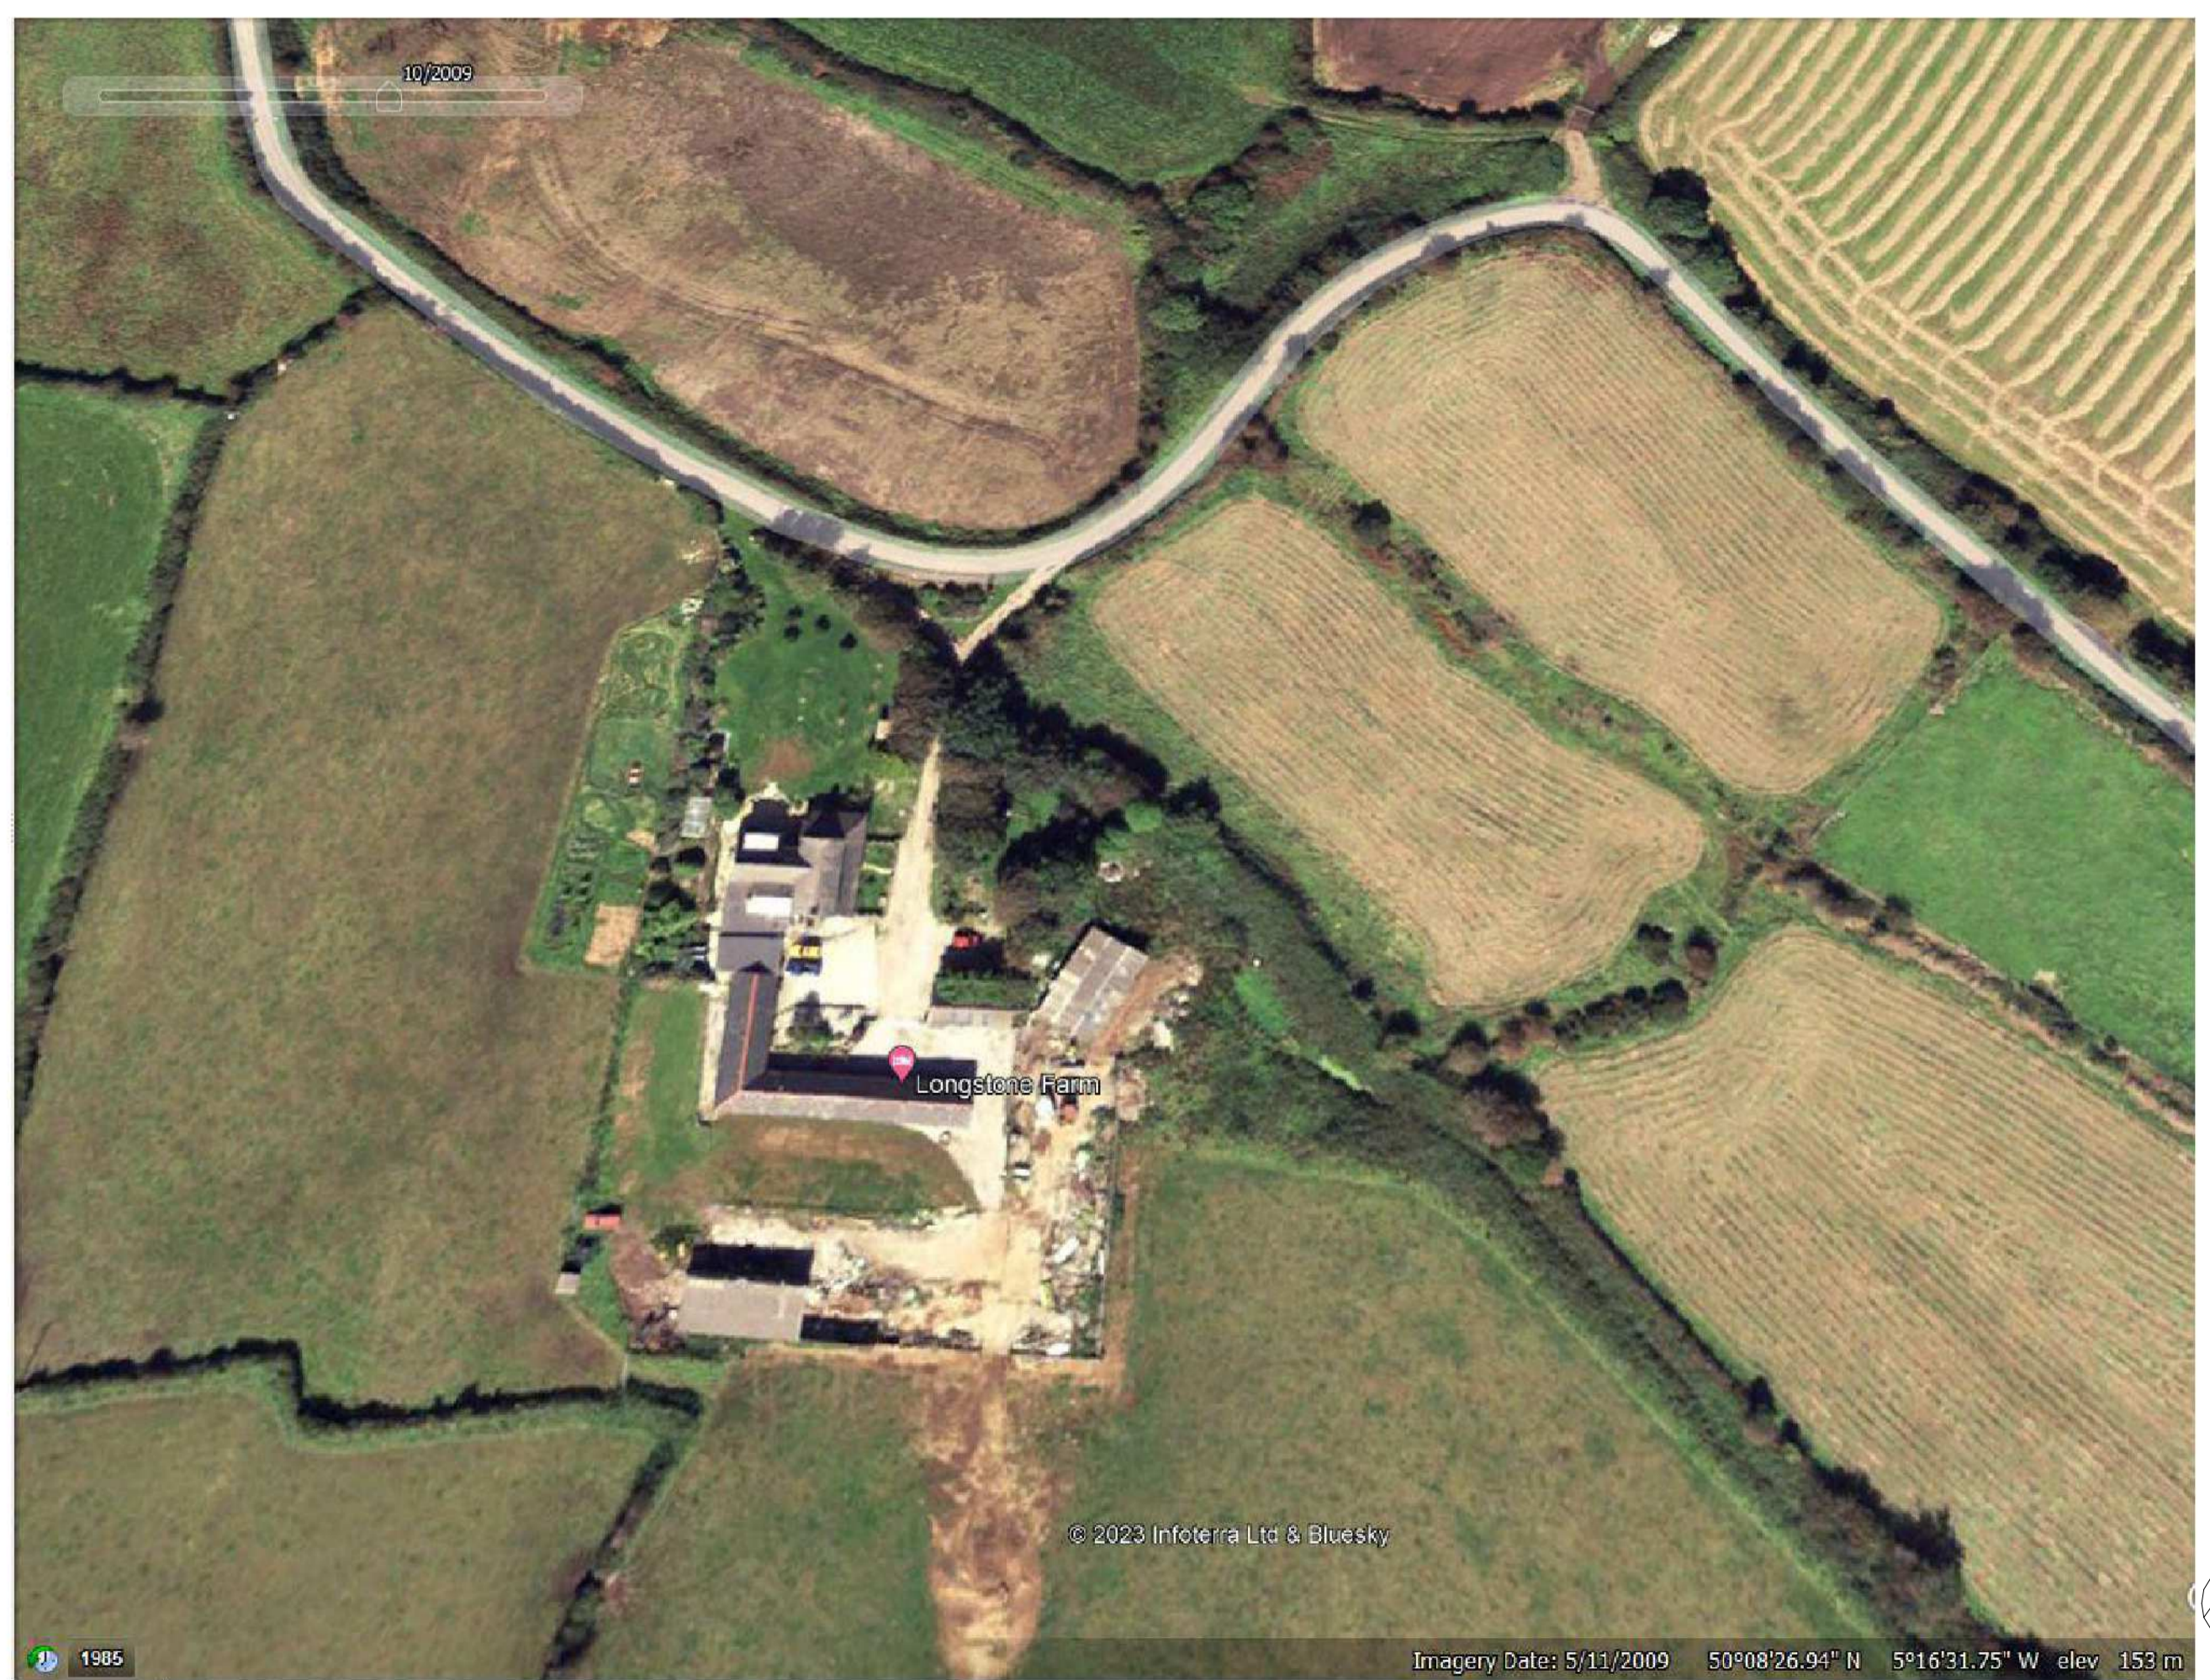
Google Pro Site image dated 2009 - Building has been in place for a minimum of 15 years

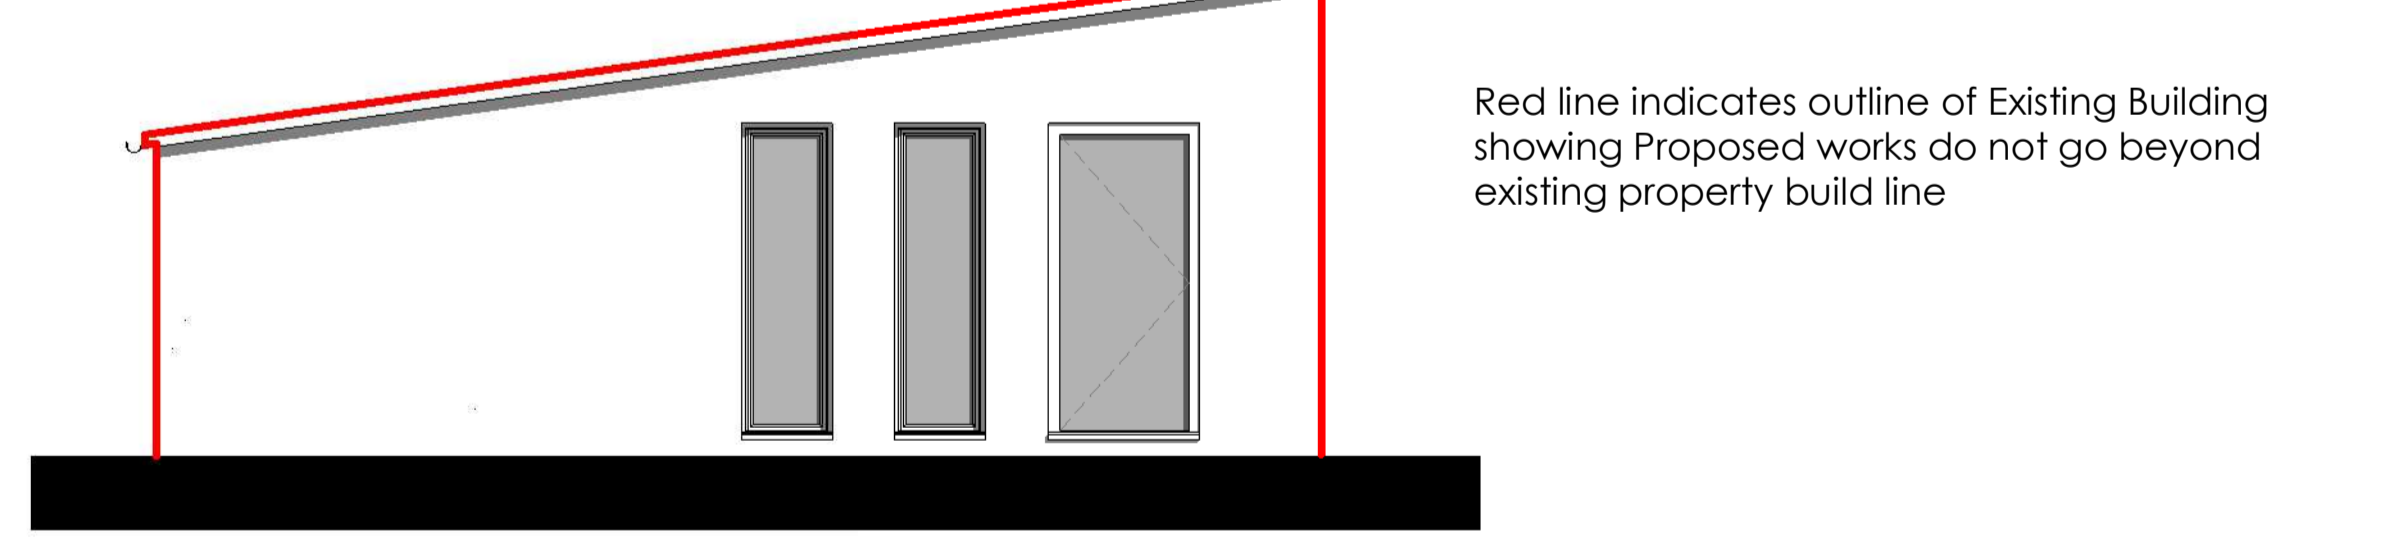
Proposed South West Elevation
1 : 50

Red line indicates outline of Existing Building showing Proposed works do not go beyond existing property build line
