**BS5837:2012 TREE SURVEY AND  
ARBORICULTURAL IMPACT ASSESSMENT:  
65 Crescent Road, Barnet, EN4 9RD**

Dated: 24<sup>th</sup> November 2023

Our reference: GHA/DS/162350:23

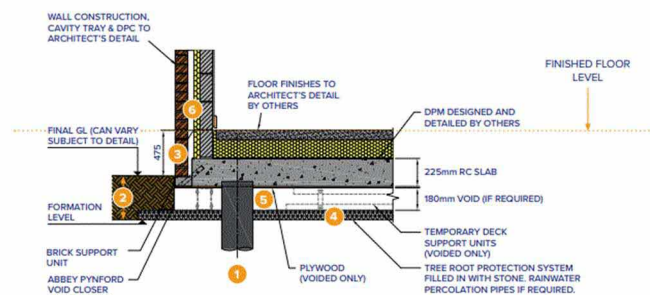
*Below: Treesafe footing details*

Treesafe is a version of our Housedeck ground floor solution. The system allows construction of dwellings or commercial structures close to or within tree root protection zones.

Treesafe utilises an open core working surface to support our lightweight piling rigs, minimising excavation that could potentially cause permanent damage to tree roots.

- 1 Allows construction of buildings within tree root protection zones.
- 2 Significant reduction in excavation.
- 3 Significant reduction in under build.
- 4 Open core deck system in place of piling mat.
- 5 Clear void to mitigate heave risk.
- 6 No venting required.

- 6.8 Localised piles will be positioned (following trial digs) to ensure that any significant roots (over 25mm) that are present in the area where the new building will sit can be retained and protected to coexist with the new structure.
