0423 23 Bank Street, Hillhead, Glasgow

Supporting Document for Retrospective Planning and Listed Building

Consent Applications

November 2023

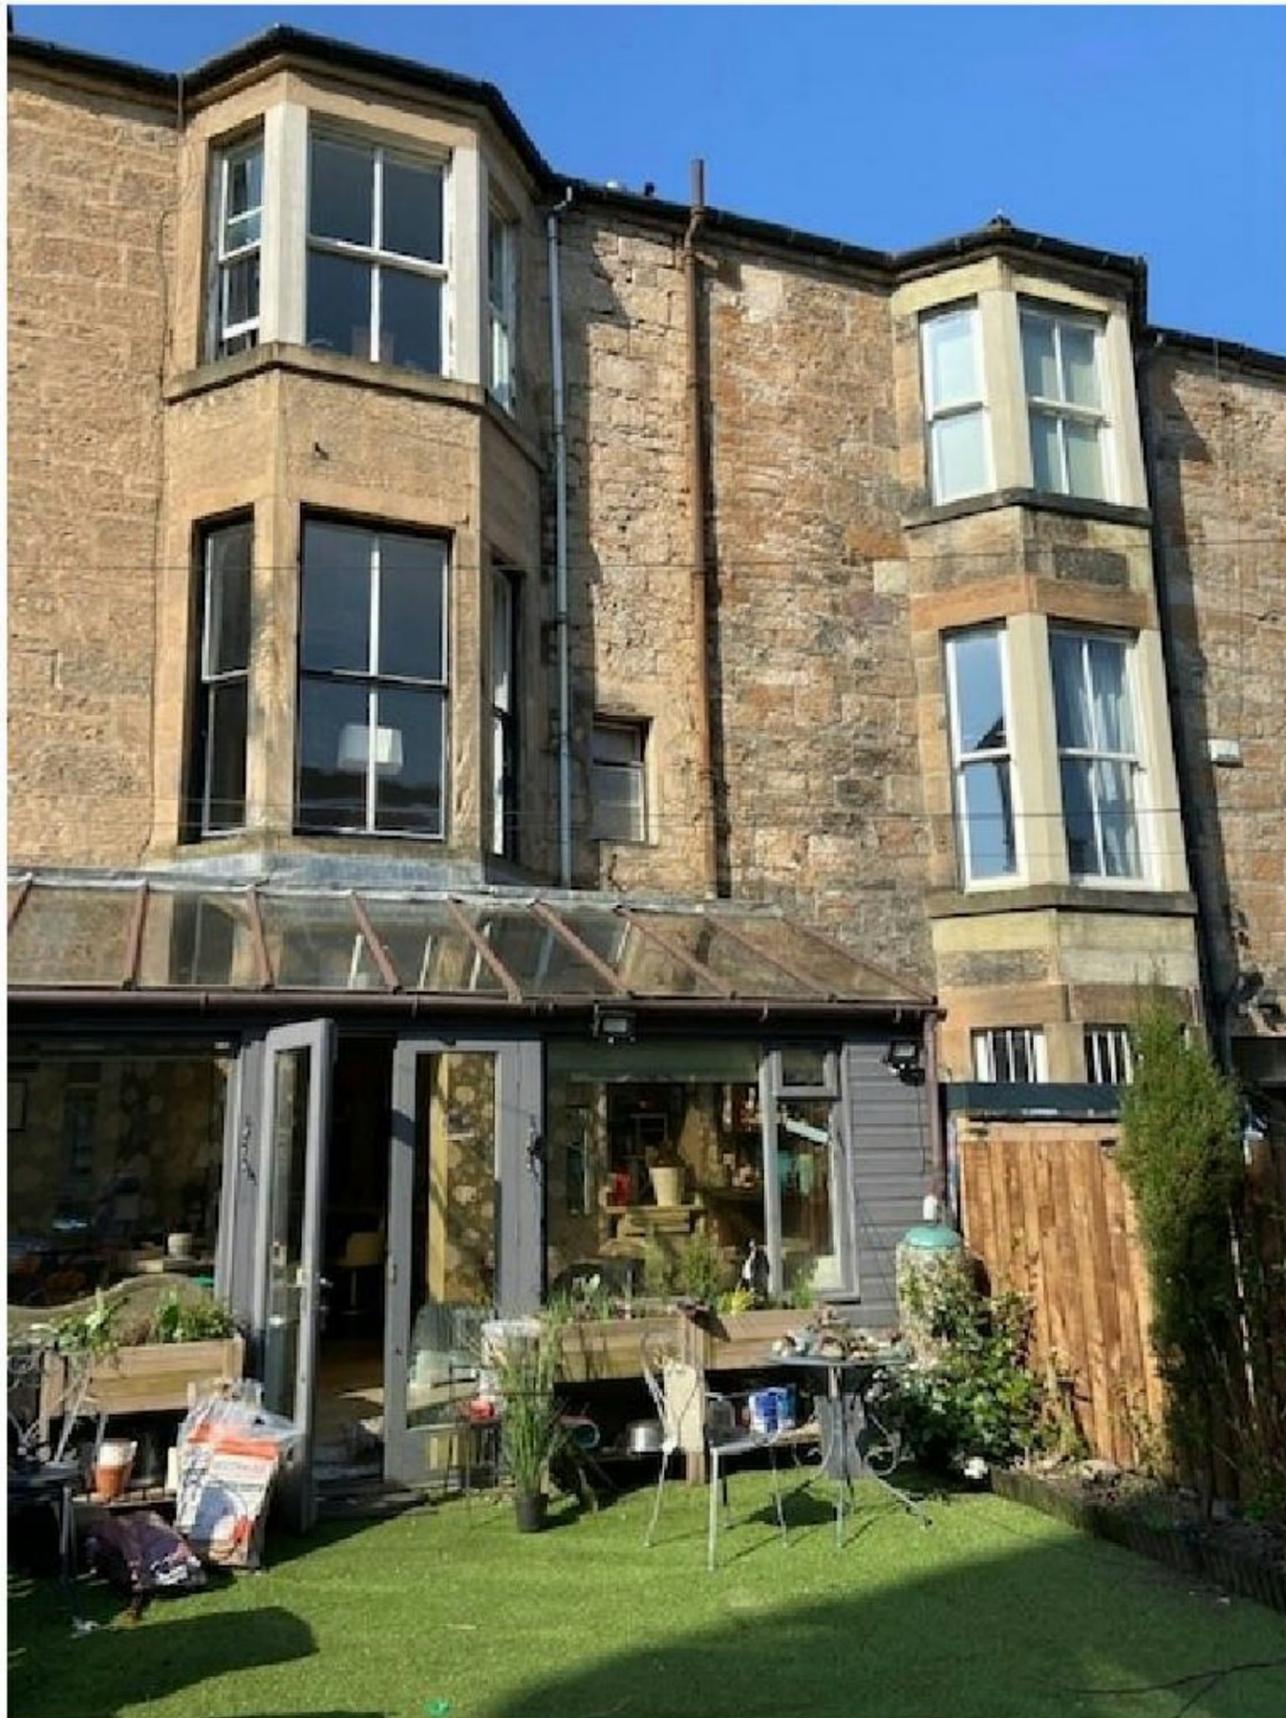
Existing small window to rear blocked from inner face of lounge.

In 2012 the current owner refurbished the property, remodelling the lower-ground floor and removing the bathroom from the ground floor. This allowed the reinstatement of the main lounge and cornicing to original proportions. The small window in the bathroom, which had been added to the rear elevation, was blocked from the inside. It has now been fully removed and natural stone inserted.

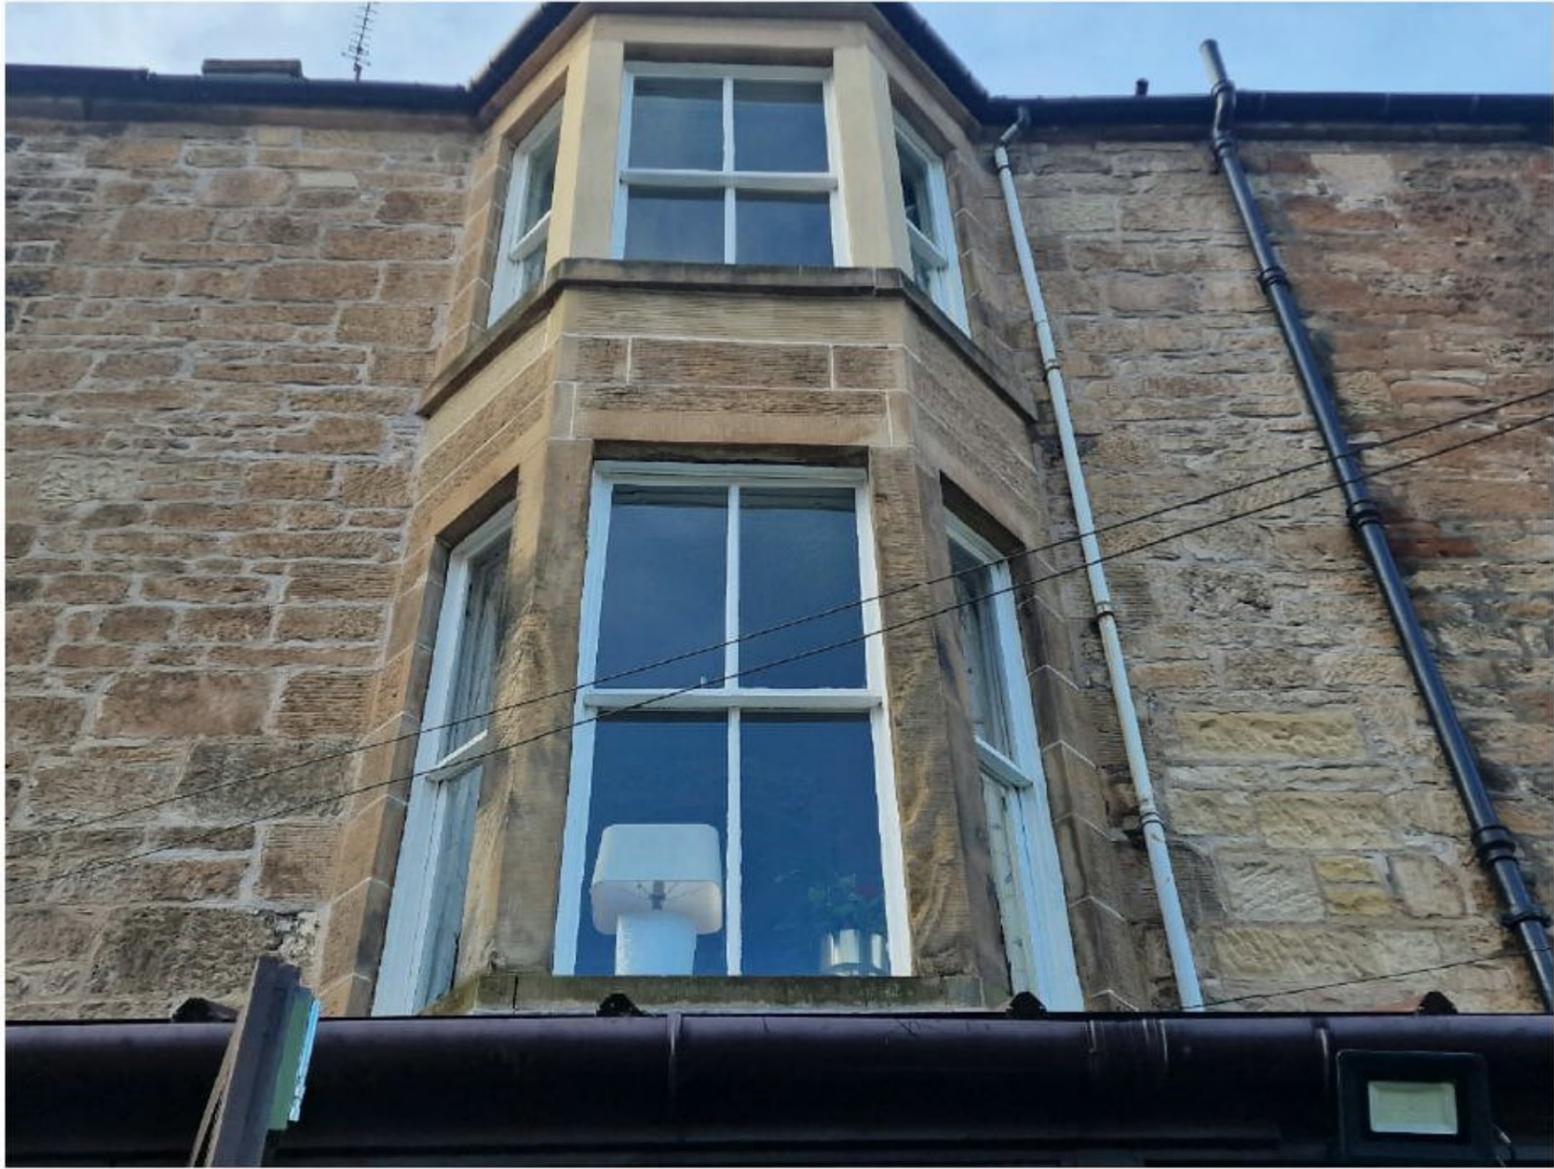
Window opening infilled with natural stone to match existing.

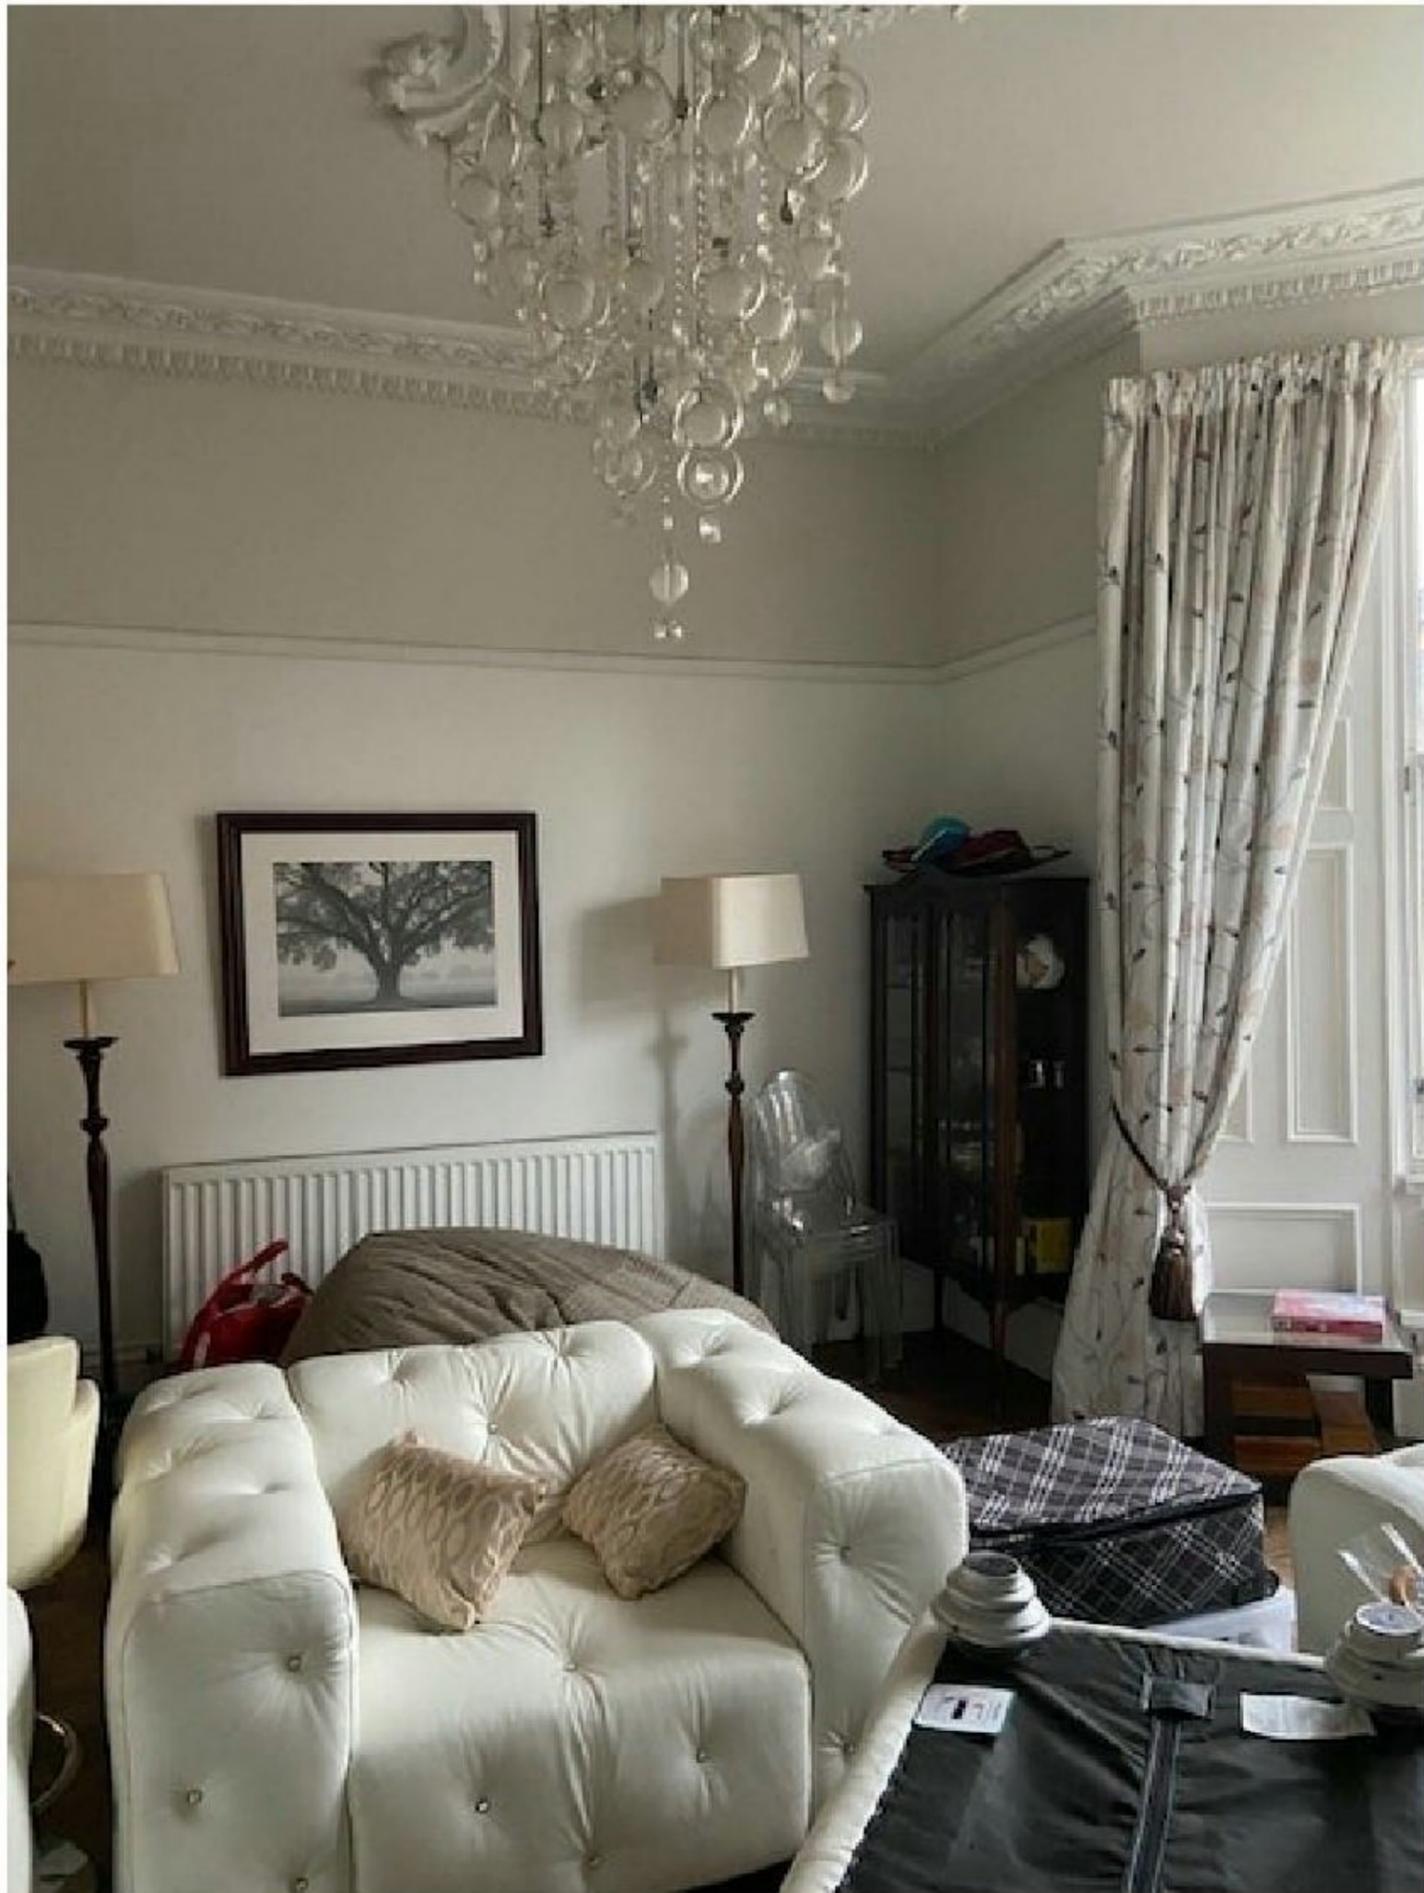
Existing lounge and cornicing reinstated following removal of bathroom conversion.

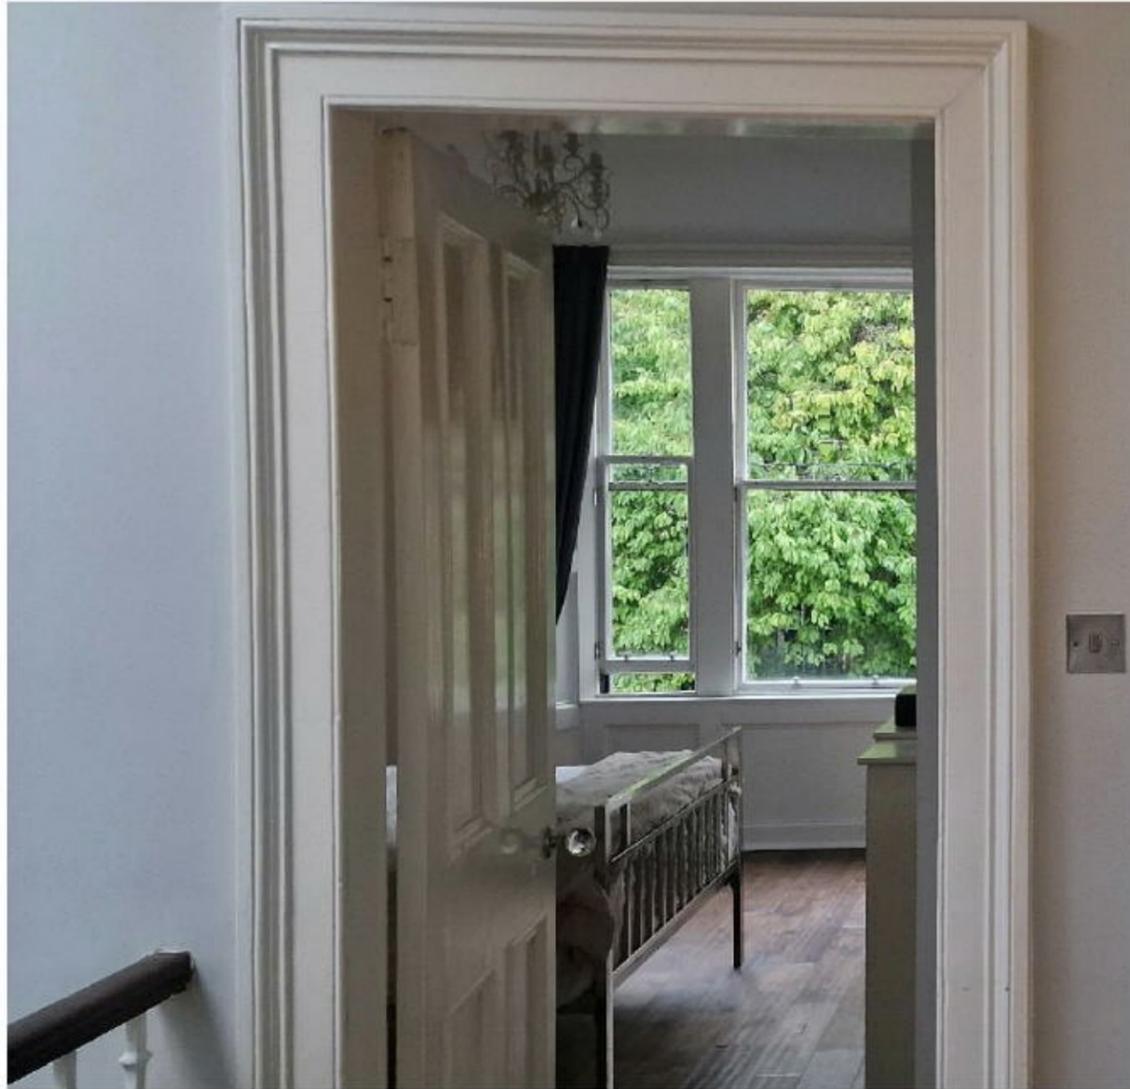
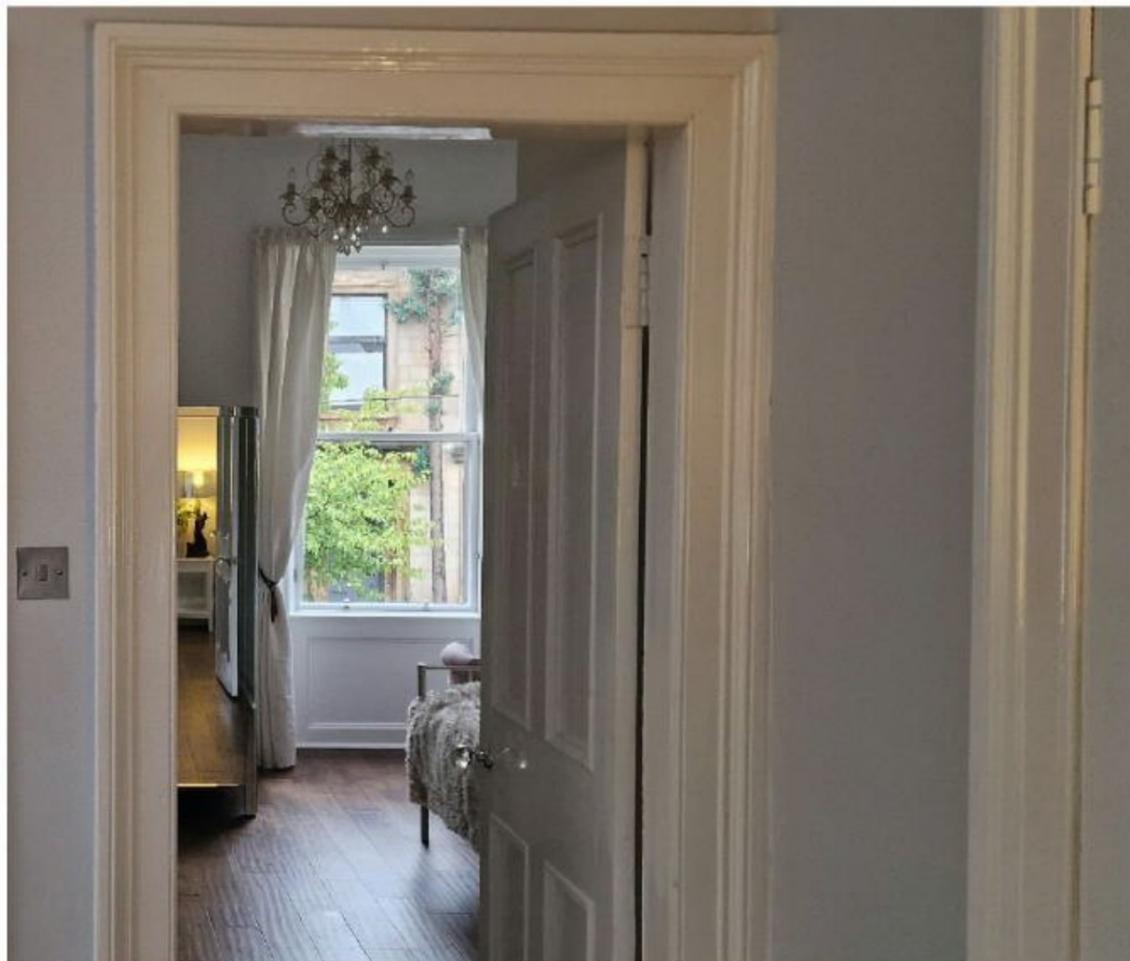
View from upper hall into front bedrooms

It is the removal of the redundant external window at ground floor level, and the alteration of the upper floor bathroom area, that the applicant wishes to apply for retrospective Planning Permission and Listed Building Consent for. The stepped party wall between the 2 front bedrooms will be reinstated to the

original location following feedback at the Planning Pre Application stage. This will prevent any projection in front of the windows to either of the bedrooms.

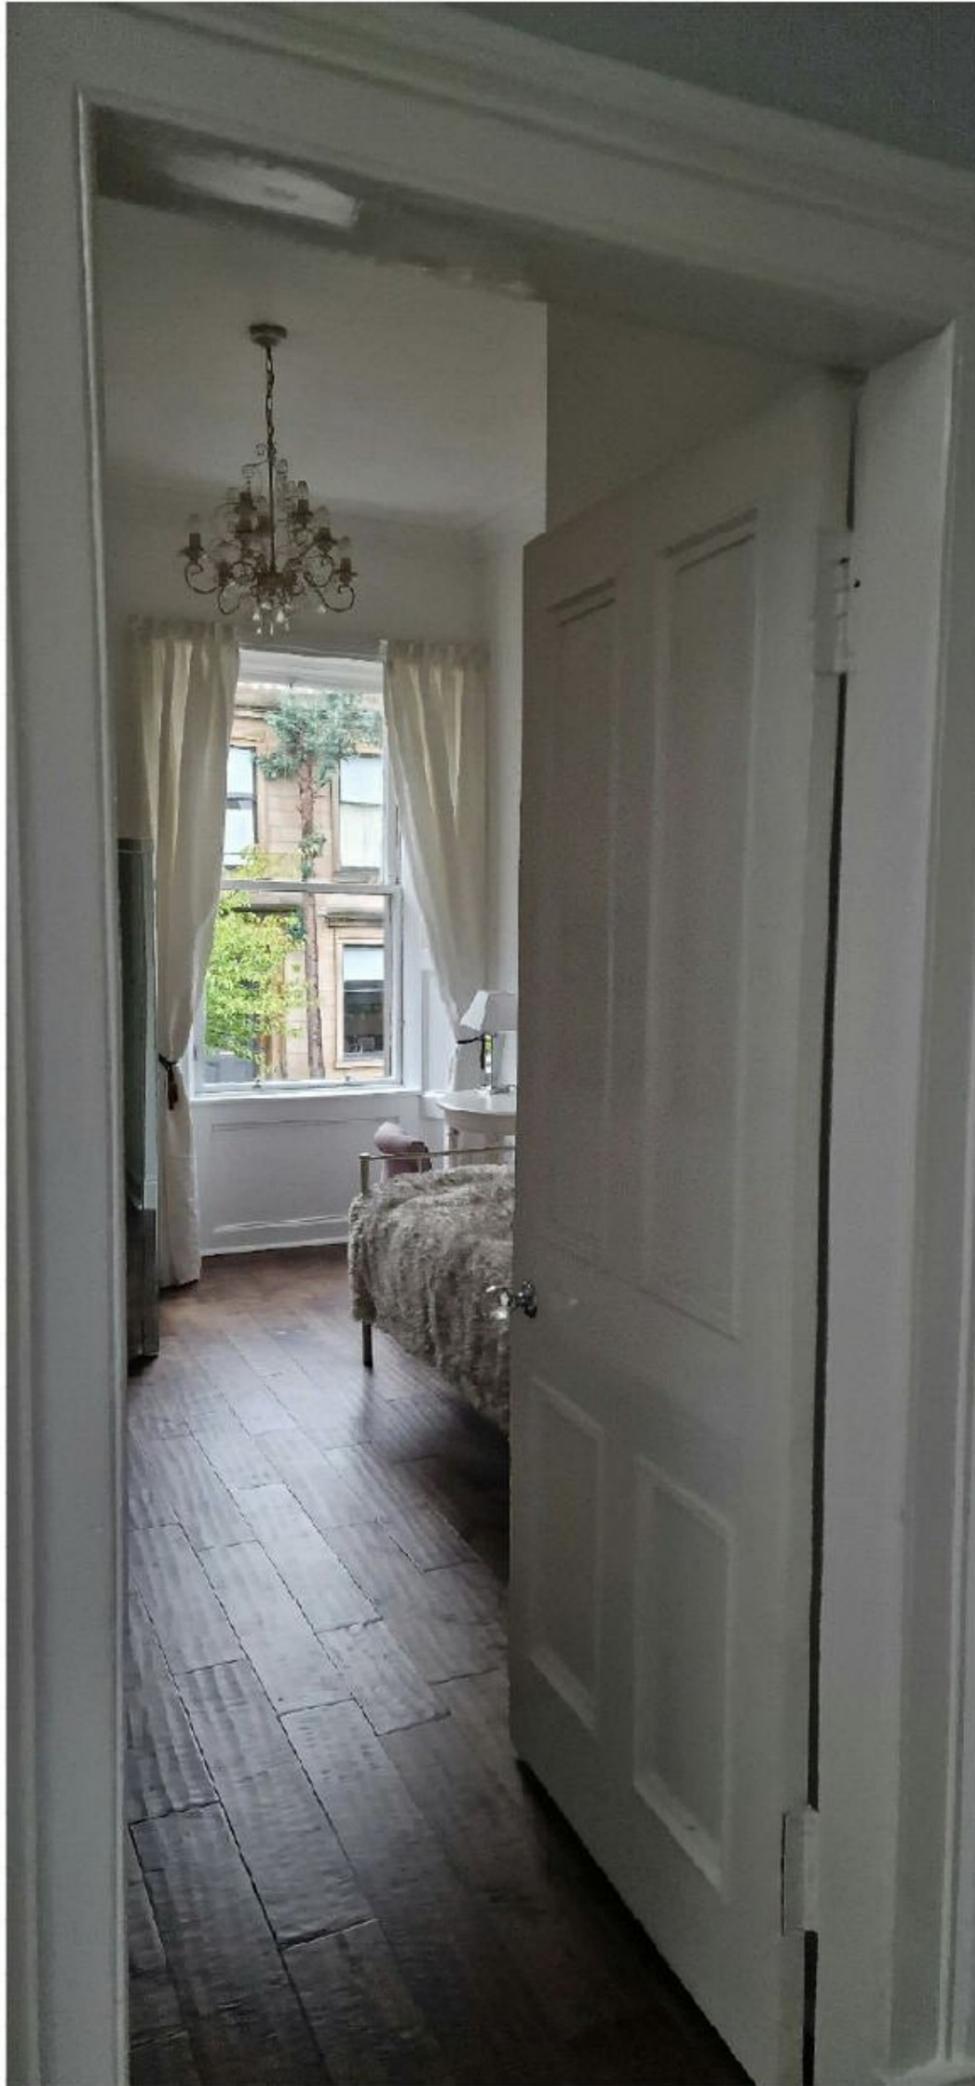
View into front bedroom with projection from shower room.

No cornicing existed in upper rooms. Client added coving to wall head.

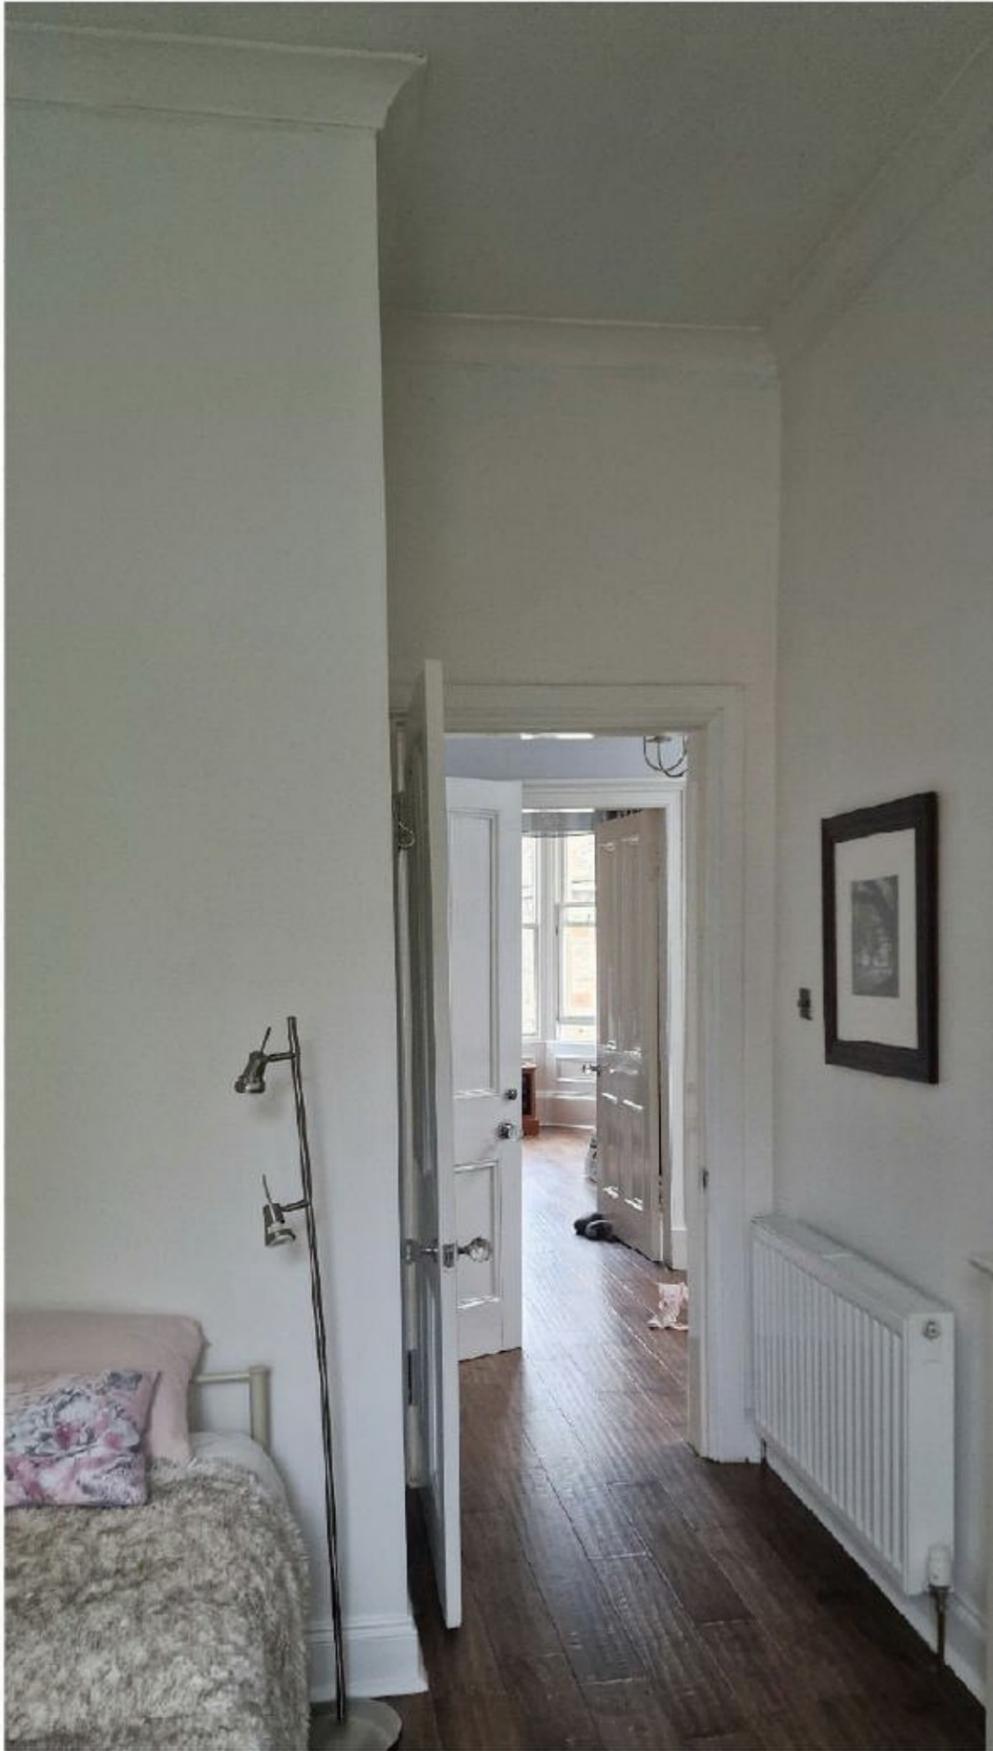
View from front bedroom to hall with projection from shower room.
No cornicing existed in upper rooms. Client added coving to wall head.
