0423 23 Bank Street, Hillhead, Glasgow

Supporting Document for Retrospective Planning and Listed Building

Consent Applications

November 2023

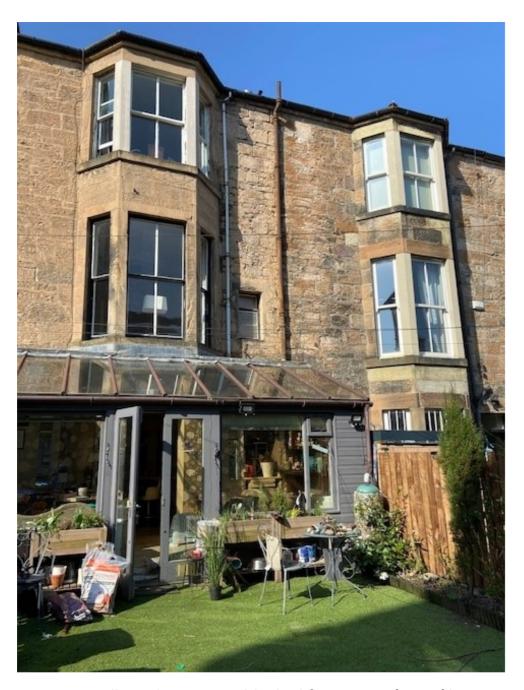
Existing small window to rear blocked from inner face of lounge.

In 2012 the current owner refurbished the property, remodelling the lower-ground floor and removing the bathroom from the ground floor. This allowed the reinstatement of the main lounge and cornicing to original proportions. The small window in the bathroom, which had been added to the rear elevation, was blocked from the inside. It has now been fully removed and natural stone inserted.

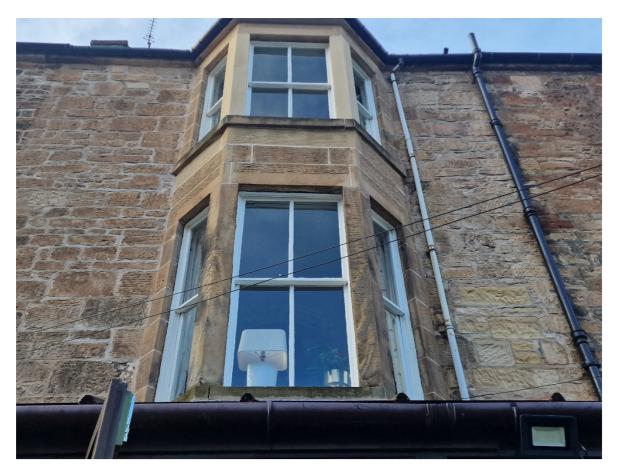
Window opening infilled with natural stone to match existing.

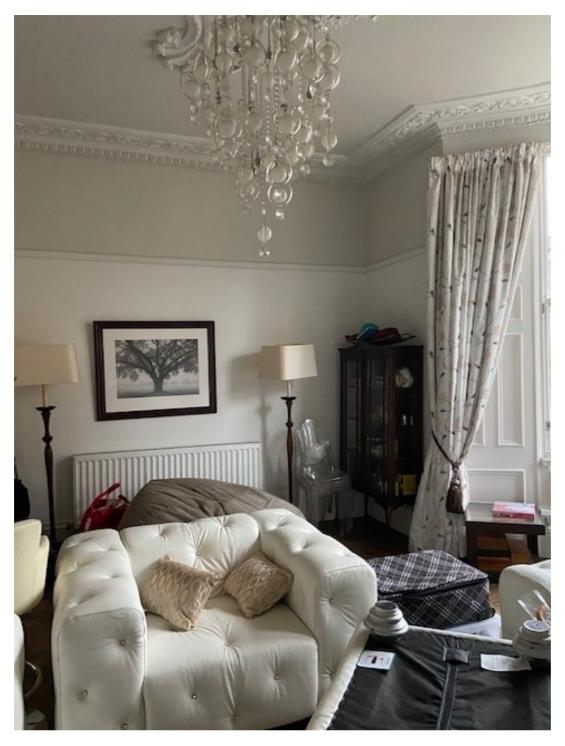
Existing lounge and cornicing reinstated following removal of bathroom conversion.

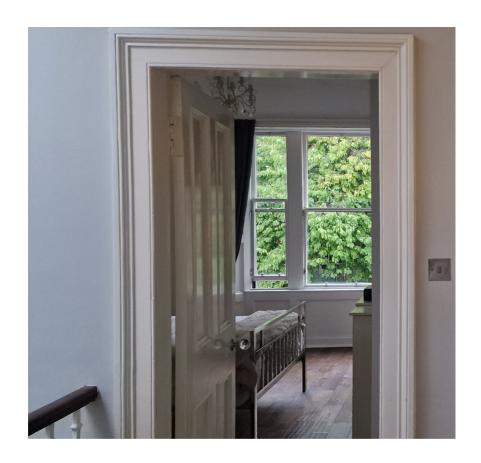
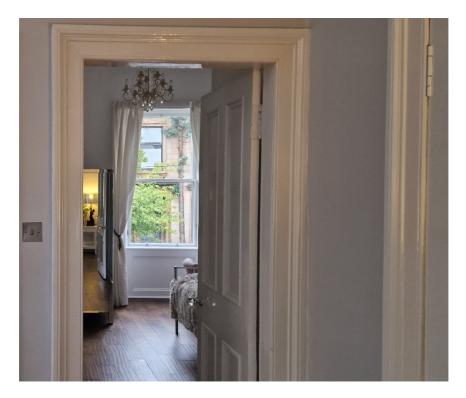
View from upper hall into front bedrooms

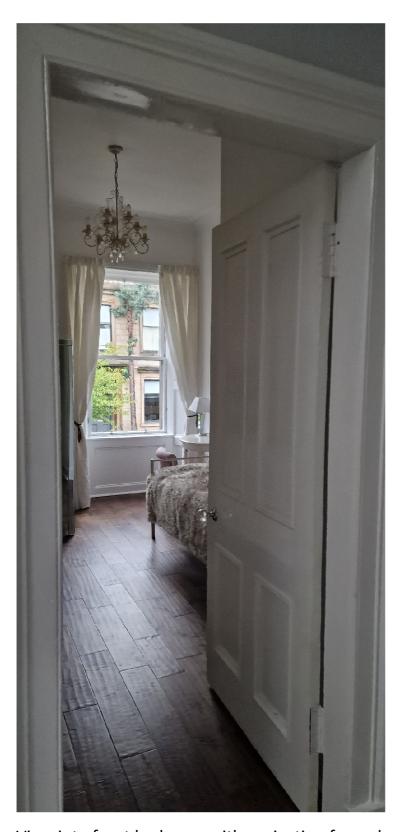
View into front bedroom with projection from shower room.

No cornicing existed in upper rooms. Client added coving to wall head.

It is the removal of the redundant external window at ground floor level, and the alteration of the upper floor bathroom area, that the applicant wishes to apply for retrospective Planning Permission and Listed Building Consent for. The stepped party wall between the 2 front bedrooms will be reinstated to the

original location following feedback at the Planning Pre Application stage. This will prevent any projection in front of the windows to either of the bedrooms.

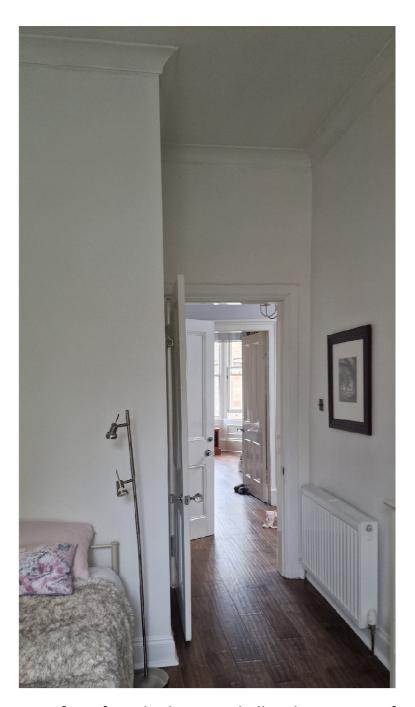
View from front bedroom to hall with projection from shower room.

No cornicing existed in upper rooms. Client added coving to wall head.
