# EAST LODGE, DYRHAM PARK – PROPOSED MASONRY REPAIRS TO SCREEN WALL

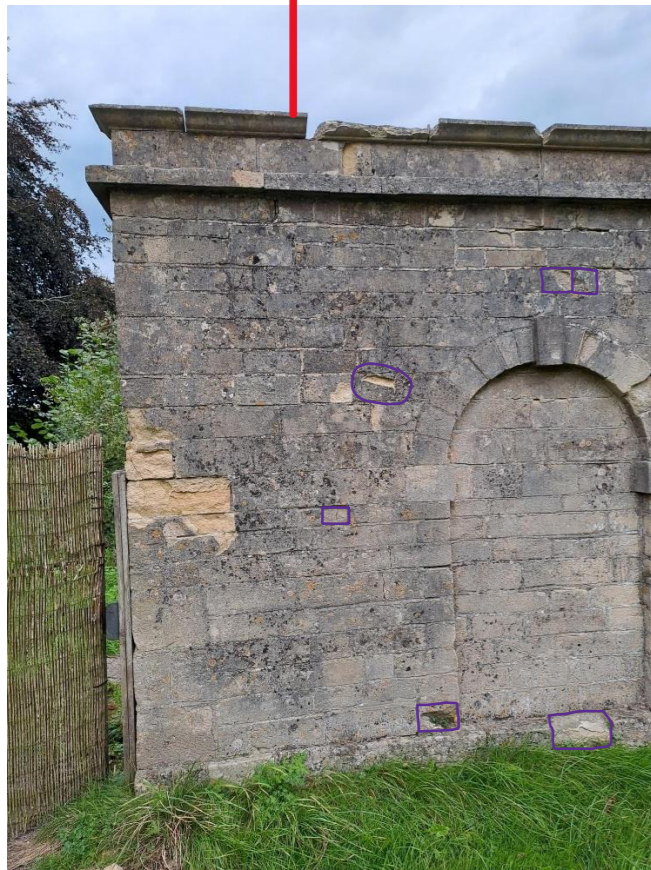
8 no. damaged Bath Stone coping stones to be renewed at top of wall and mortar repairs to upper surface of 2 no. to prevent water ponding.

All coping stones to be repointed in lime mortar

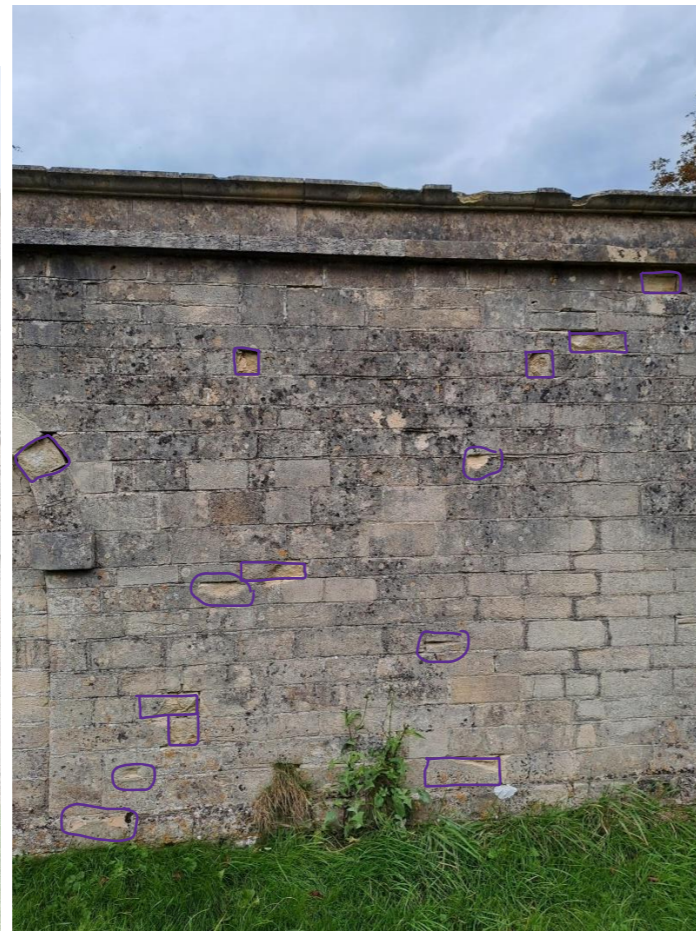
Piecing in to damaged Bath Stone quoins

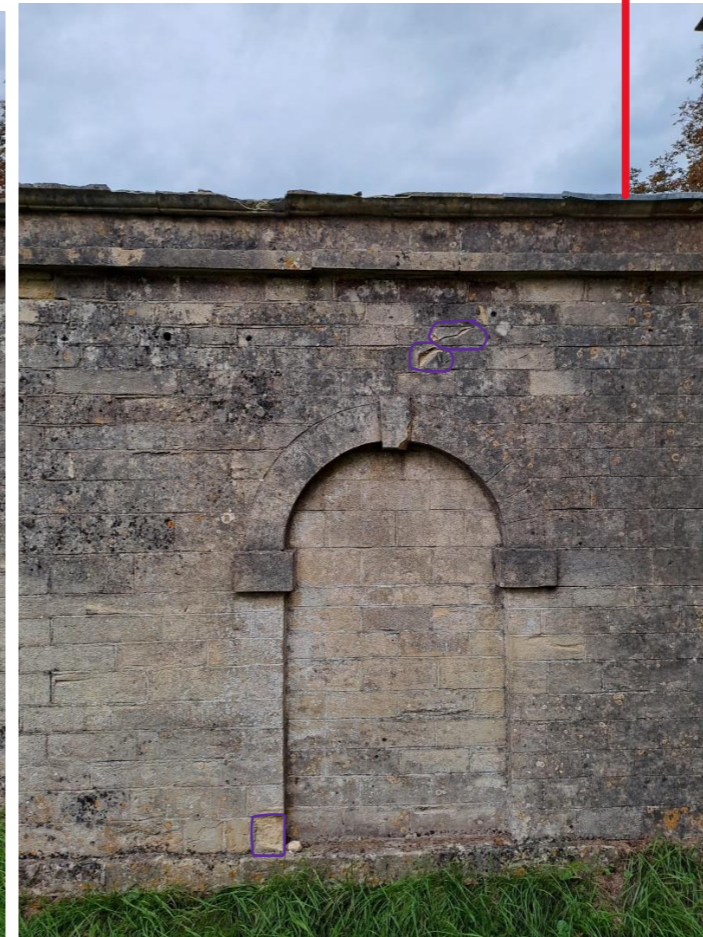
Piecing in to damaged Bath Stone parapet stone

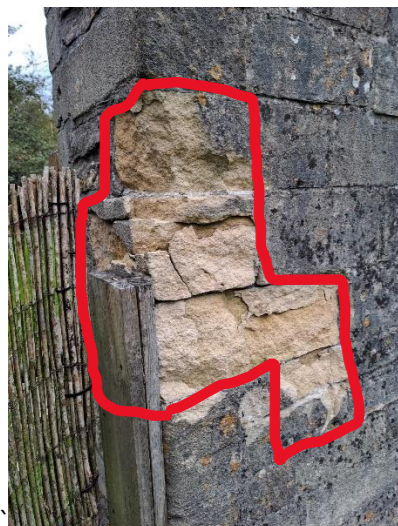
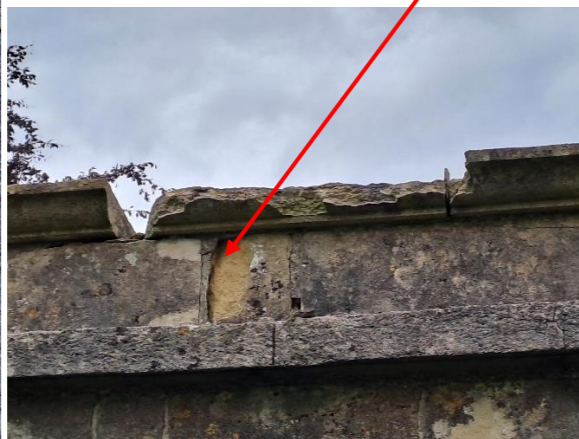
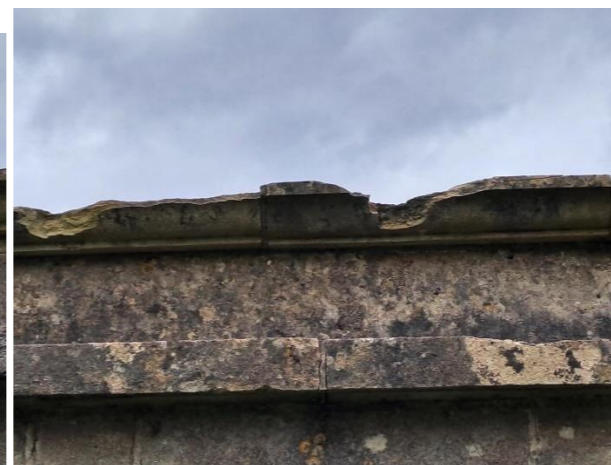
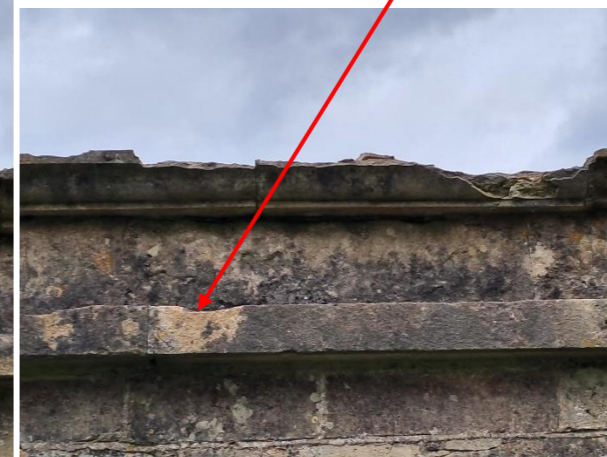
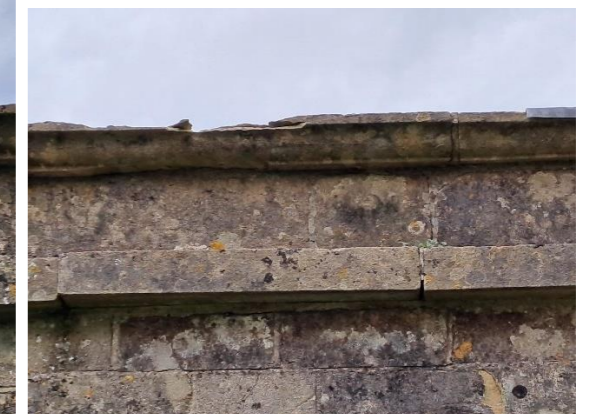
Mortar repairs to upper face of lower copings to prevent water ponding

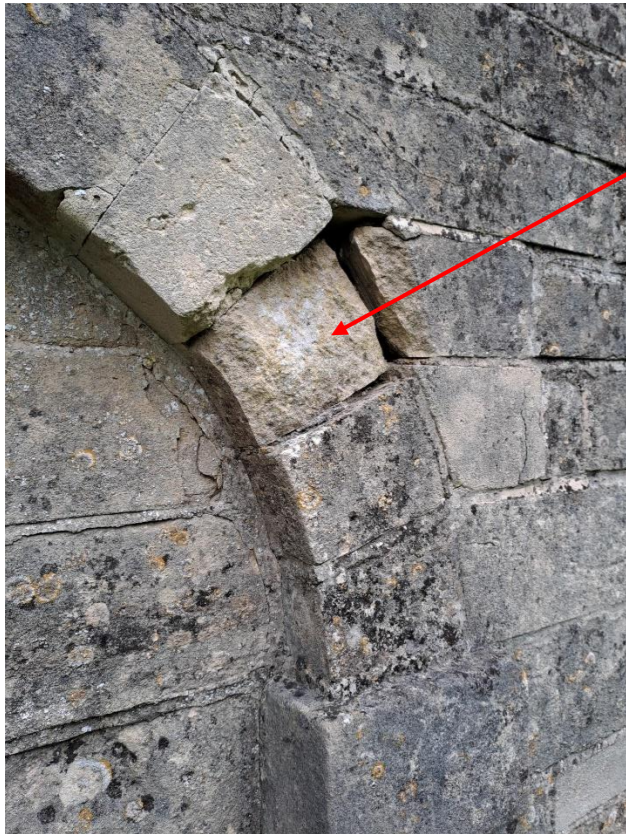
New Bath Stone to be pieced into voussoir and repointed in lime mortar

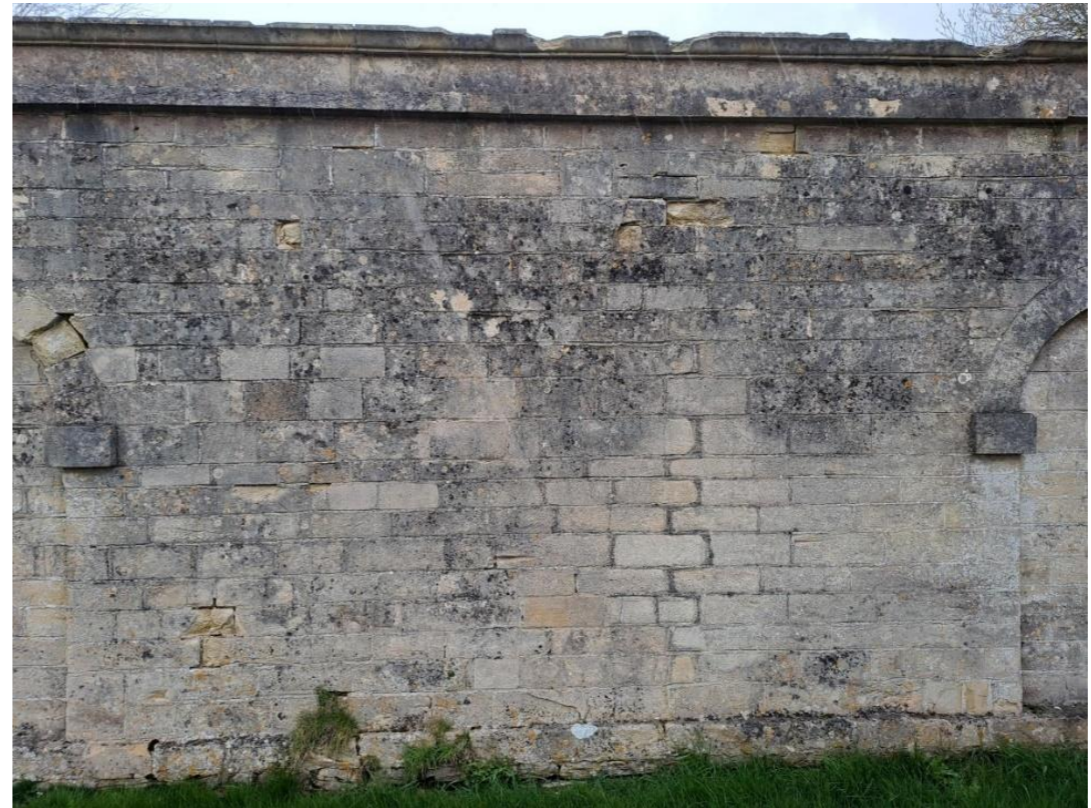
Piecing in new Bath Stone to replace 15 no. damaged facing stones (purple squares shown on pg 1 above) and 8 no. lime mortar repairs (purple circles shown on pg 1 above) across face of wall to prevent water ponding.

Selective repointing in lime mortar where missing/loose especially at base of wall

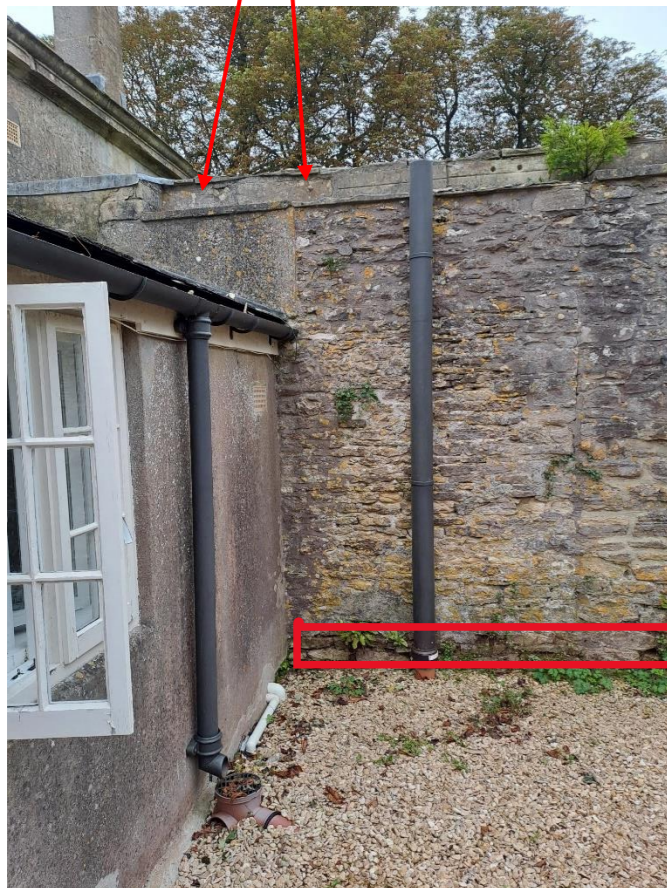
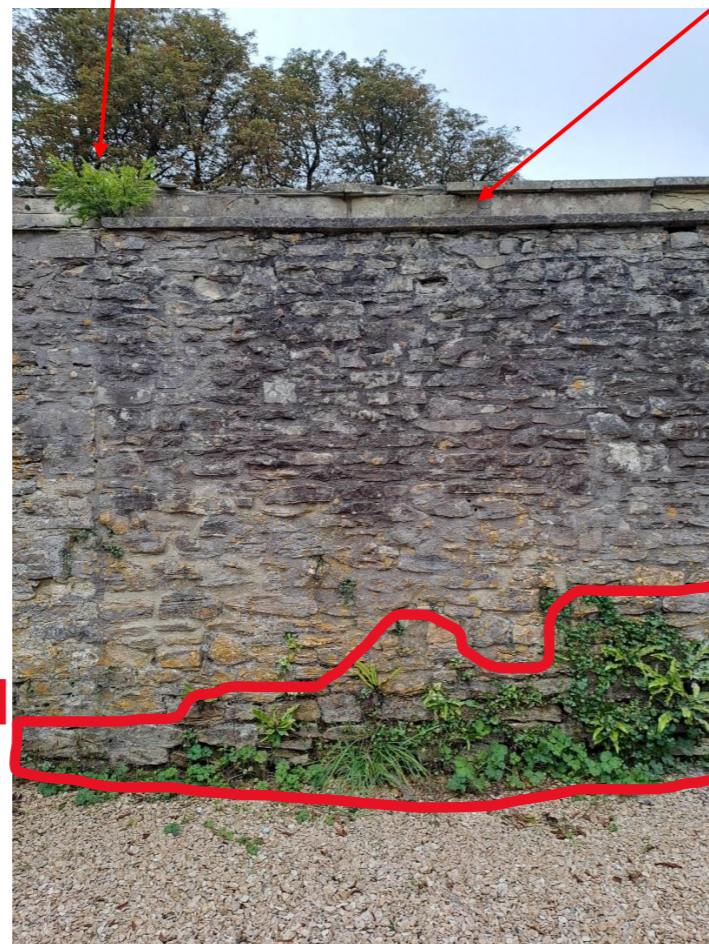
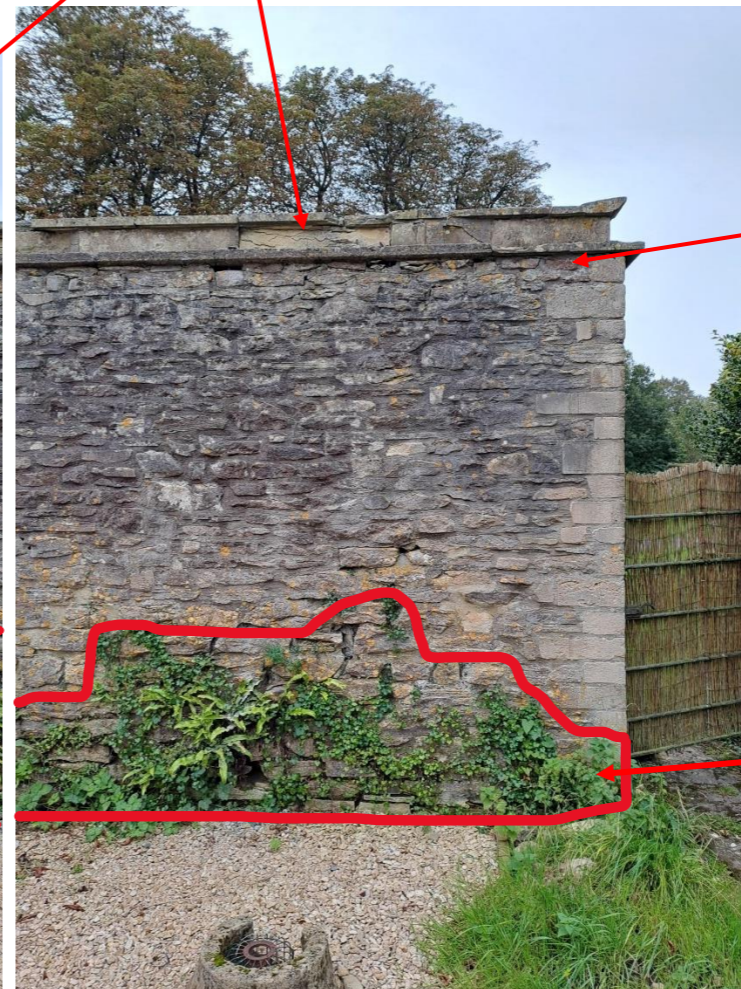
Damaged render to parapet stones to be renewed in 2-coat lime render

Tree sapling growing in wall head to be removed

Damaged Bath Stone parapet stones to be renewed

Lower coping bed joints to be repointed in lime mortar

Vegetation in wall to be removed and wall repointed in lime mortar where mortar missing or loose

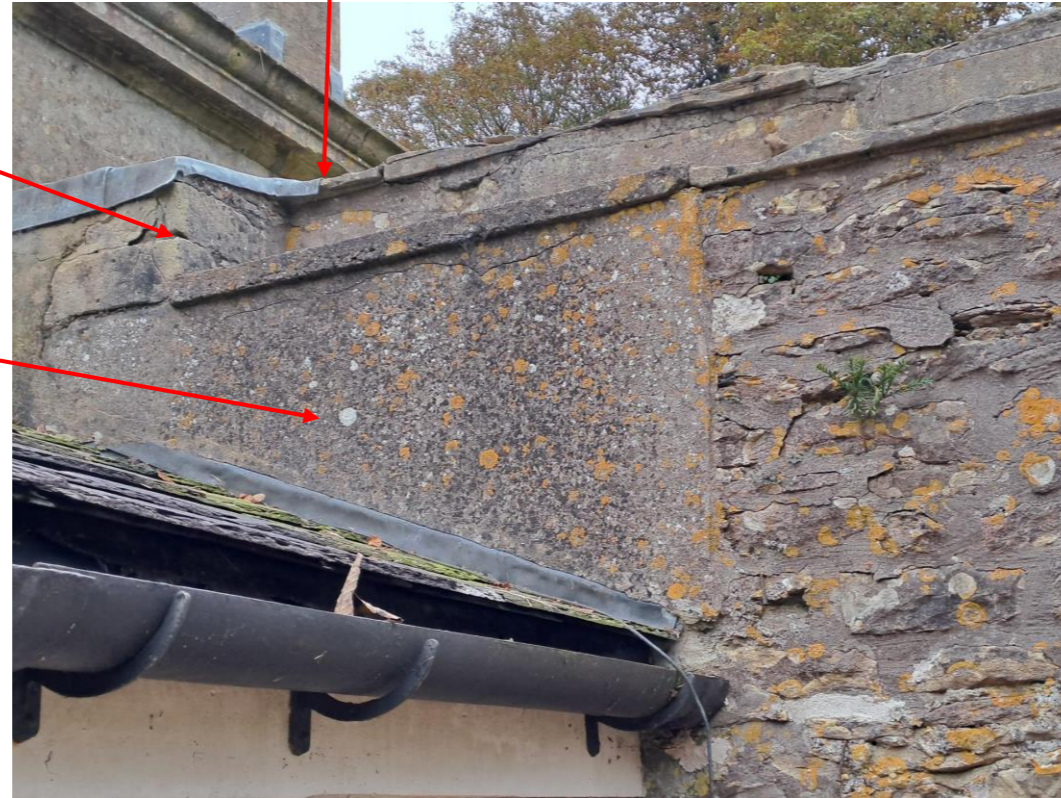
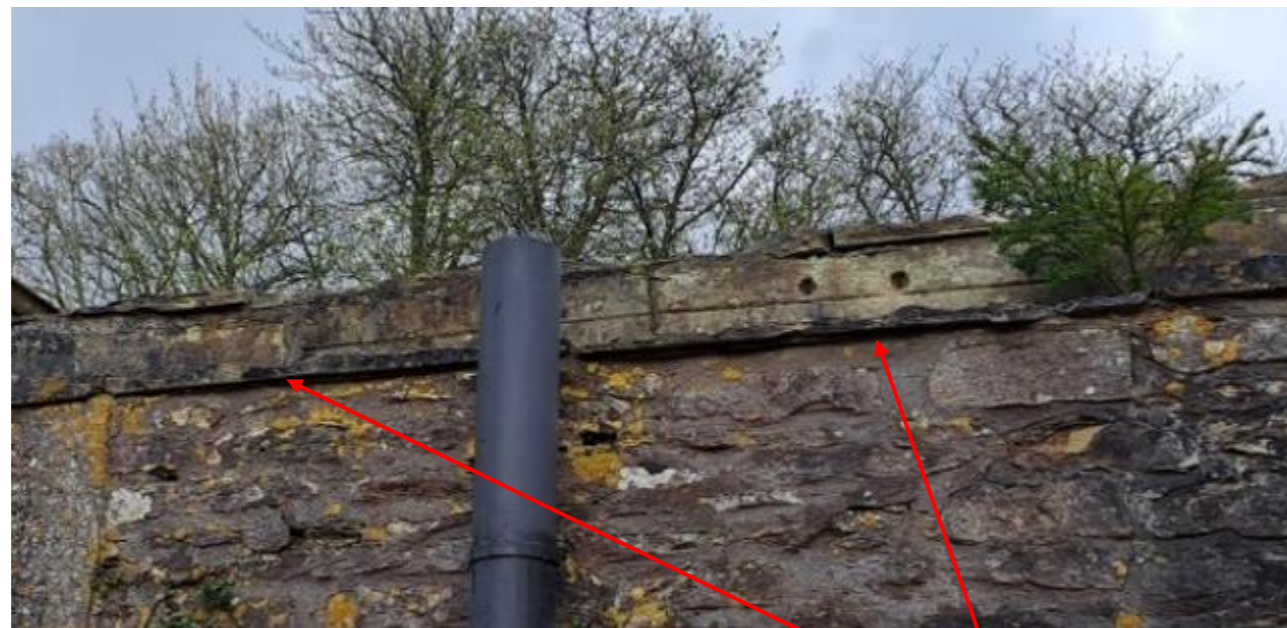
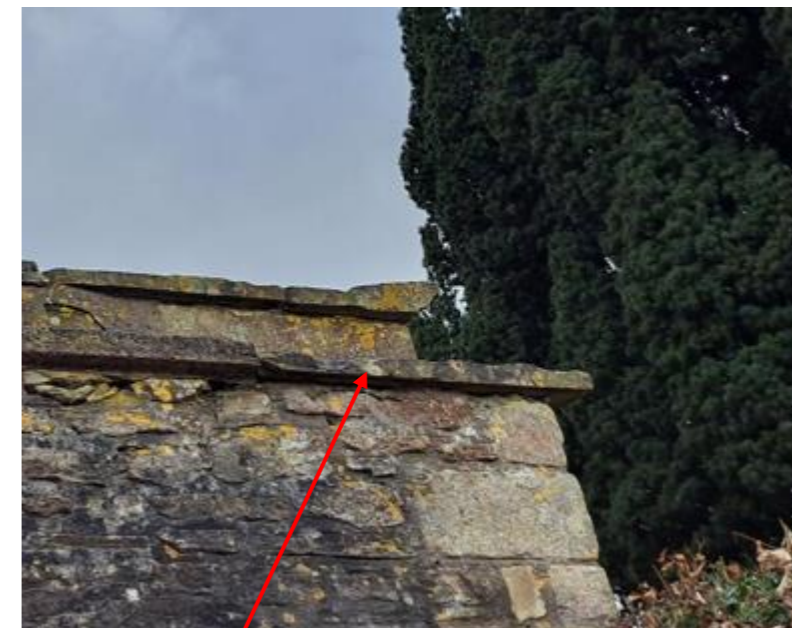
Small section of damaged Bath Stone coping below lead to be renewed

Masonry below lead weathering to be repointed in lime mortar where existing pointing loose/missing

Hollow and cracked render to be removed and renewed in 2-coat lime render

Lower Bath Stone coping edges to be cut back and renewed
