PROJECT 16 College St,  
St Andrews  
KY16 9AA

DRAWING Before and After Images

SCALE	NTS	JOB No.	4145
DATE	SEPT 23	NUMBER	4145-0113
DRAWN	FC

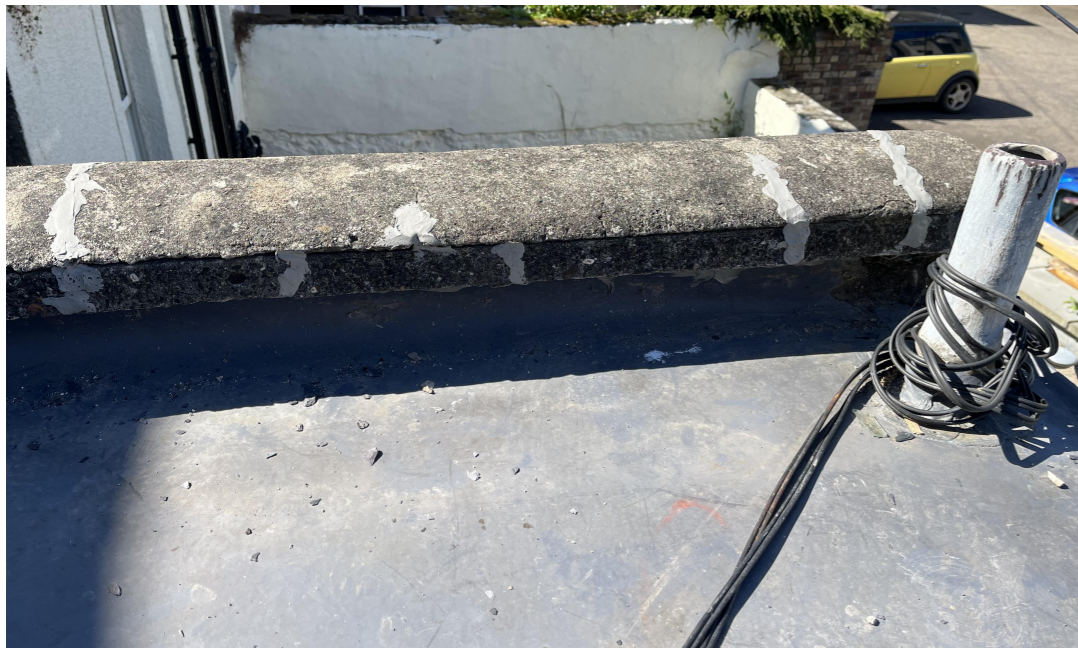
**Before**  
Single ply roof membrane, established as source of the leak, not ragged into rendered wall

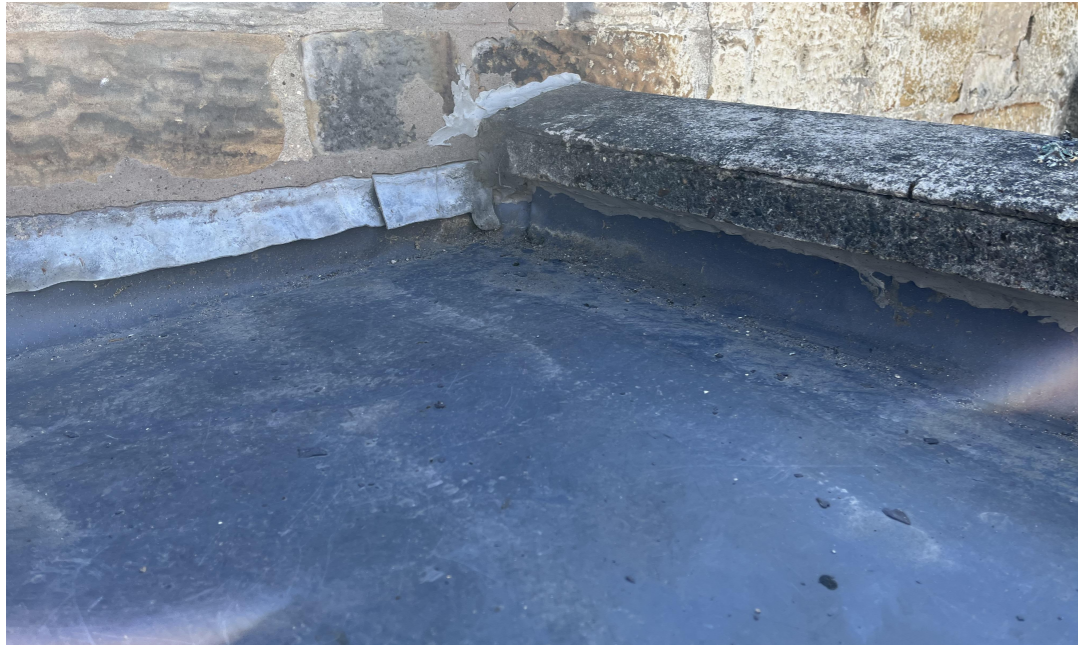
**Before**  
Single ply roof membrane, established as source of the leak, not ragged into rendered wall

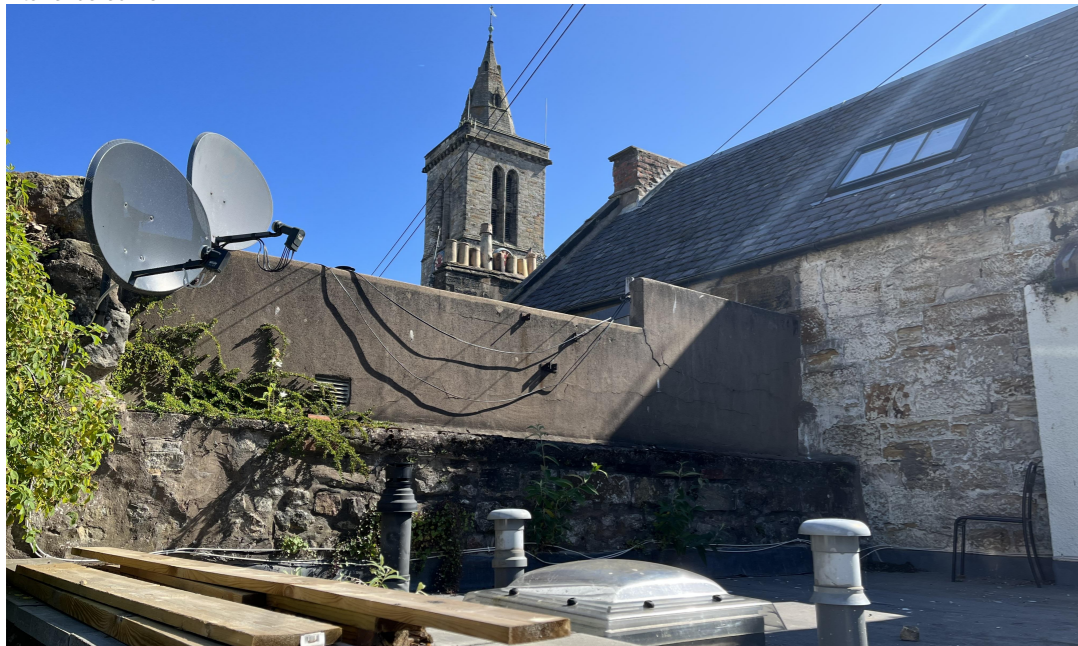
**Before**  
Render finish to wall showing cracking
