FLAT 3-1, 104 HILL STREET GLASGOW

REAR ELEVATION AS PROPOSED

Drg. No. P002

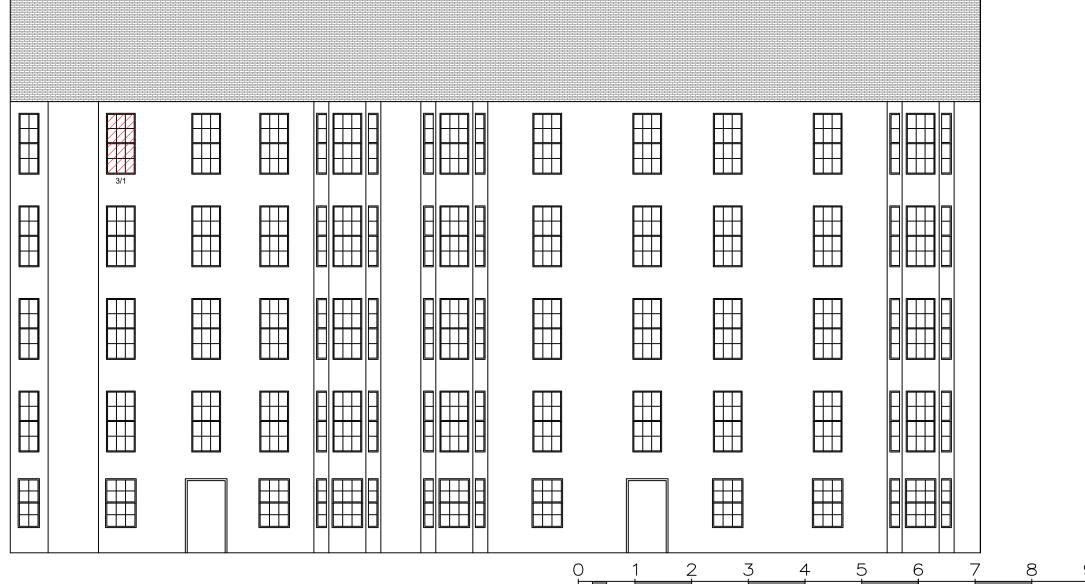
Image of typical existing window

Existing window to be replaced by new double glazed window to match existing/original on a like-by-like basis including details such as horns, astragals etc.

Existing window to be repaired, with decorative glass to be preserved where possible.

Existing window to be replaced by new double glazed U-PVC window
