BARN AT MONTROSE, HENTON, WELLS

PROPOSED ANNEXE  
1:50 ELEVATIONS & SECTIONS

0812

122A

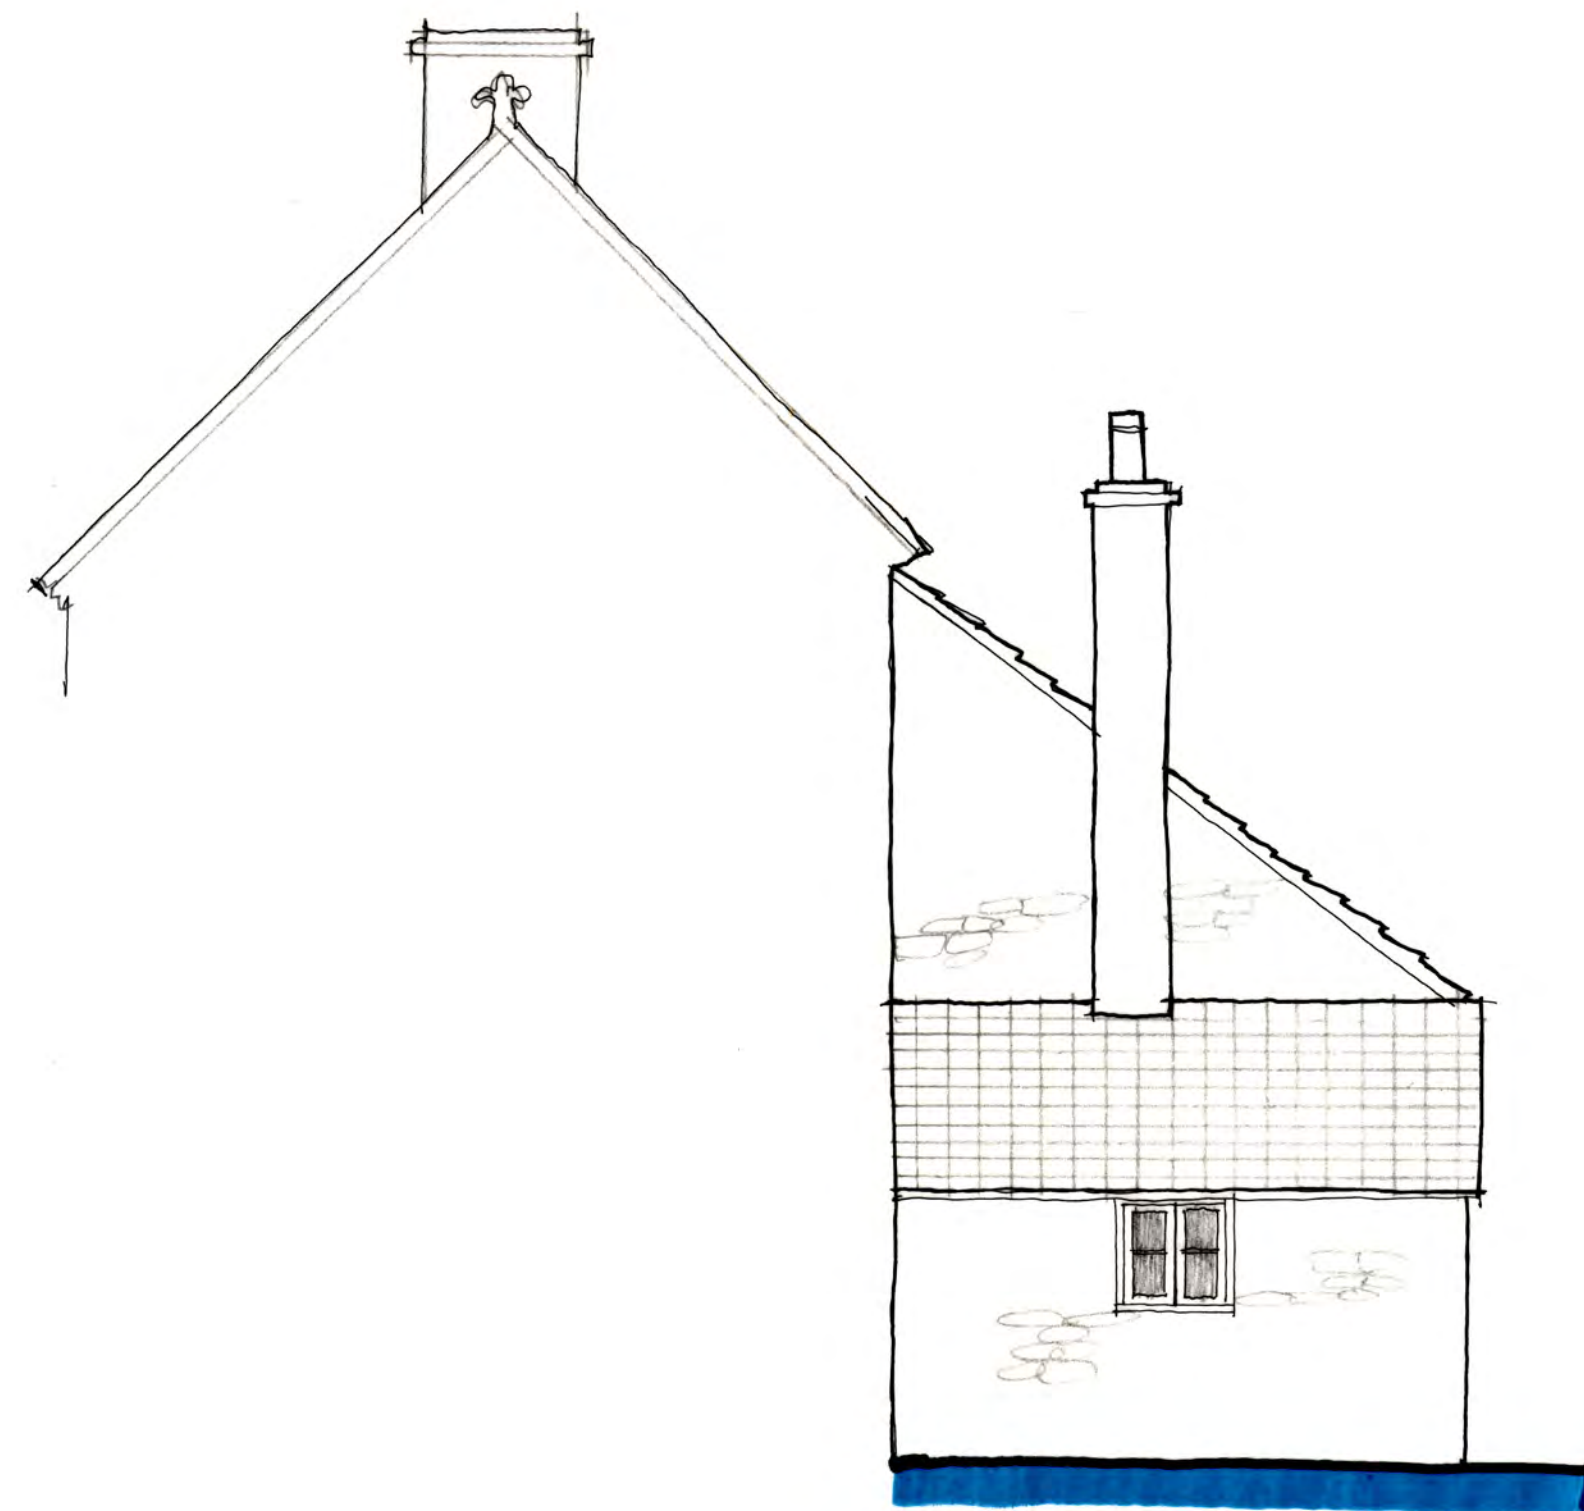
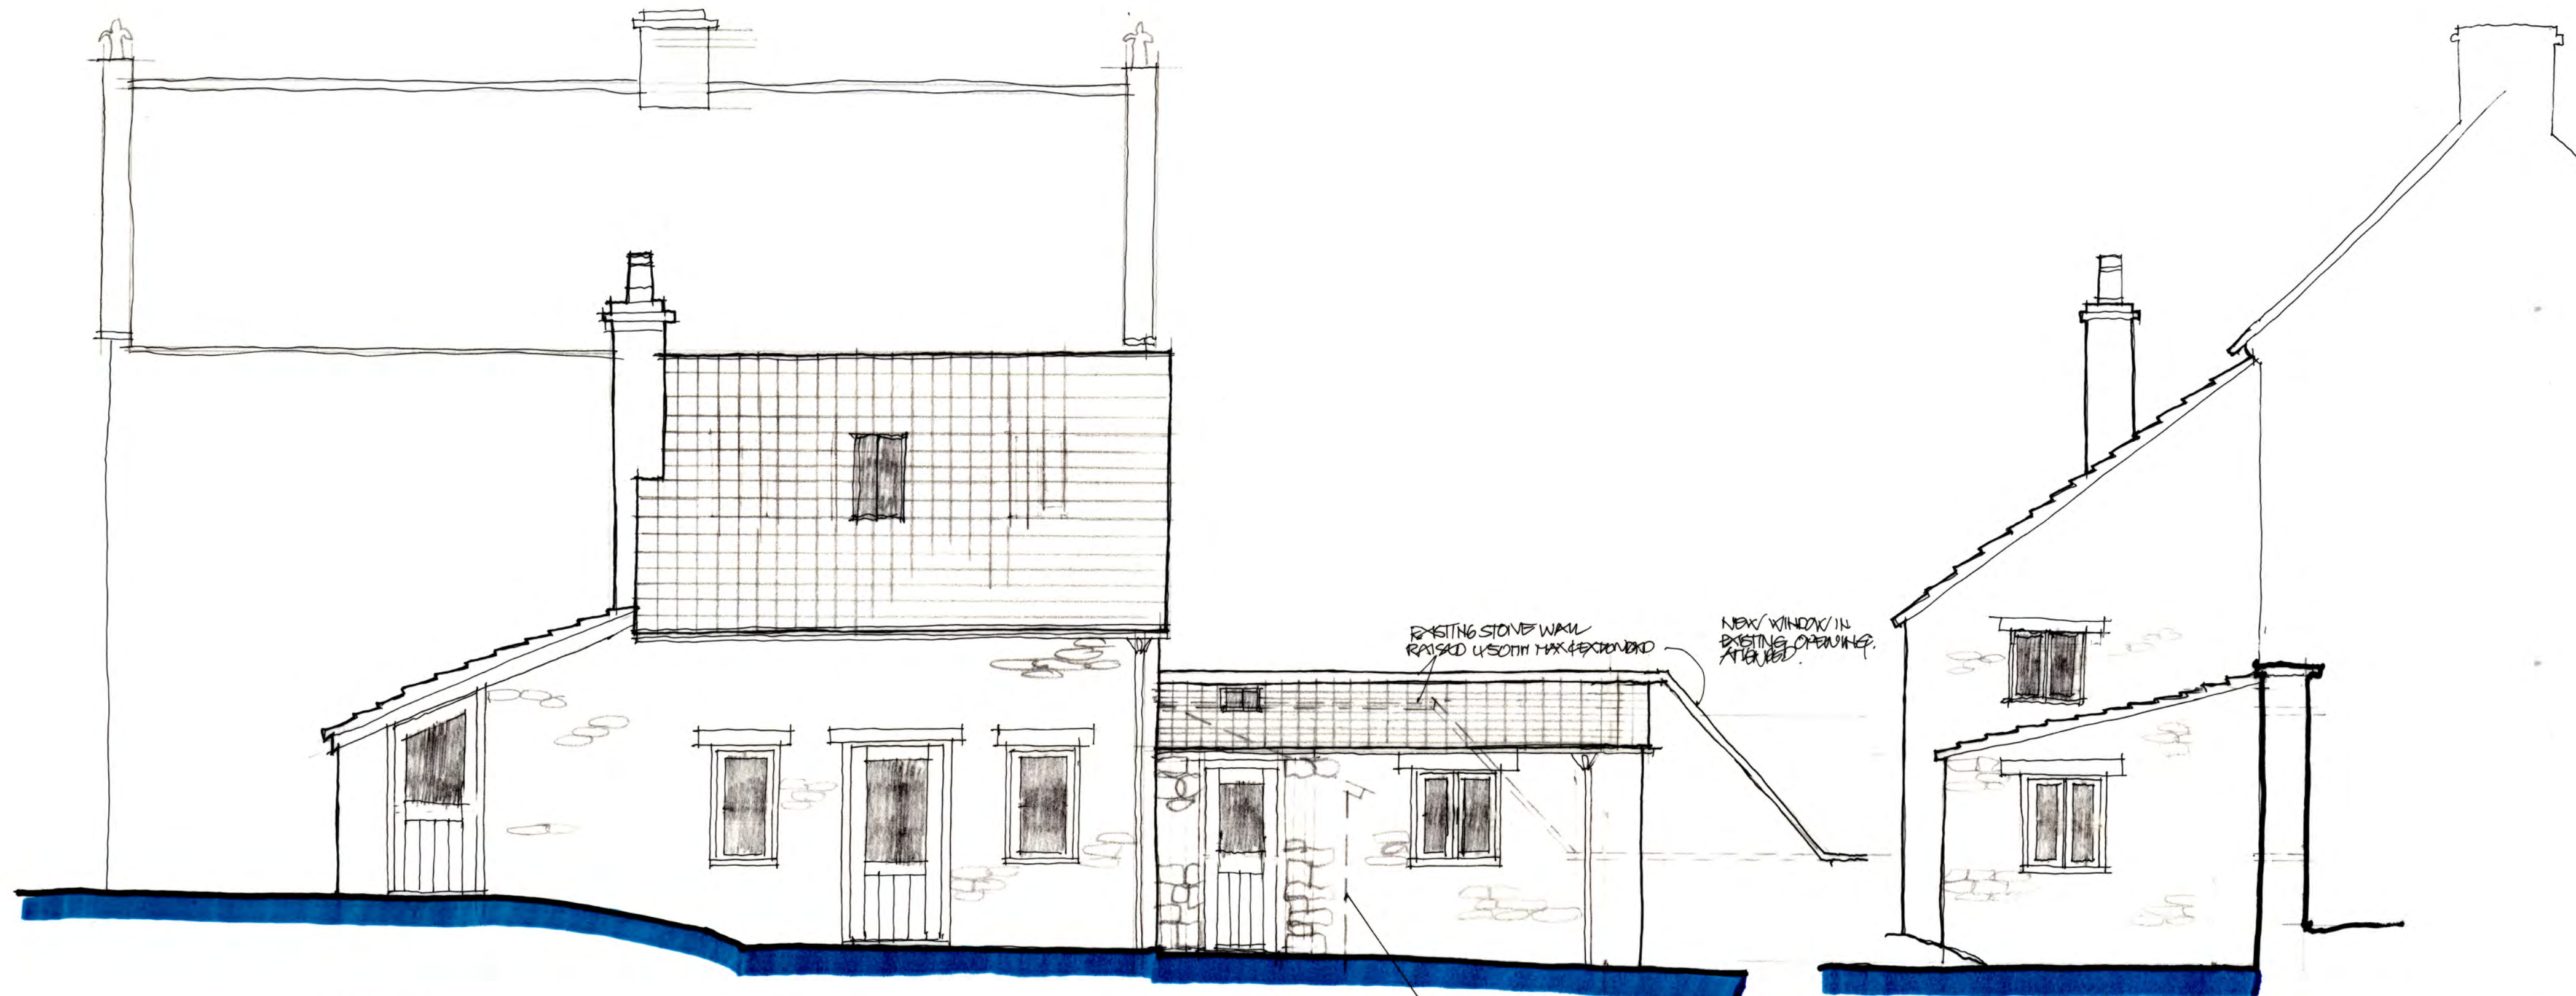
ELEVATIONS 1:50 SOUTH

NEW WINDOW IN EXISTING OPENING

4 NO CONSERVATION REPROUGHTS  
BLIND WINDOWS VANDERED  
NEW JOINERY IN ALL OPENINGS

LINE OF LEAD TO  
TAKEN DOWN

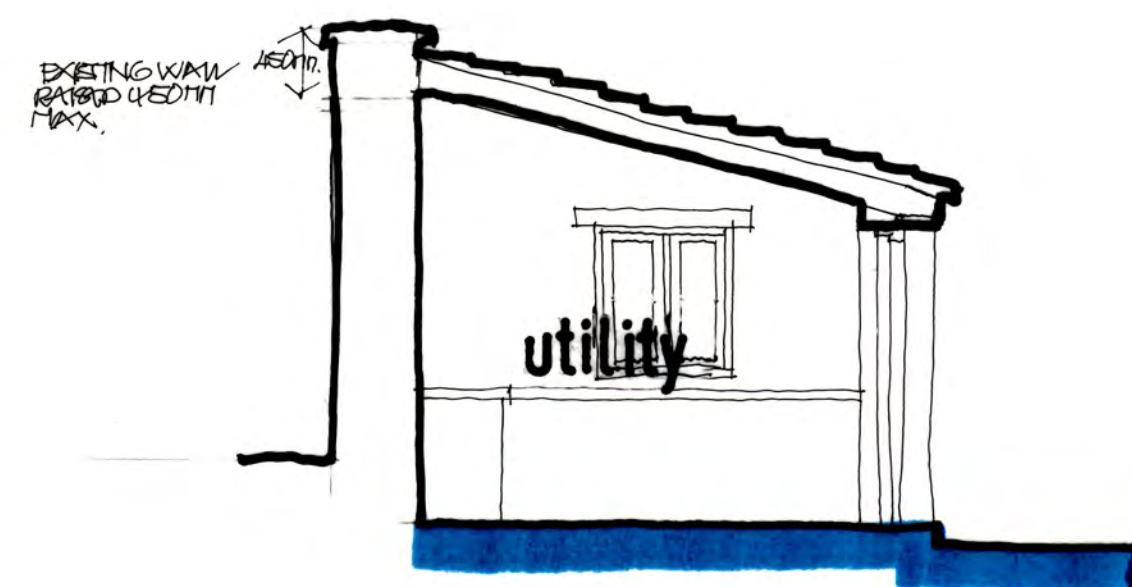
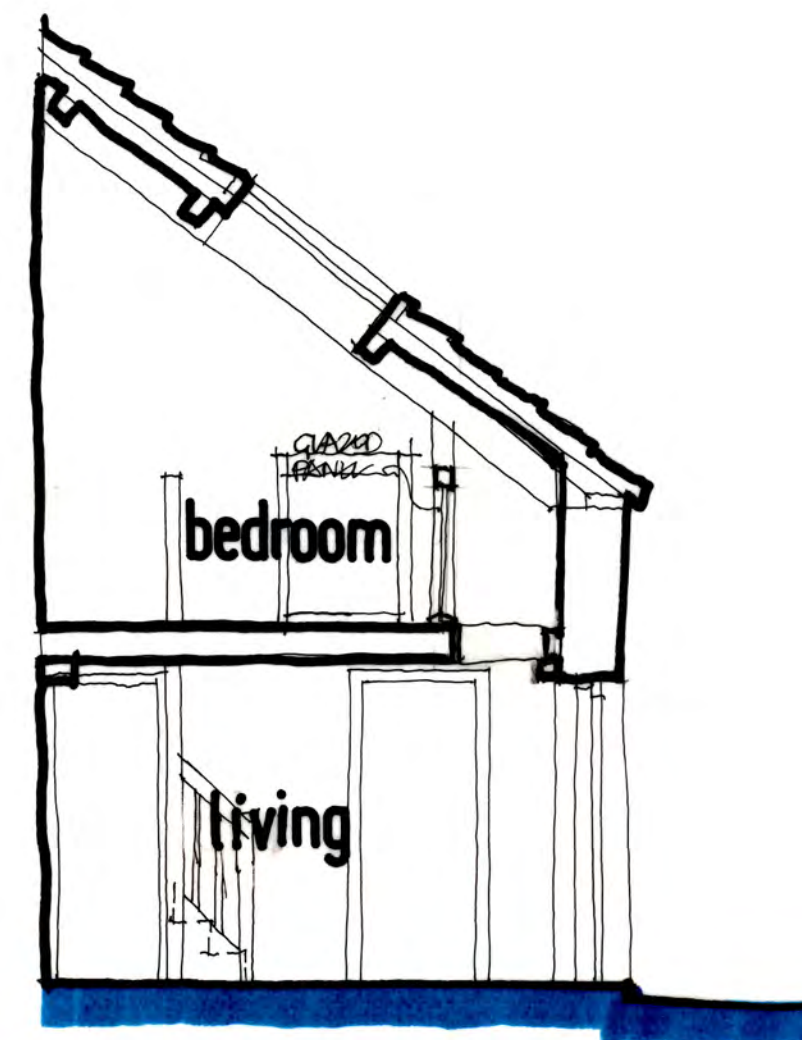
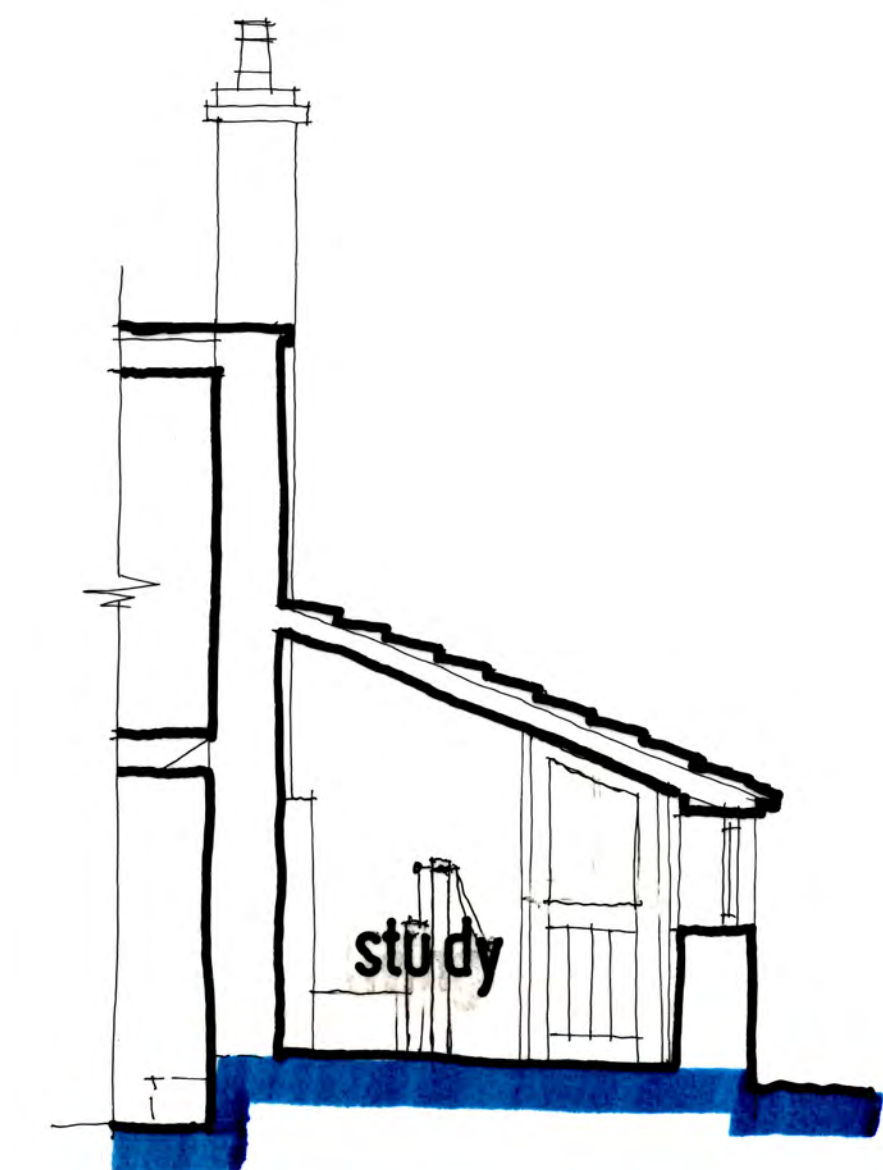
SECTIONS 1:50 AA<sub>1</sub>

WALLS: RANDOM WAS RUBBER TO MATCH EXISTING  
ROOF: CLAY ROMAN TILES SALVAGED/RECYCLED  
JOINERY: TIMBER STAINED GREY  
R.V. GOODS: CAST IRON ALUMINIUM  
CHIMNEY: EXISTING BRICK CHIMNEY PRESERVED WITH BRICKS TO MATCH ORIGINAL WHERE REQUIRED.
