er Second Floor Plan

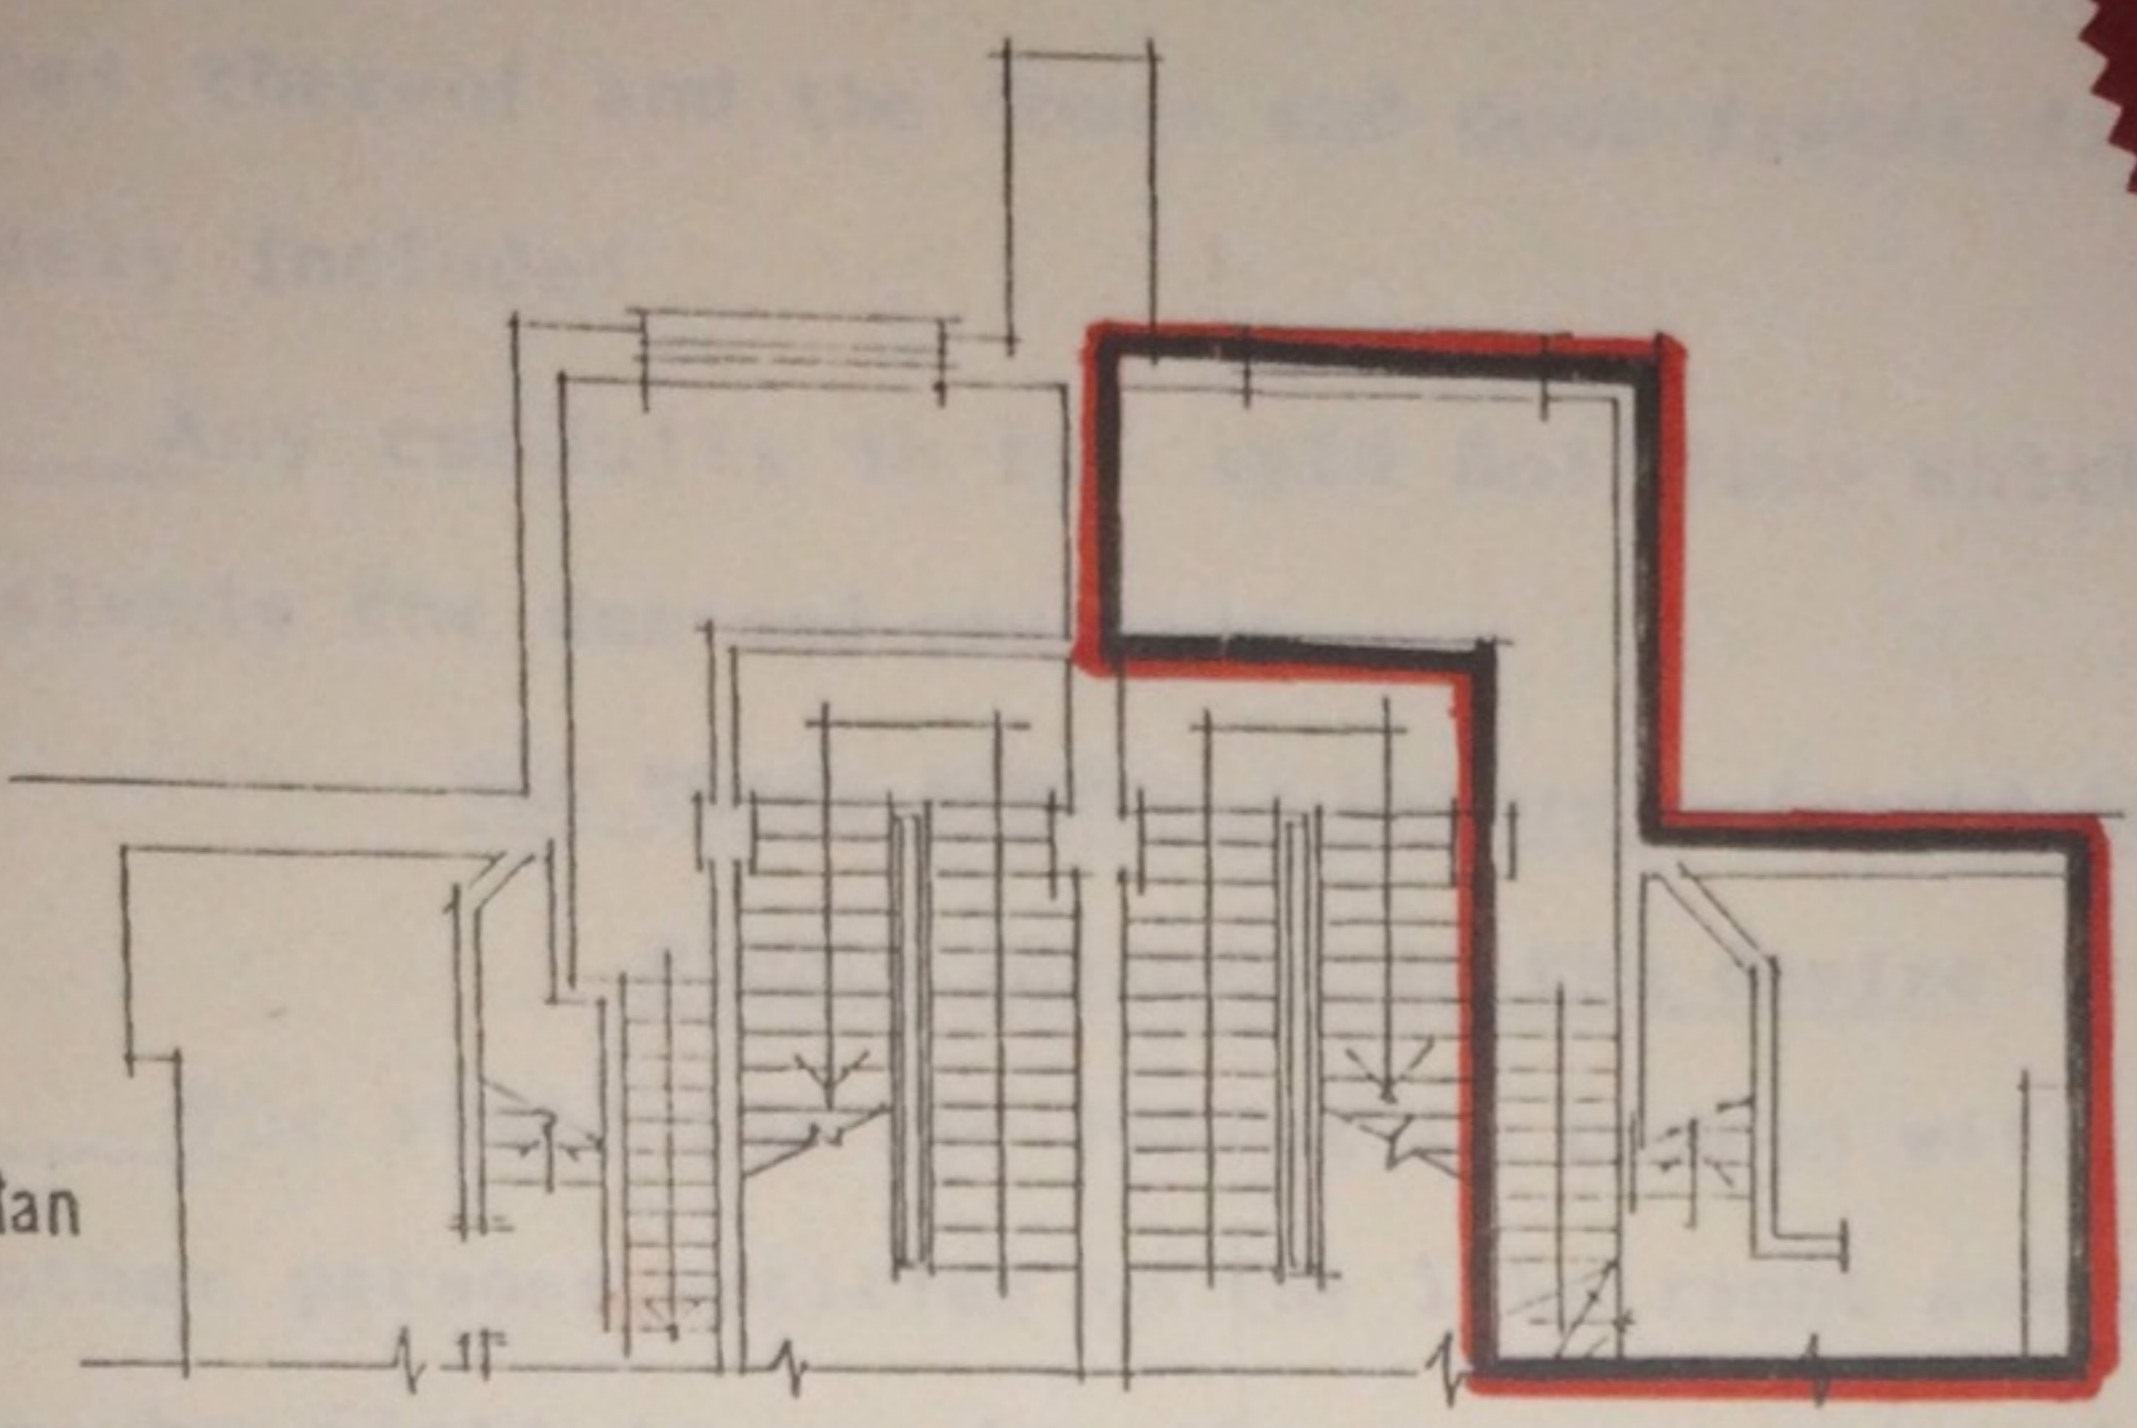
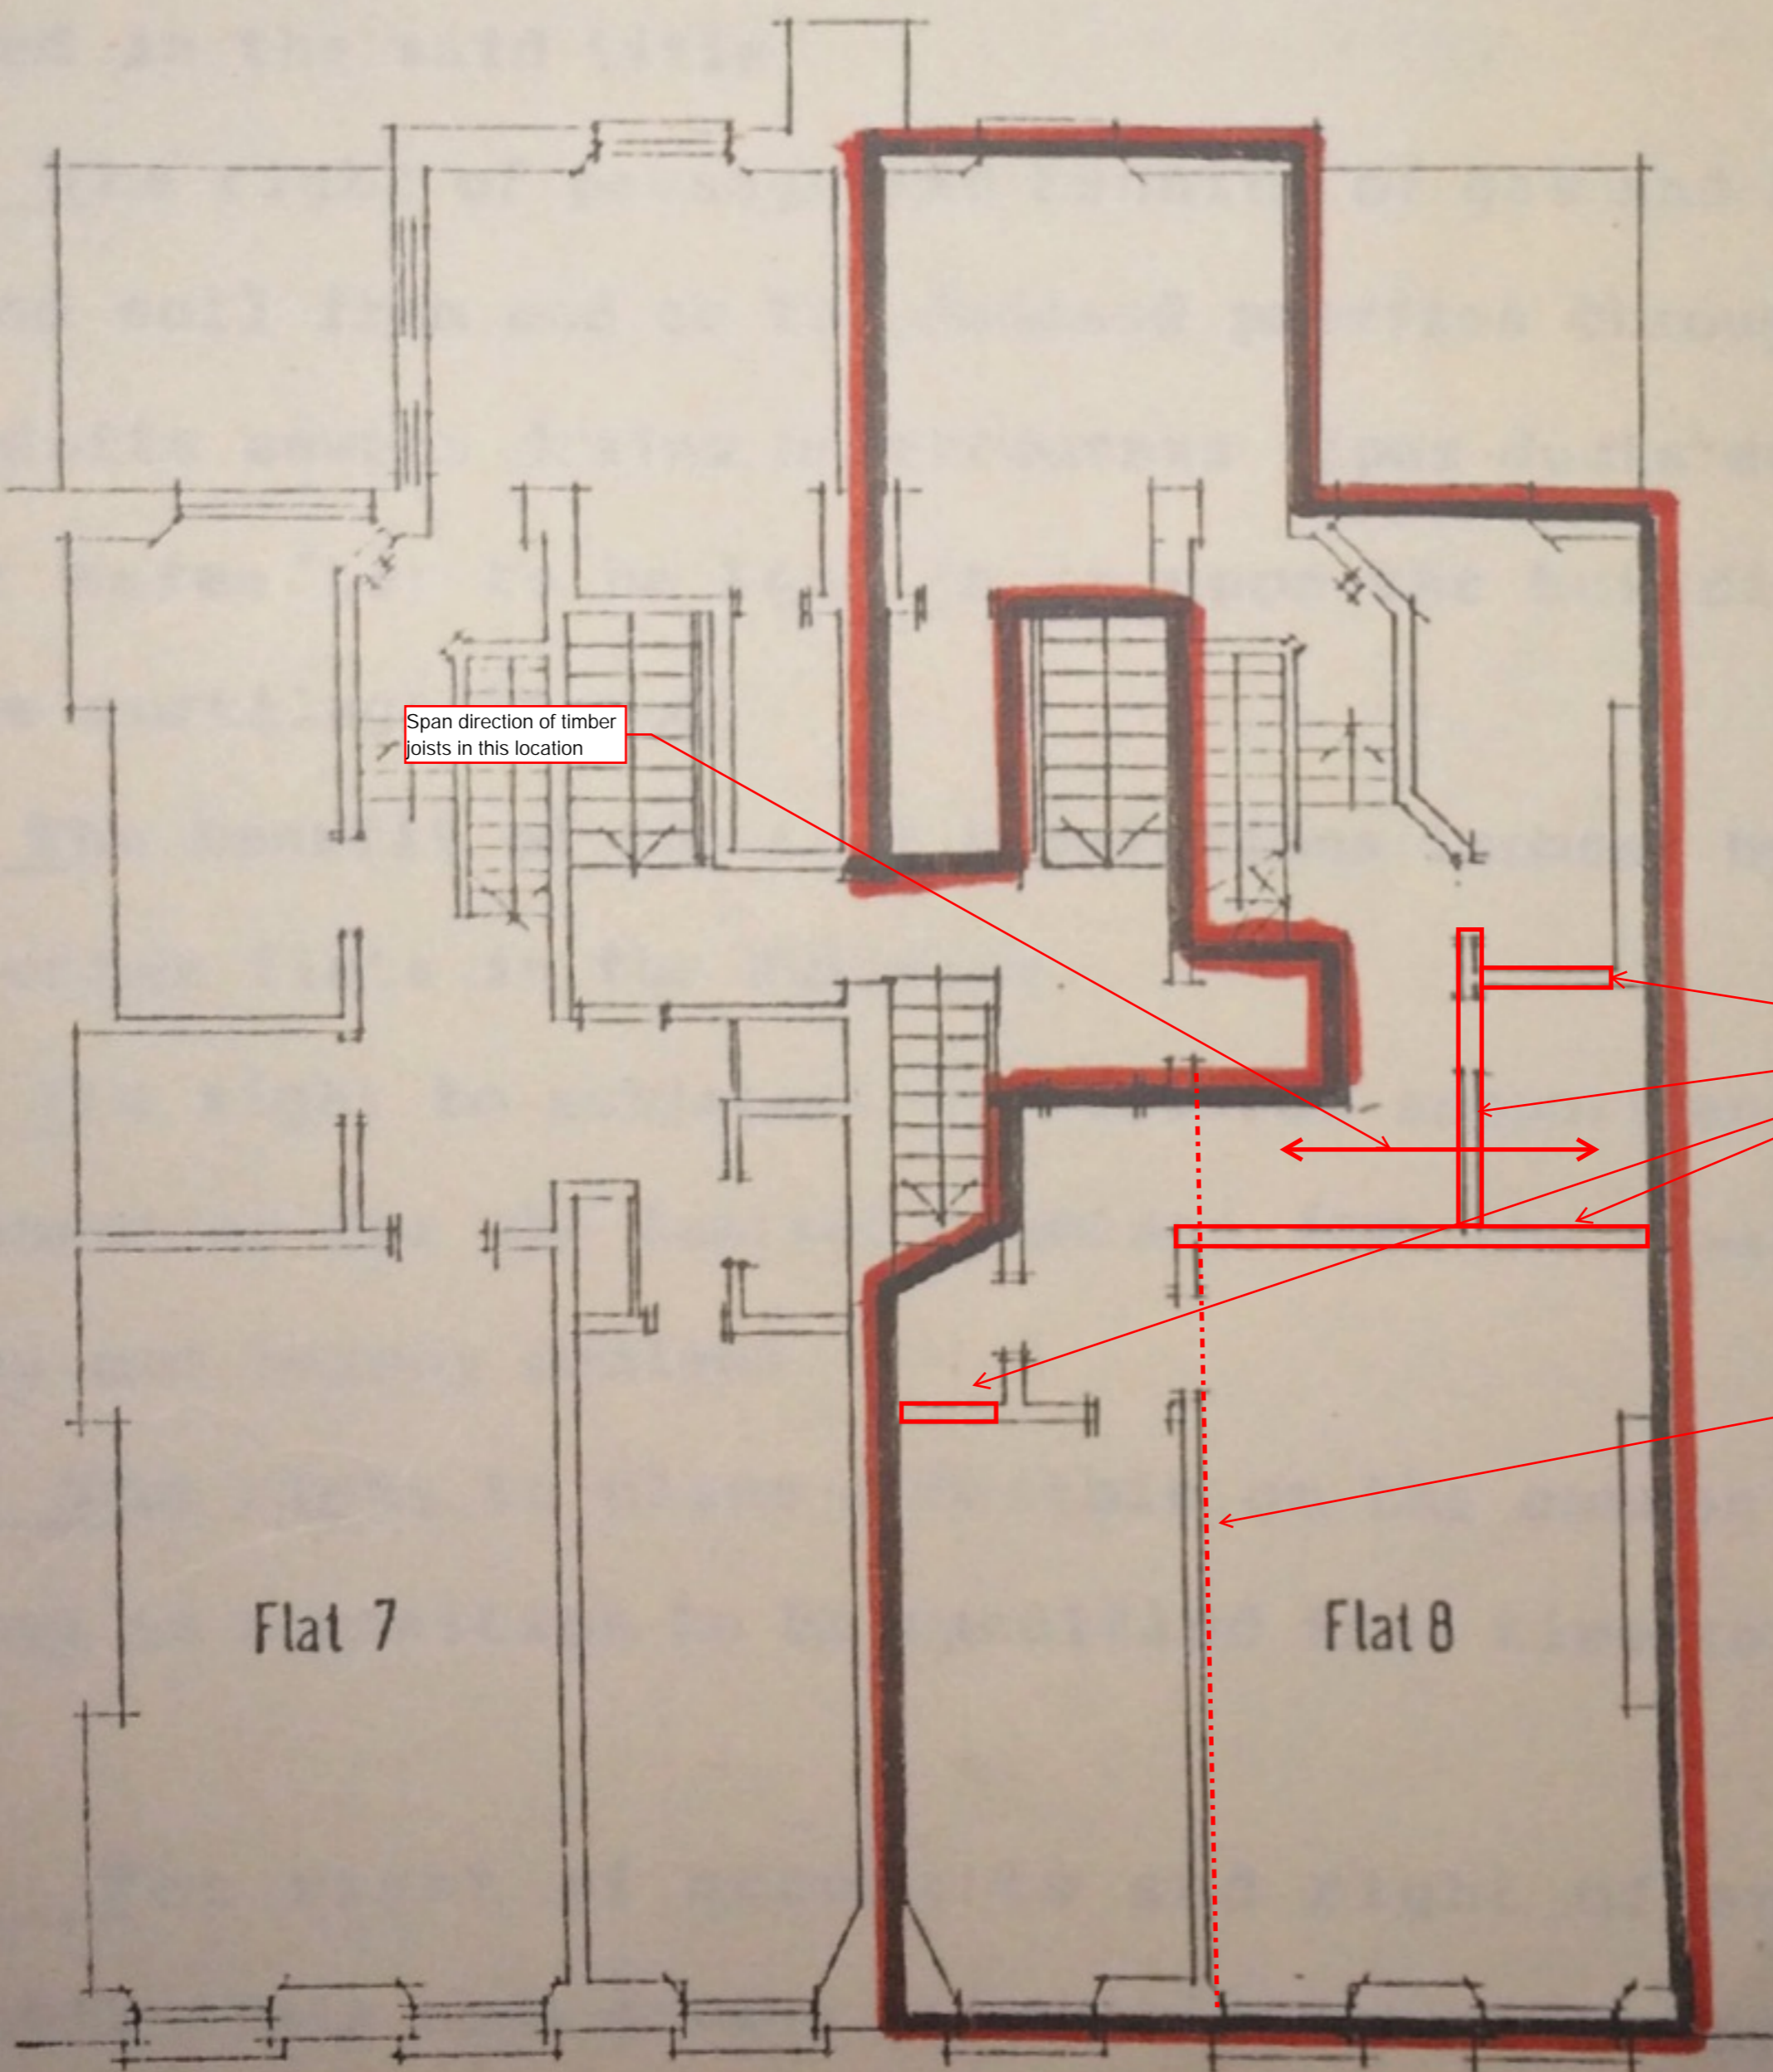
Span direction of timber joists in this location

Non structural walls

Existing steel beam
