RE: To seek planning permission for Rebuild of Barn 8, Abbey Farm, Alby, NR11 7HG in line with the existing Class Q planning permission but now falls outside its criteria due to necessary works

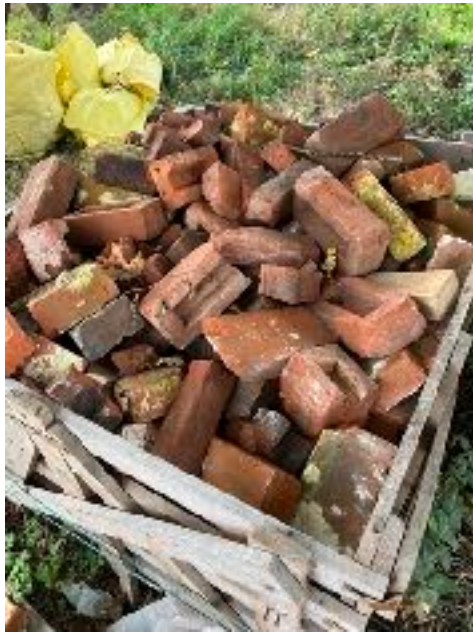
3.1 Fig 1 - Mixed Flint & soft reds savaged for Bungaroosh wall sections on East & West elevation

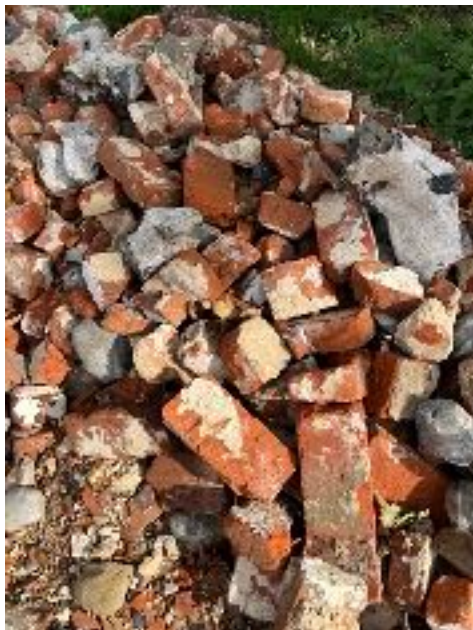
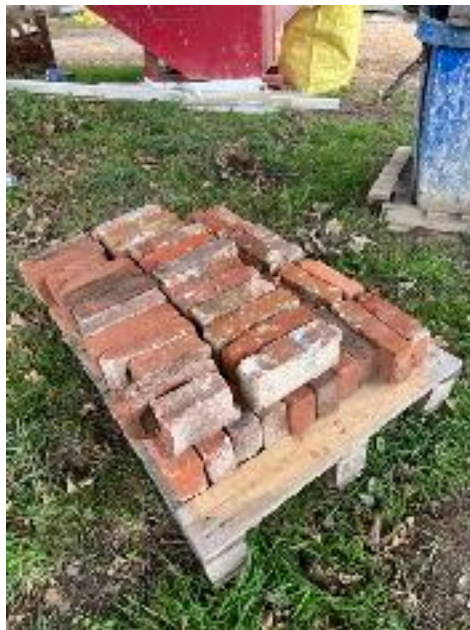
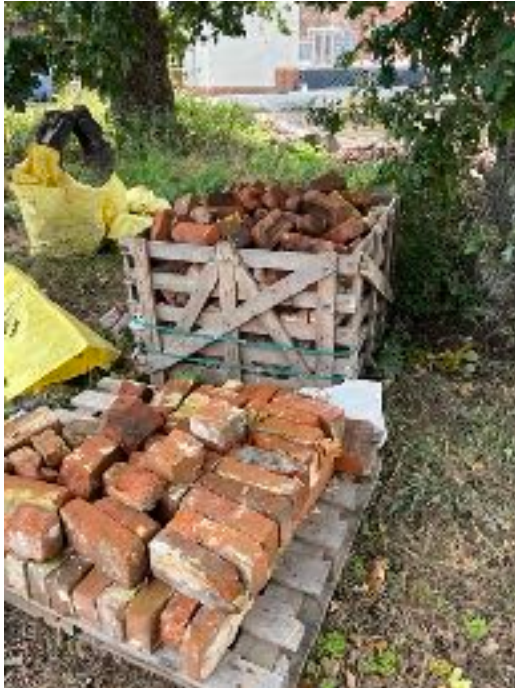
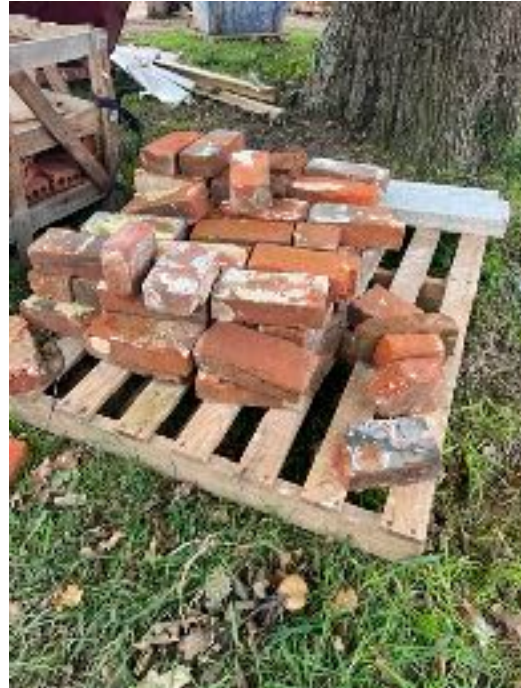
3.2 Fig 2 - Soft reds savaged for coursed work and ashlar on North & South elevations

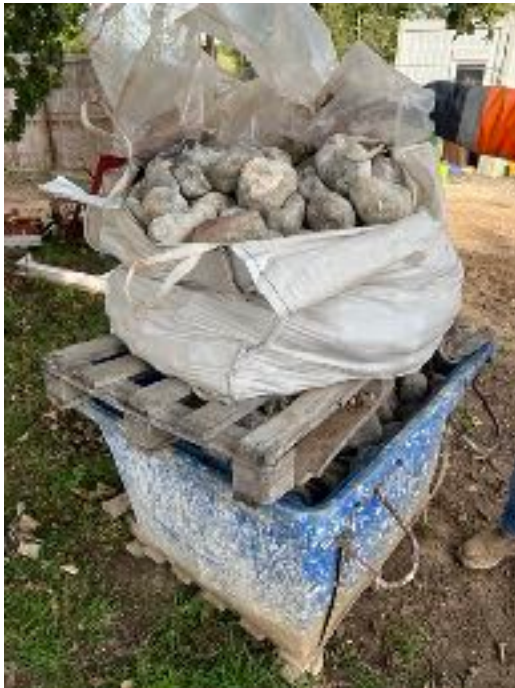
3.3 Fig 3 - Flints Salvaged for South Facing elevation

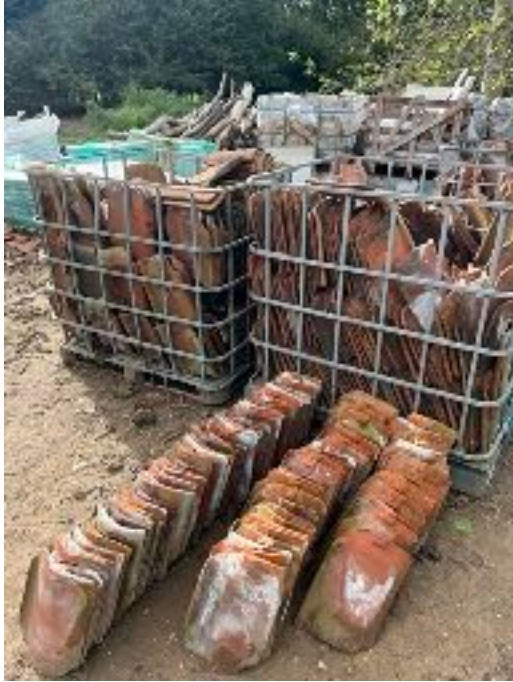
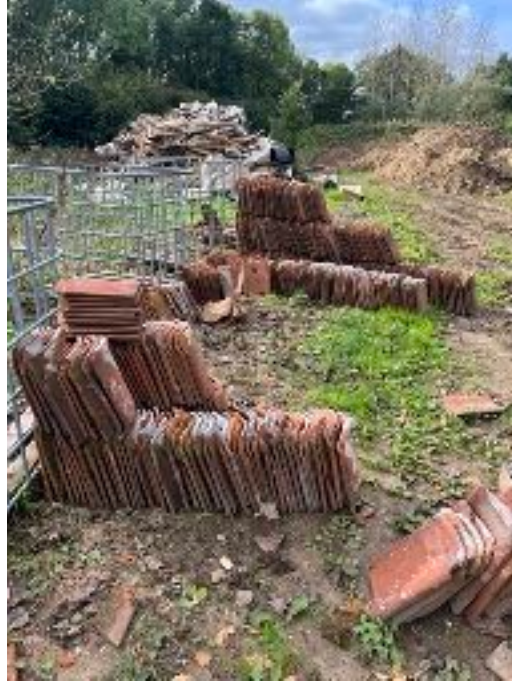
3.4 Fig 5 - Norfolk Pantile Salvaged for Roof
