Heritage Statement

External Alterations including dormer window changes, removal of chimneys, reroofing, replacement windows and new gutters

2 Elders Yard, Silver Street, Whitby, YO21 3BV

BHD Design Ltd, Airy Hill Manor, Whitby, YO21 1QB

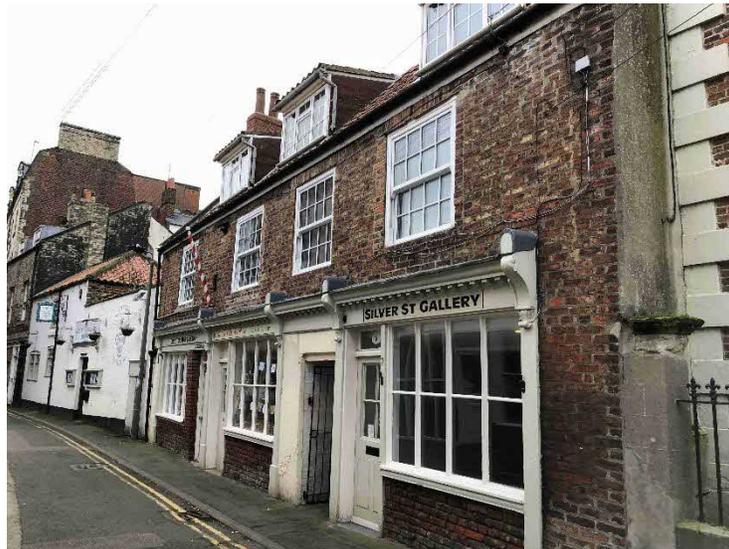
Walls:	clay brindle brickwork
Roof:	non interlocking clay pantiles
Front dormer windows:	clay pantile roof (almost flat), felted cheeks and white upvc windows

Photo 1
Front, Silver Street elevation

The front dormer windows will also be reclad as part of the reroofing. The tiles although at a less than recommended pitch will still be used as a finish but a fully

The current felt cheeks will be replaced with lead, flashed down onto the main roof.

The proposed windows will use the VEKA Flush sash range designed for a conservation appearance.

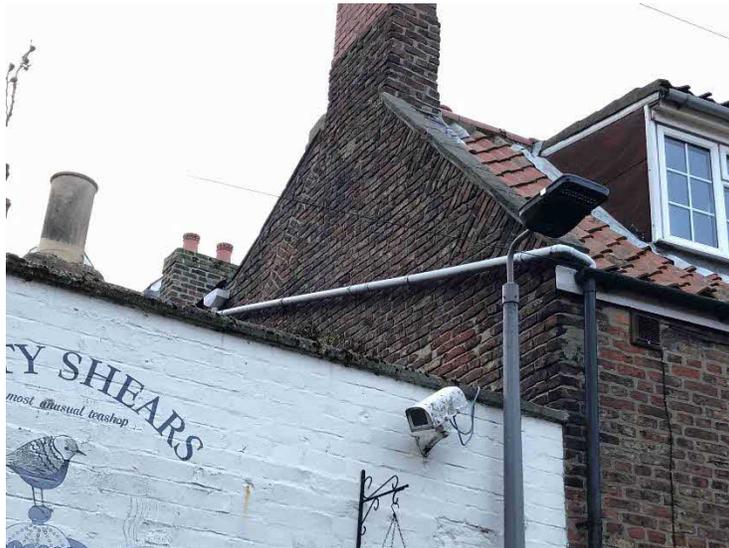
Historically, the rear elevation of the roof has been lifted to presumably increase habitable accommodation. This is evident on the South gable.

Photo 2
South gable, raised brick to rear with original 'brick tumbling' below copings

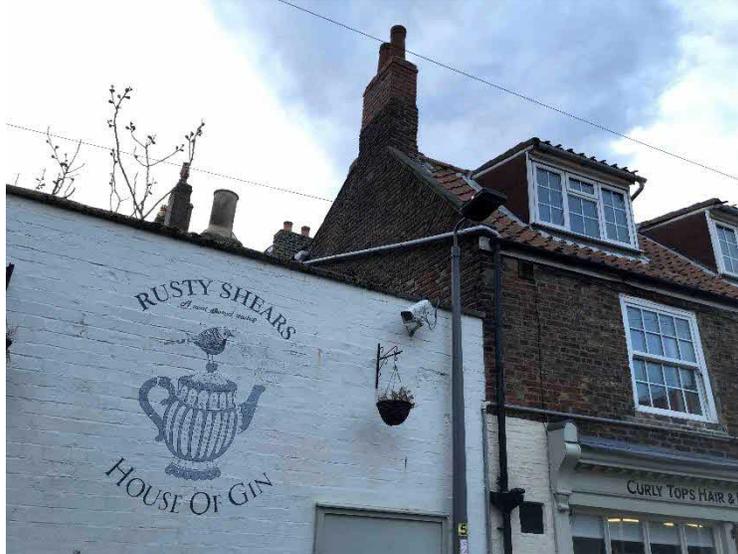
Photo 3
South gable, dormer detail and chimney

This is due to the roof, its abutments with the chimney stack and the dormer windows. The tiled but 'flat' nature of the dormer roofs is a poor detail.

Remove the above roof chimney stacks to allow an improved weather tightness and eliminate the current structural issues with the brickwork.

Remove the damaged brick chimney stacks, the Northern one has been reduced down to only just appear above the tiles. This will allow the roof to be more weather resistant.

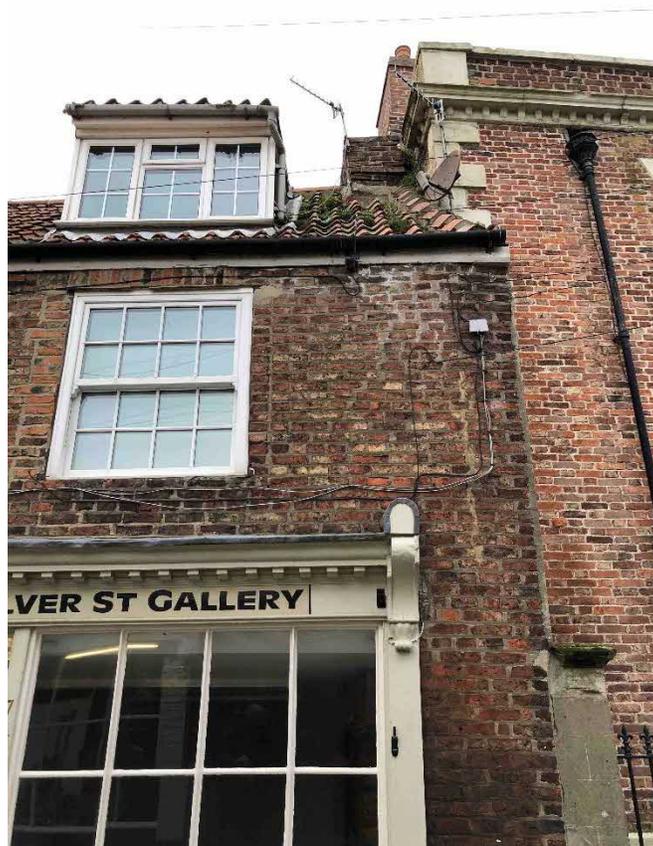
Photo 4
North end of roof, brick stub chimney

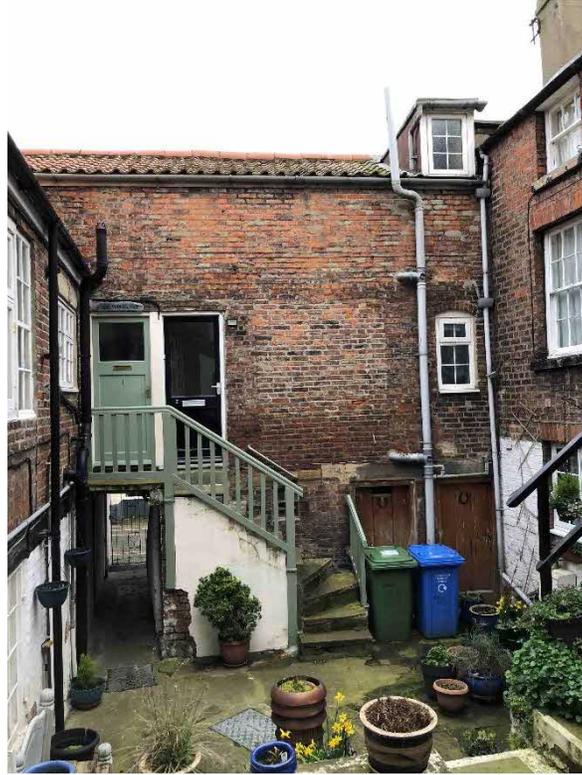
Rear dormer: Felt flat roof and cheeks. White upvc window
Door: Timber with glazed panel
Rainwater goods: Grey pvc to rear, black pvc to front

Photo 5
Rear elevation from Elders Yard

The existing flat roofed rear dormer is to be replaced with a larger version.

Replace gutters with new black pvc to both elevations.

Rainwater goods are also to be replaced. All will be black and not a mix of black and grey as currently appears. The type will be Polypipe, half round 112mm with 68mm downpipes.

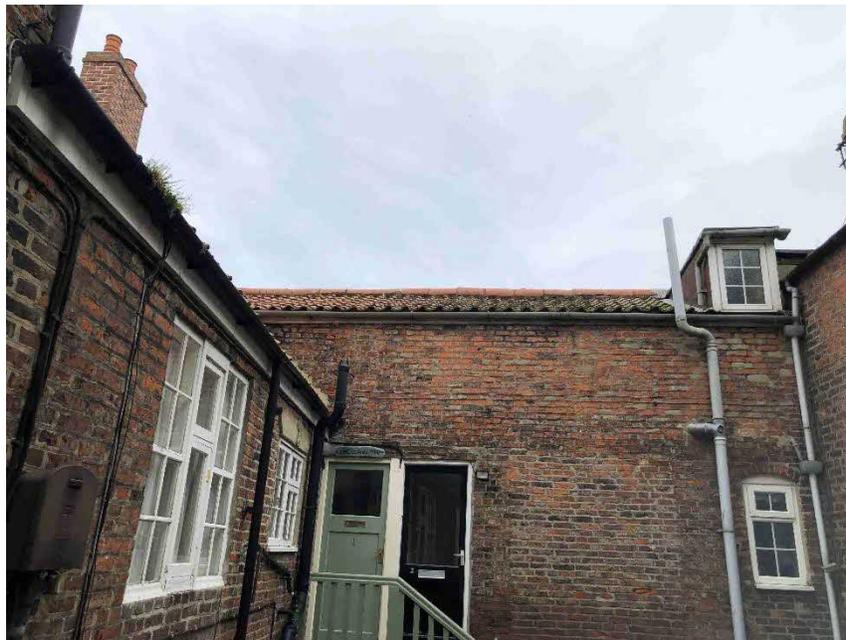
Photo 6
Rear elevation detail of dormer and raised brickwork

The rear dormer will have a grp roof and lead lined cheeks instead of the mineral felt currently used.
